2010 Inspection Report Lake Lemon Dam Unionville, Indiana

Lake Lemon Conservancy District
7599 North Tunnel Road
Unionville, Indiana 47468

DLZ Ohio, Inc.

December, 2010

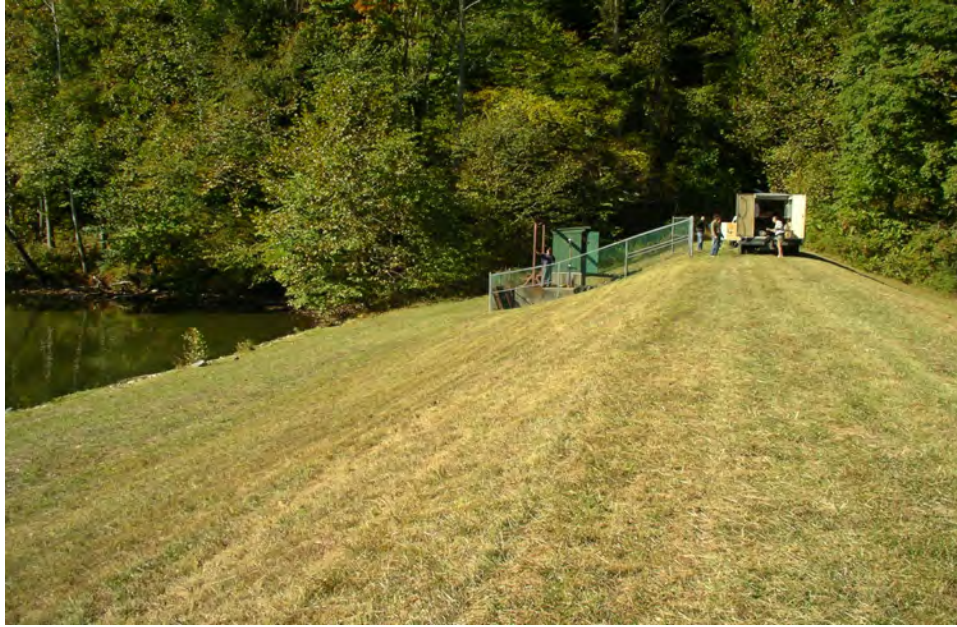
Photo 1. Embankment crest; view is towards left abutment.

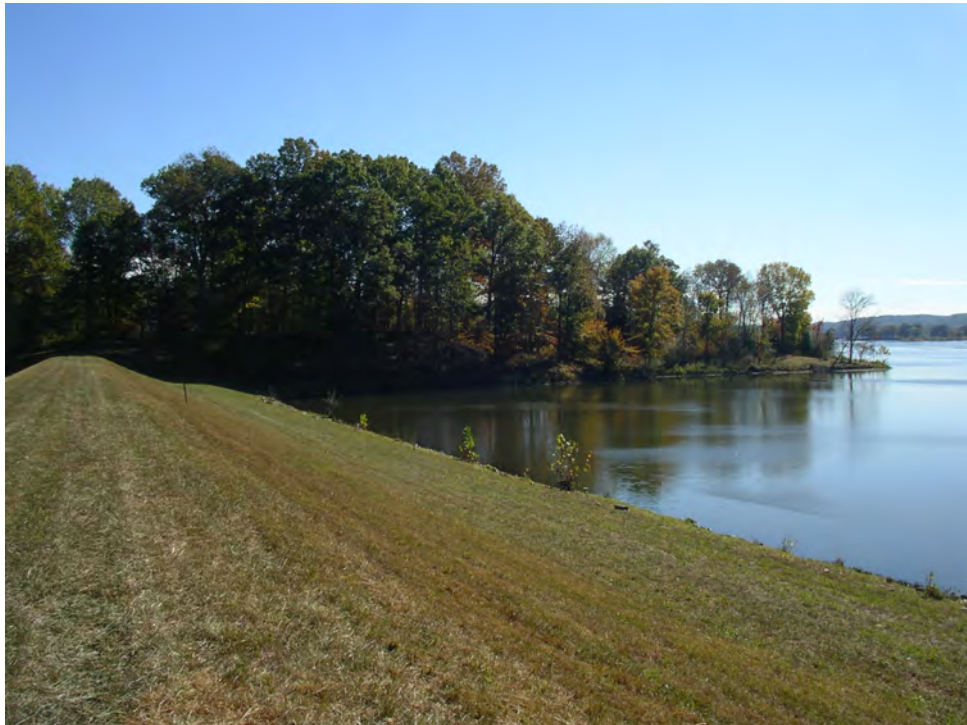
Photo 2. Upstream embankment slope; view is towards right abutment.

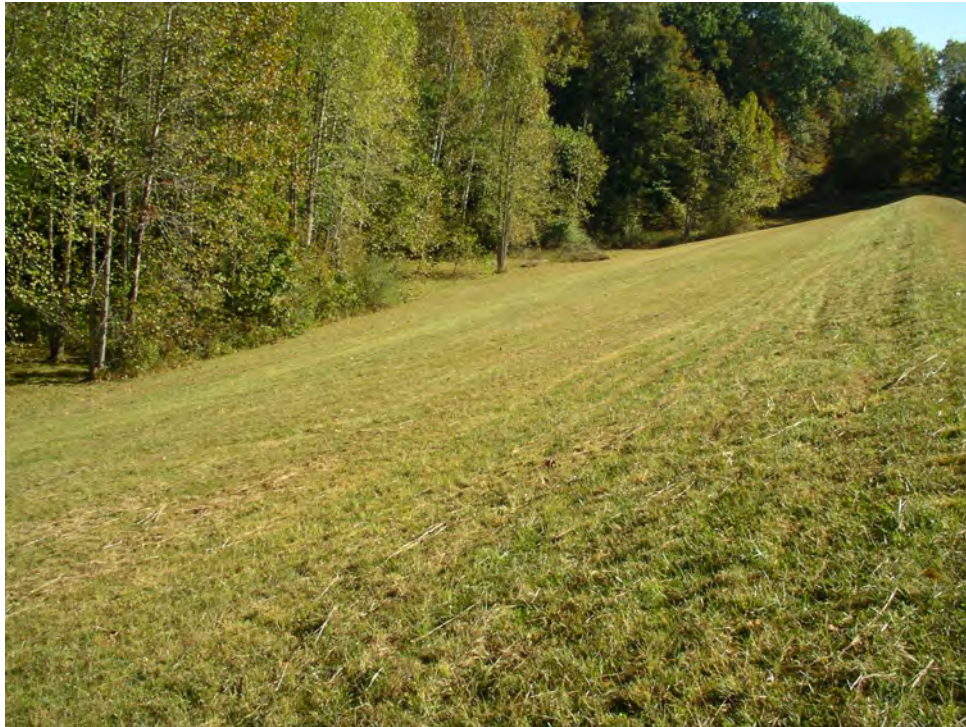
Photo 3. Downstream embankment slope; view is towards right abutment.

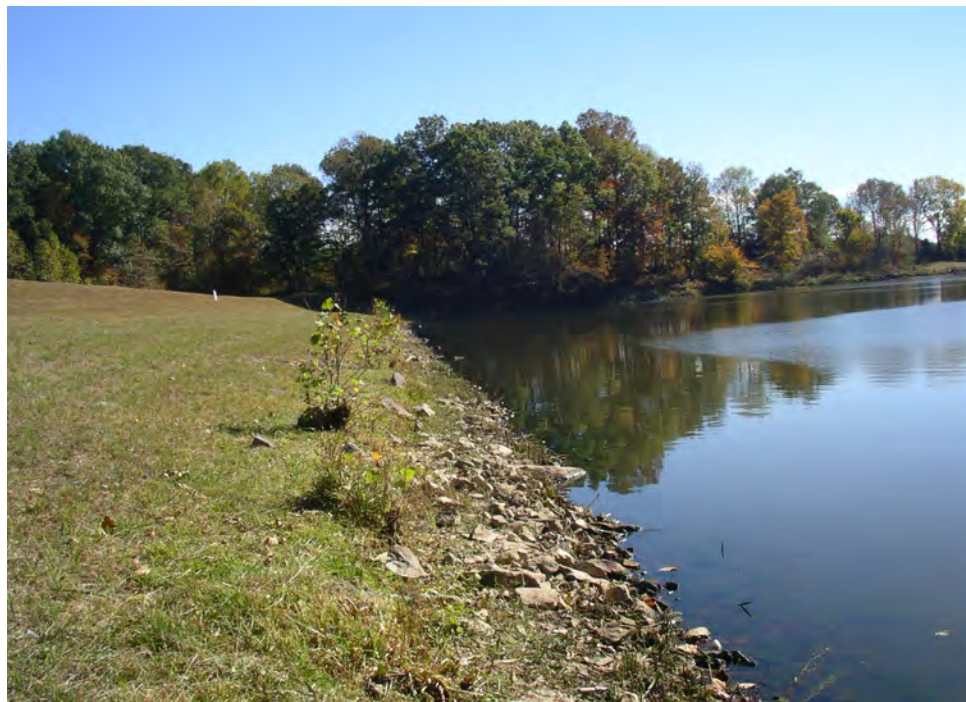
Isolated small trees were observed along the shore of the upstream embankment slope (Photo 4). These small trees should be removed. Rutting on the crest was noted in the 2008 inspection. The rutting occurred as a result of a large rainfall event in June 2008 and subsequent vehicular mower traffic. The ruts were filled after the 2008 inspection. Rutting was not observed during this inspection. An animal burrow was observed on the right side of the upstream slope, near the shore (Photo 5). Since animal passageways can lead to water piping in the embankment soils, it is recommended that the embankment be monitored visually on a regular basis. Any burrows should be filled with competent, well compacted material. If deemed necessary, a rodent control program may be needed to prevent the propagation of the burrowing animal population and to prevent future damage to the dam.

Photo 4. Isolated small trees along the shore.

1. Remove isolated small trees along the shore.
2. Fill any animal borrows on the embankment with competent, well compacted material. Monitor animal activities on the embankment.

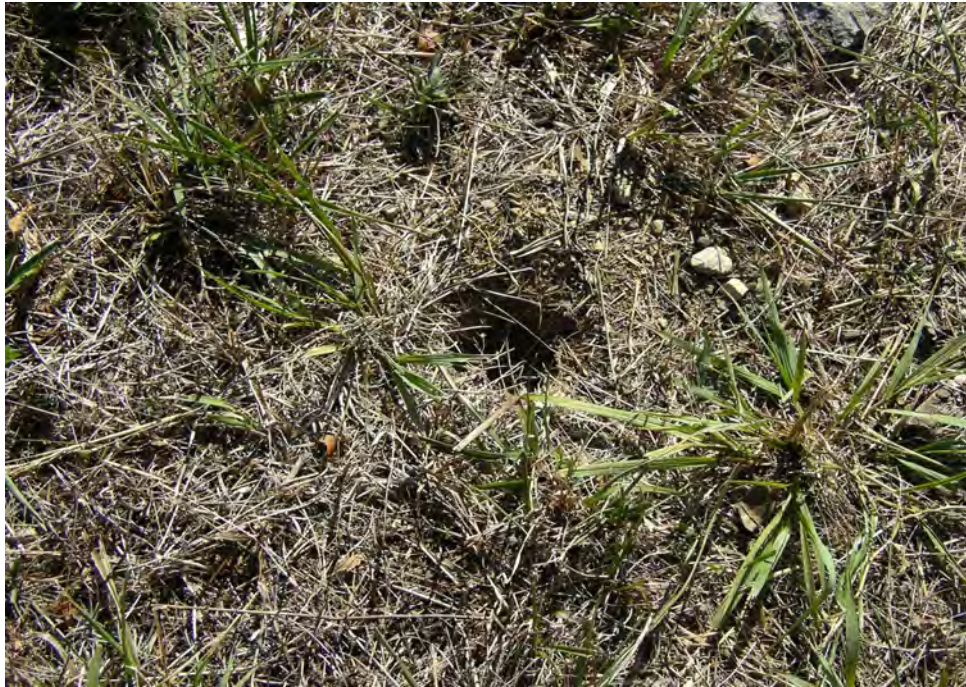
Photo 5. A burrow was observed on right side of upstream slope, near the shore.

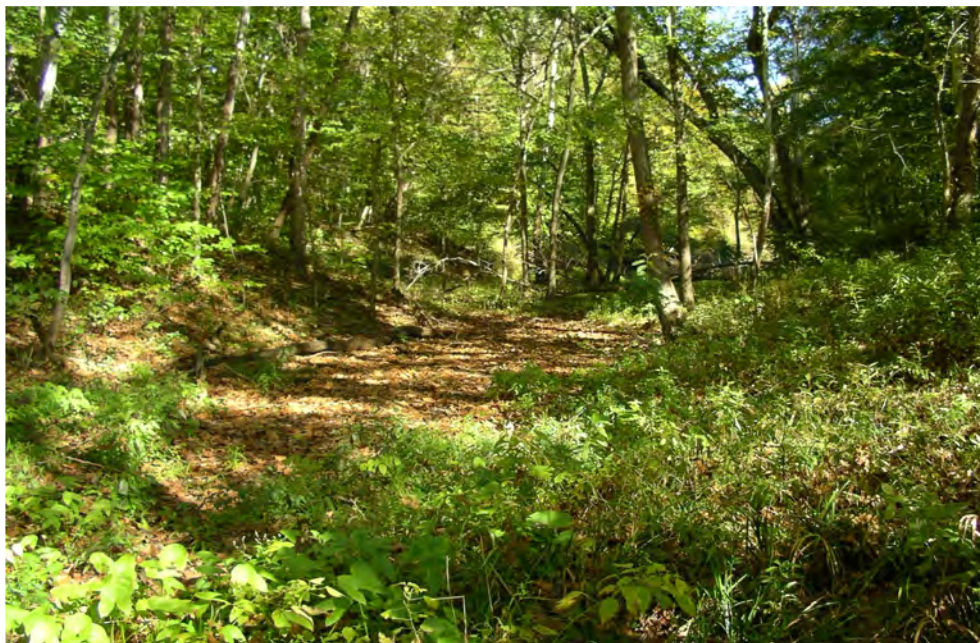
Photo 6. Original stream channel downstream from midpoint of embankment.

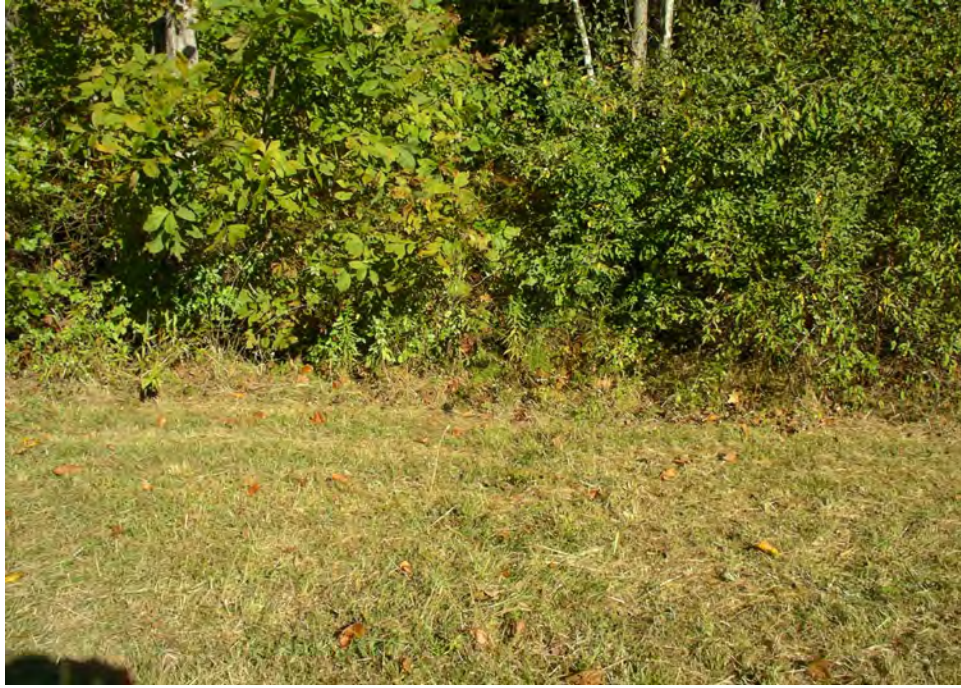
In previous inspections, an area of possible seepage was observed along the downstream toe, near the midpoint of the embankment. This area appears to be the location of the original stream channel. No discharge was seen during the 2008 inspection, but the old channel was wet with iron-stained, brackish water. However, during this inspection the old channel was dry (Photo 6) and no seepage was noted along the downstream toe (Photo 7). Because of the high hazard

Photo 7. Downstream toe near midpoint of embankment.

associated with the project, it is recommended that this area be monitored on a monthly basis and following significant rainfall events. Any appearance of seepage and subsequent changes in seepage quantity in this area should be brought to the attention of a dam engineer immediately.

3. Monitor the area downstream of the right abutment groin for standing water following high pool events and after periods of heavy rain.
4. Monitor the area along the downstream toe near the midpoint of the embankment for possible seepage. Report any changes to a dam engineer immediately.

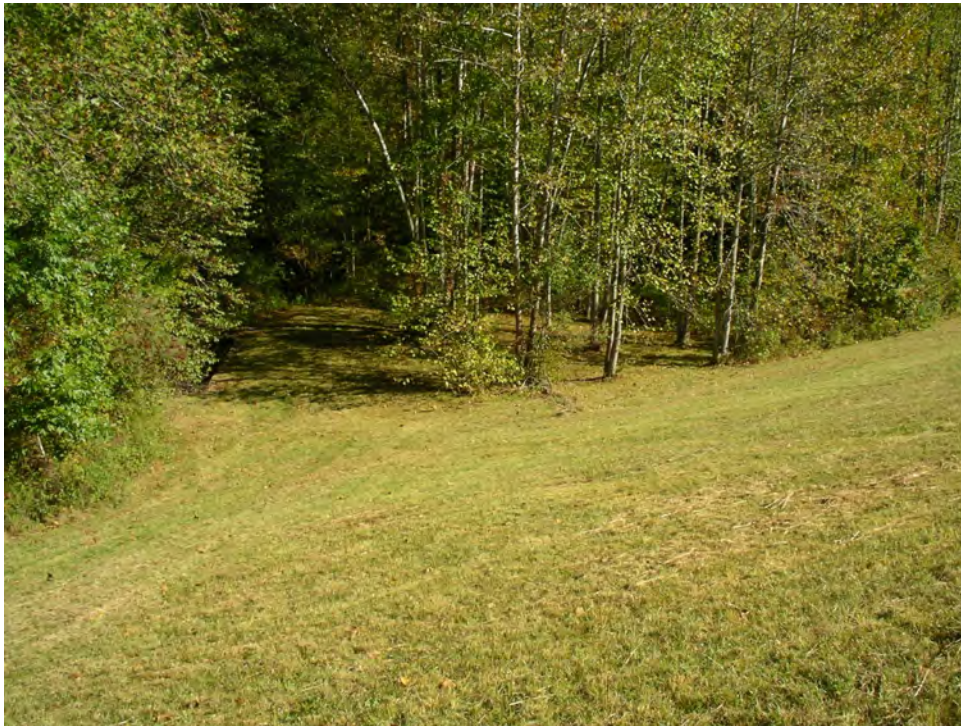
Ponded water was observed immediately downstream of the right groin in previous inspections. Runoff from the embankment and right abutment tends to pond in this area. In past inspections, it was suggested that the owner consider regrading this area to allow for proper water drainage. It is understood that the owner did review this area in 2007 and the area was dry at that time. Consequently, the owner did not feel re-grading was necessary. During this inspection, standing water was not observed immediately downstream of the right groin (Photo 8). However, it is recommended that the area be monitored particularly after periods of heavy rain.

Photo 8. Right groin area of embankment.

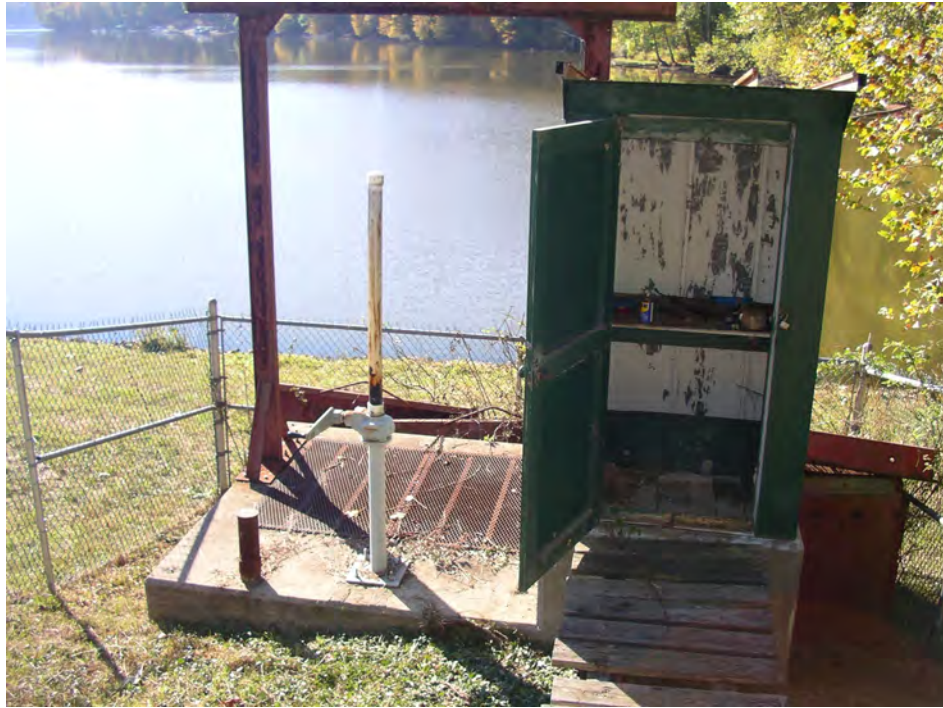
During this inspection, the upstream portion of the outlet works, between the gatewell and the pipe inlet, was inspected. No obvious distress was noted in the concrete walls and floors during the inspection. However, the steel bars of the trash rack that keeps logs and debris from entering the gatewell have rusted almost half way through and should be replaced or repaired.

Photo 9. Gatewell structure.

8. Replace or repair the ladder at the gatewell.
9. Replace or repair the trash rack at the intake conduit.
10. Remove the small tree and what appeared to be “mud dauber’s nests” on the lower end of the right training of the principal spillway. Repair the concrete surface, if necessary.

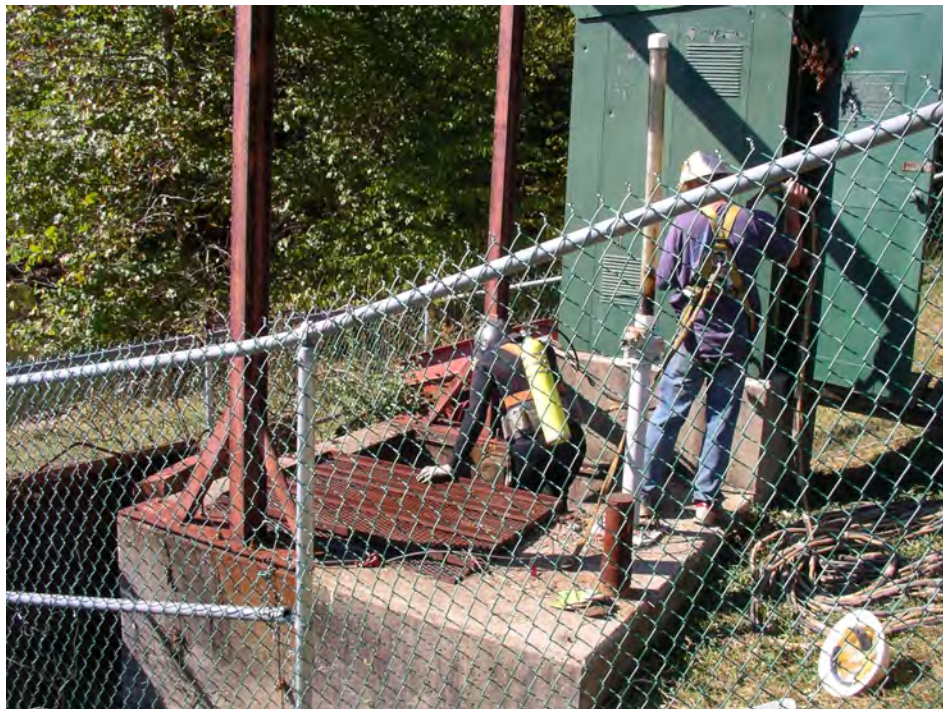
Photo 10. Diver entering gatewell for inspection.

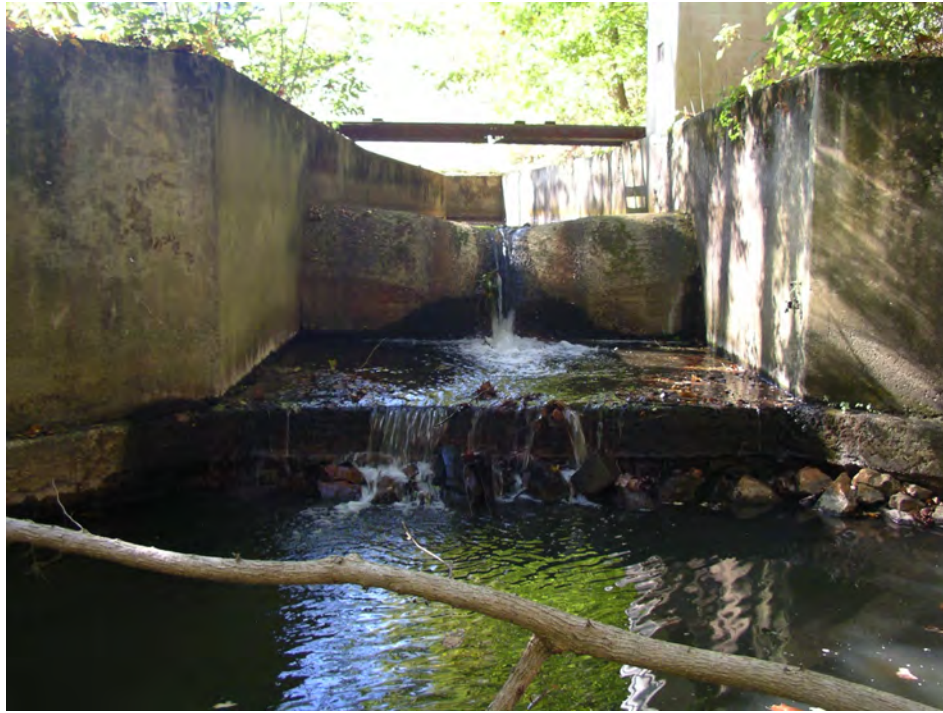
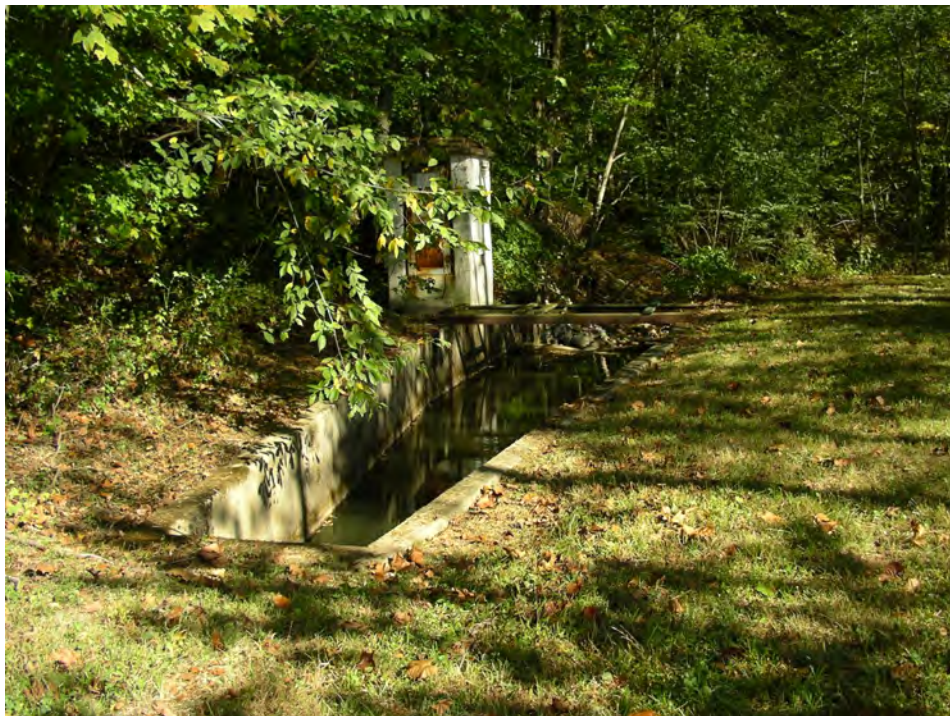
The visible portions of the outlet works appeared in satisfactory condition. The condition of the stilling basin appeared unchanged from previous inspections (Photo 11 and Photo 12).

Photo 11. Stilling basin; view is towards upstream.

Photo 12. Stilling basin; view is towards downstream.

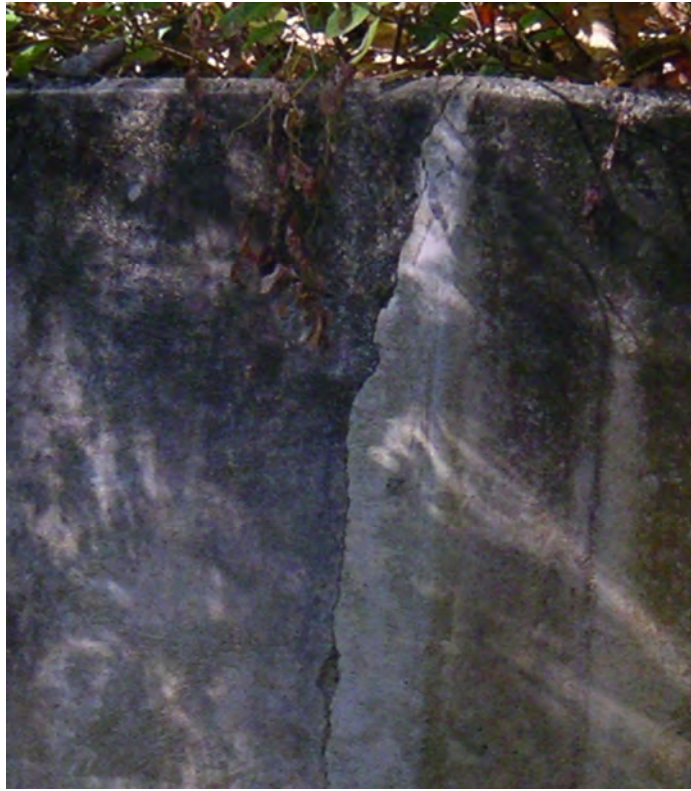
In previous inspections, a large crack was observed in the left wall near the end of the stilling basin. This crack appeared to be about ½ inch wide and extended from the top of the wall to the bottom (Photo 13). This crack appeared old and appeared unchanged from the 2008 inspection.

Photo 13. A crack in left stilling basin wall.

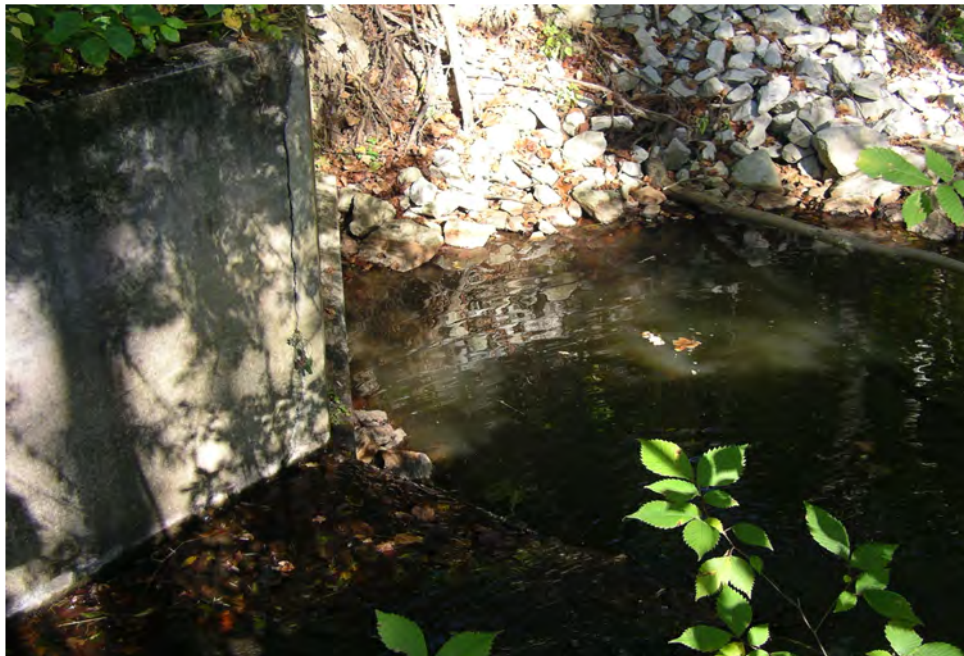
During the 2008 inspection, the stilling basin was dewatered as part of the inspection. An area of scour beneath the channel bottom was noted immediately downstream of the end of the stilling basin concrete pad. This scoured area was repaired by placement of riprap in the fall of 2009. However, it is understood that the rip rap was washed away during winter drawdown in the same year. The scoured area has not yet been backfilled with riprap (Photo 14). It is recommended that the scoured area be backfilled again with large riprap to prevent the scoured area from enlarging and undermining the stilling basin concrete slab. The stilling basin design should be reviewed to determine the water flow velocities at the end of the stilling basin so that the riprap can be properly sized for the anticipated velocities.

Photo 14. Scoured area immediately downstream of stilling basin concrete pad.

5. Repair scoured areas in the channel bottom immediately downstream of the end of the stilling basin concrete slab. It is anticipated that large riprap will be needed. The design velocities for the outflow will need to be evaluated to properly size the riprap.

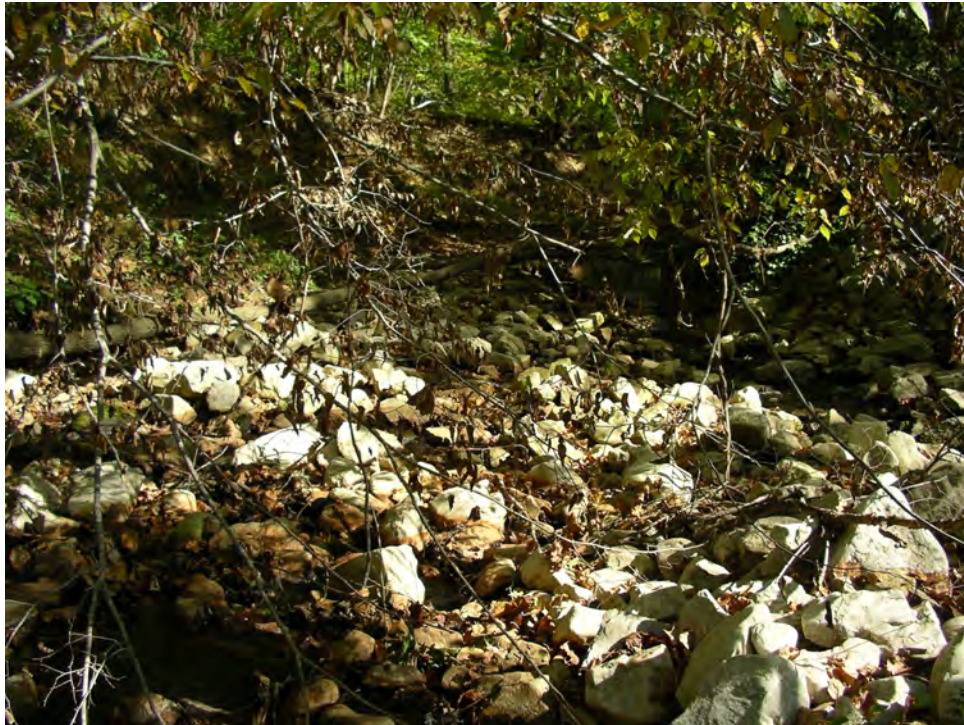
The banks of the outlet channel downstream of the stilling basin were showing signs of erosion and instability (Photo 15). This condition should be monitored. If debris in the channel affects the outflow, the debris should be removed.

Photo 15. Outlet channel downstream of stilling basin.

6. Monitor the stability and erosion condition of the banks of the outlet channel downstream of the stilling basin concrete slab. Clear excessive debris in the outlet channel regularly.

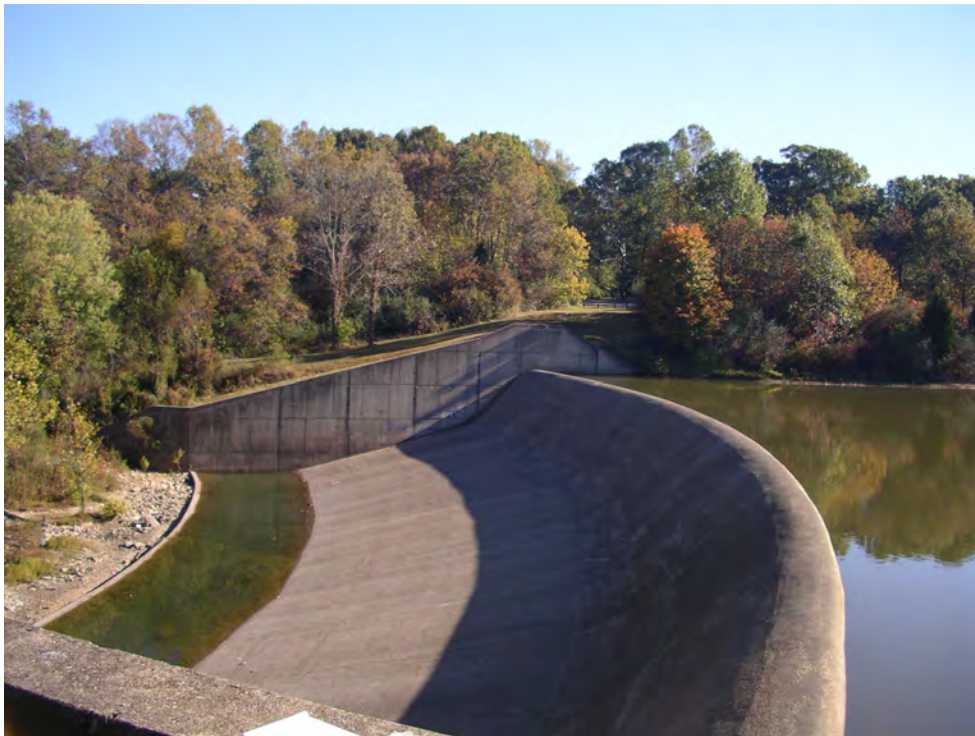
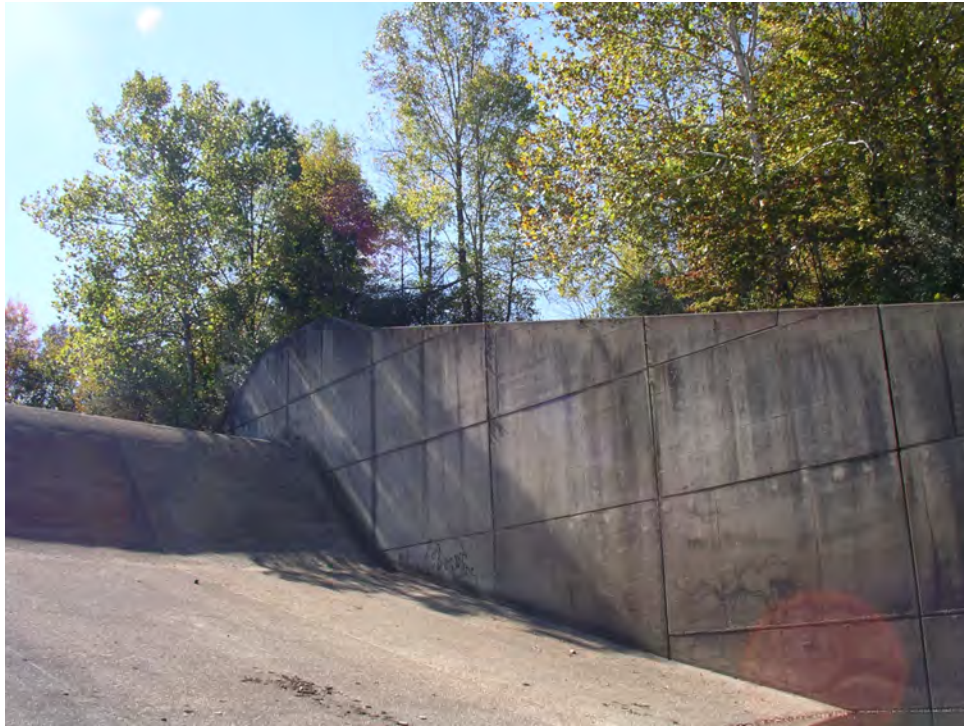
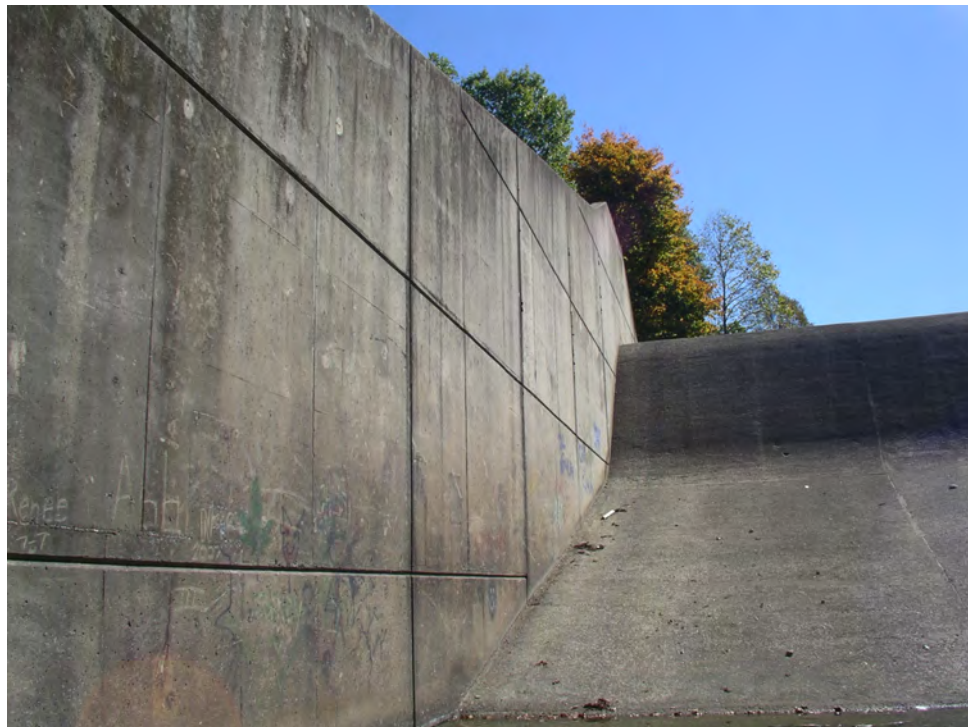
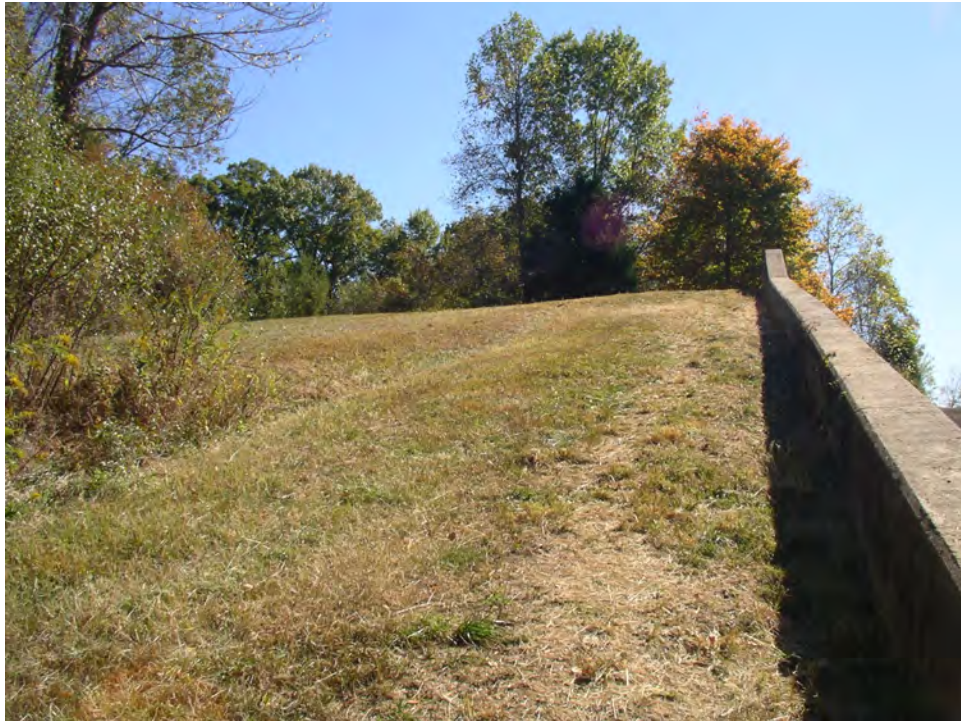
The principal spillway was in acceptable condition (Photos 16, 17, 18, and 19). There appeared to be no significant changes since the last inspection. There had been some horizontal displacements, approximately ½ to ¾ inches, in the joints of the training walls over the years (Photo 20). However, during this inspection, a joint in the upper end of the right training wall was found to have widened to slightly over an inch (Photo 21). This joint widening is probably the result of water penetration and repeated freeze-thaw attacks over time. It is recommended that all joints be properly sealed with competent material.

Photo 16. Crest of ogee spillway.

Photo 17. Left training wall of spillway.

Photo 18. Right training wall of spillway.

Photo 19. Sloping ground surface behind right training wall spillway.

11. Seal all joints and cracks in the training walls of the principal spillway. Visually monitor for any additional settlement or displacement of the principle spillway.

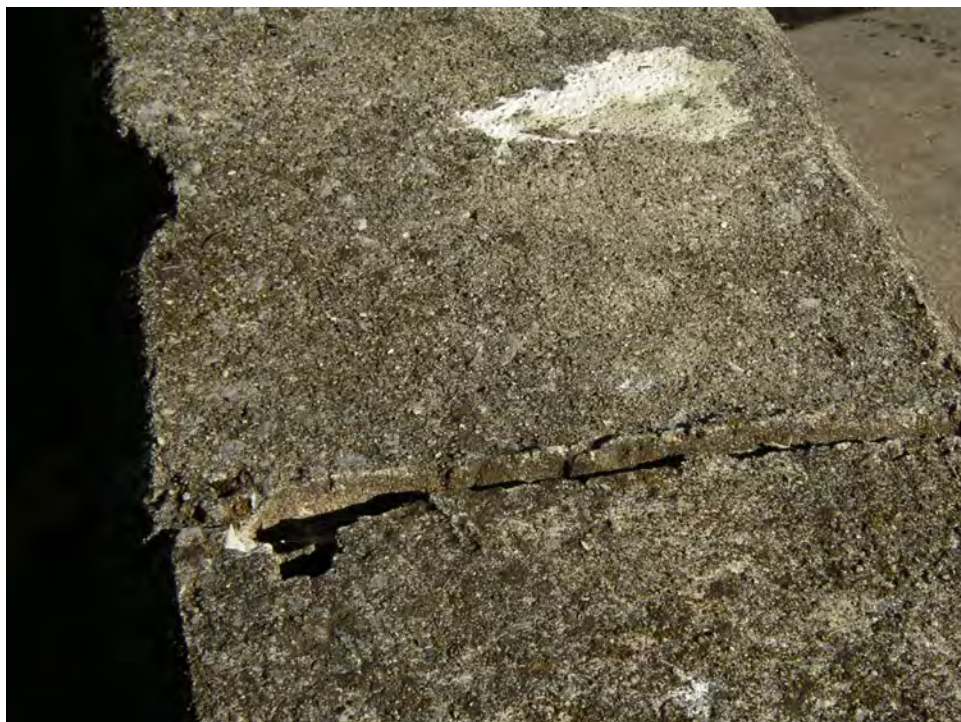
Photo 20. View of a typical joint displacement in upper end of left training wall of spillway.

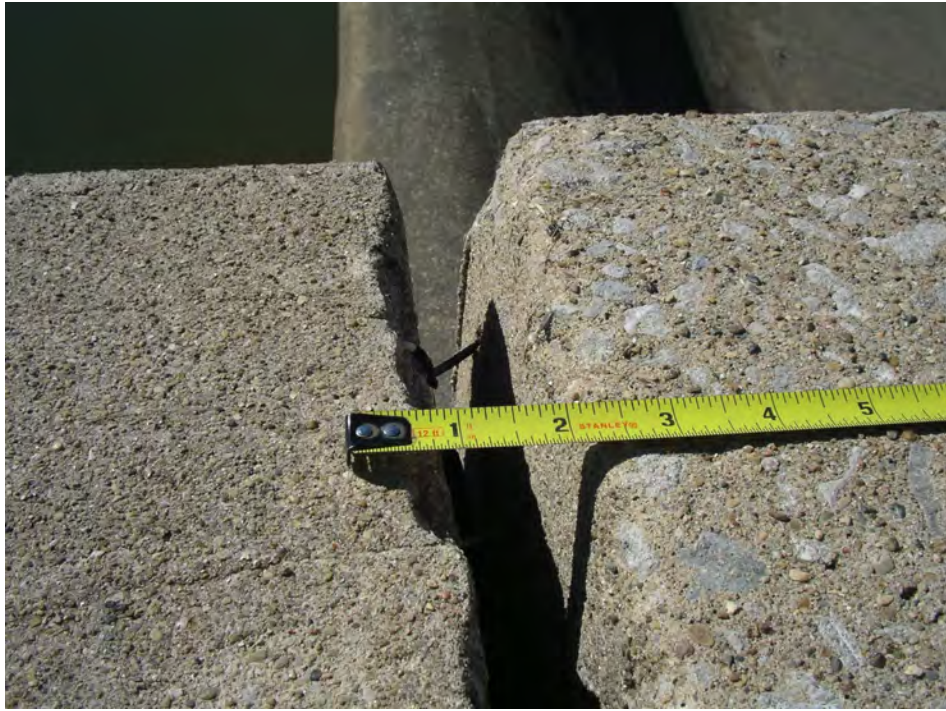
Photo 21. View of joint displacement in upper end of right training wall of spillway.

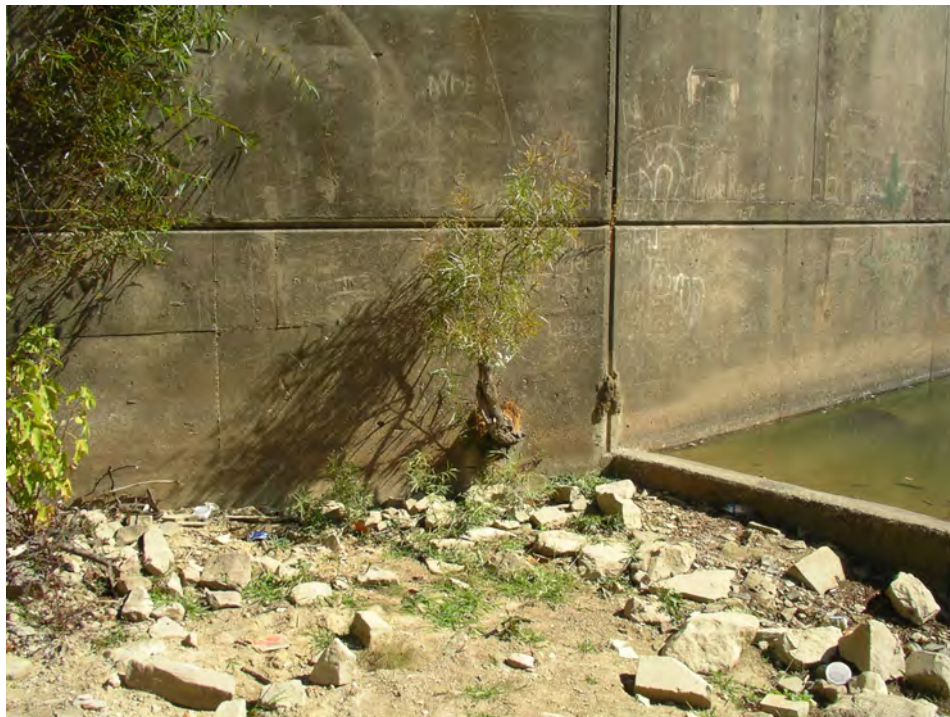
A small tree and what appeared to be “mud dauber’s nests” were observed on the lower end of the right training wall (Photo 22). The tree and the nests should be removed and the concrete surface repaired, if necessary.

Photo 22. A small tree and “mud dauber’s nests” on lower end of right training wall of spillway.

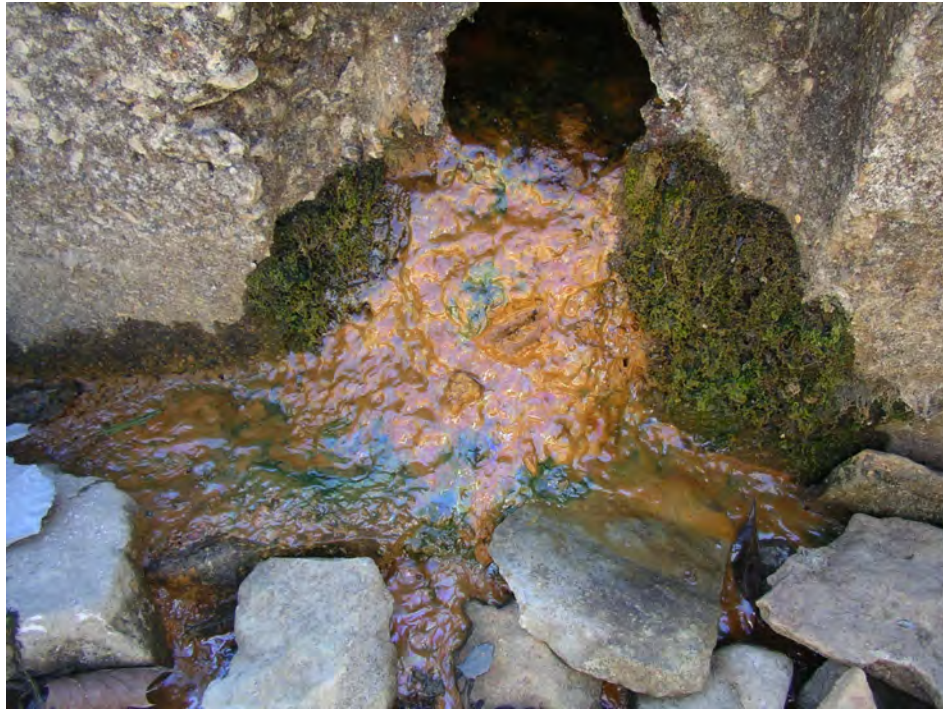
Large masses of brown “sticky” gelatinous substance were observed at the outlet pipes near the midpoint of the spillway’s end sill (Photo 23). This brown substance appeared to be iron bacteria, which could plug the outlet pipes if they grow excessively. The brown substance should be removed and cleared out of the pipes.

Photo 23. Brown “sticky” gelatinous substance (iron bacteria) at an outlet pipe of spillway.

12. Remove and clear what appeared to be iron bacteria from the outlet pipes at the downstream toe of the spillway.

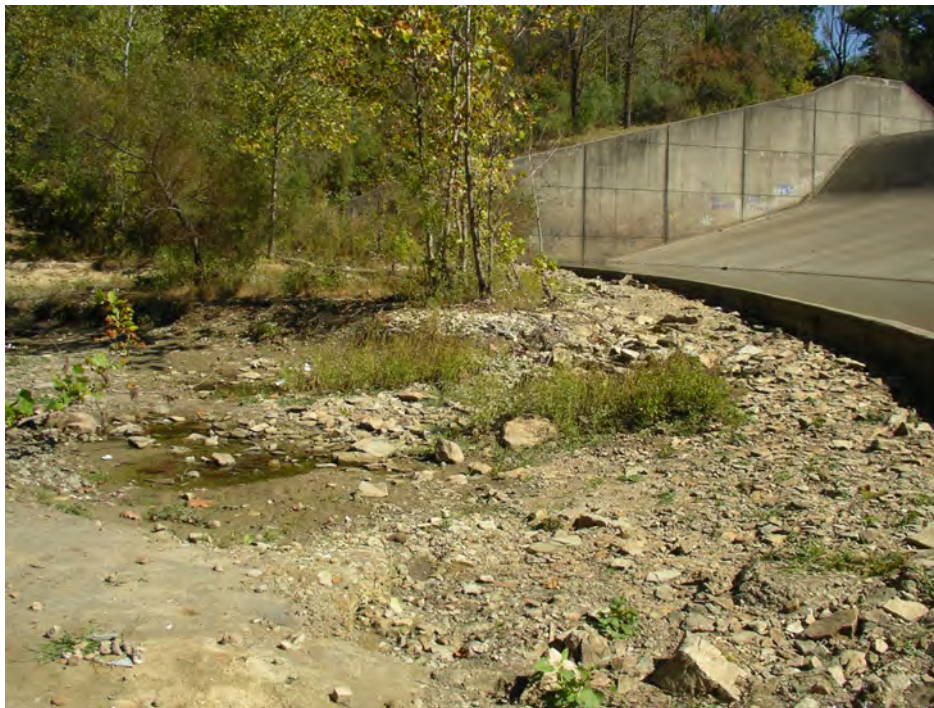
There was possible minor erosion immediately downstream of the end sill (Photo 24). If this condition worsens, the end slab could be endangered as the erosion progresses upstream beneath the slab. This erosion condition should be monitored, especially after significant spillway

Photo 24. Minor erosion along end sill of spillway.

discharges. If the condition worsens, it is anticipated that properly-sized riprap could be placed immediately downstream of the end sill to armor the area.

13. Following high pool events, monitor any channel erosion downstream of the ogee's end concrete sill.
