# 2012 Inspection Report Lake Lemon Dam Unionville, Indiana

DLZ Job No. 1263-0837.70

**December, 2012**

As requested by the Lake Lemon Conservancy District and the City of Bloomington Utilities, DLZ Ohio, Inc. (DLZ) performed a field inspection of Lake Lemon Dam on September 26, 2012. Mr. Eric Tse, a geotechnical engineer with DLZ, completed the surficial inspection of the dam. During the inspection, color photographs were taken of pertinent features of the dam. Representative photographs are included in this report in Appendix I.

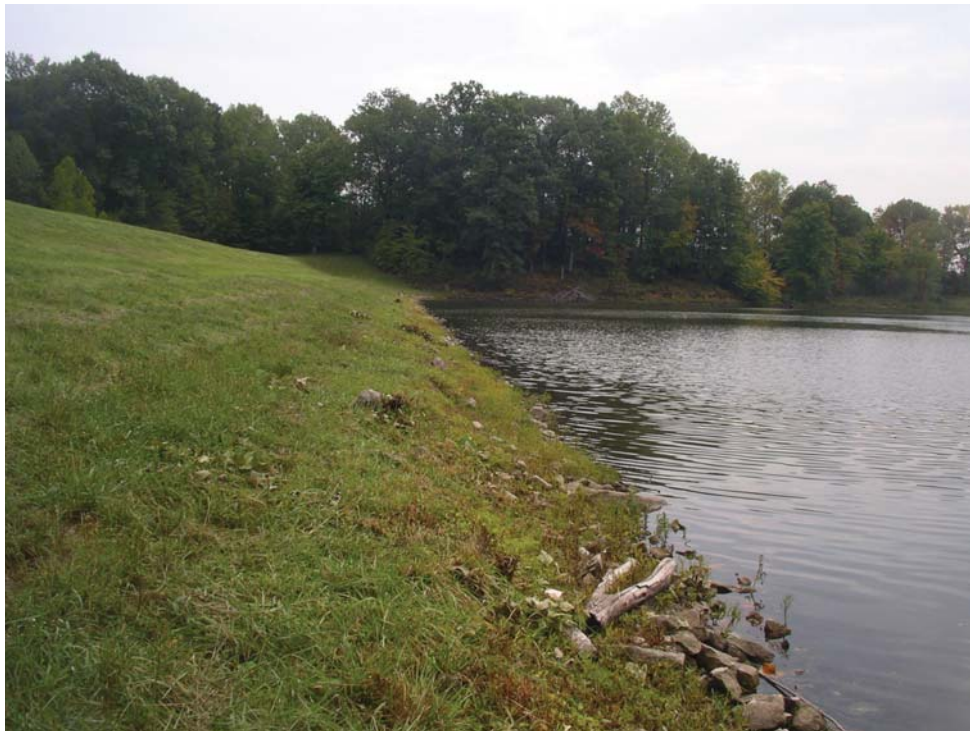
Isolated small trees were observed along the shore of the upstream embankment slope during the 2010 inspection, but these small trees had since been removed (Photograph 4). An animal burrow was observed on the right side of the upstream slope during the 2010 inspection. This animal burrow appeared to have been filled. However, several animal burrows, varying from approximately 0.5 to 2.0 inches in diameter, were observed near the central portion and the right side of the upstream slope during this inspection (Photograph 5). The locations of these animal burrows were marked and the Lake Manager was informed of the existence of the animal burrows.

Photograph 4: View of upstream slope along the shore.

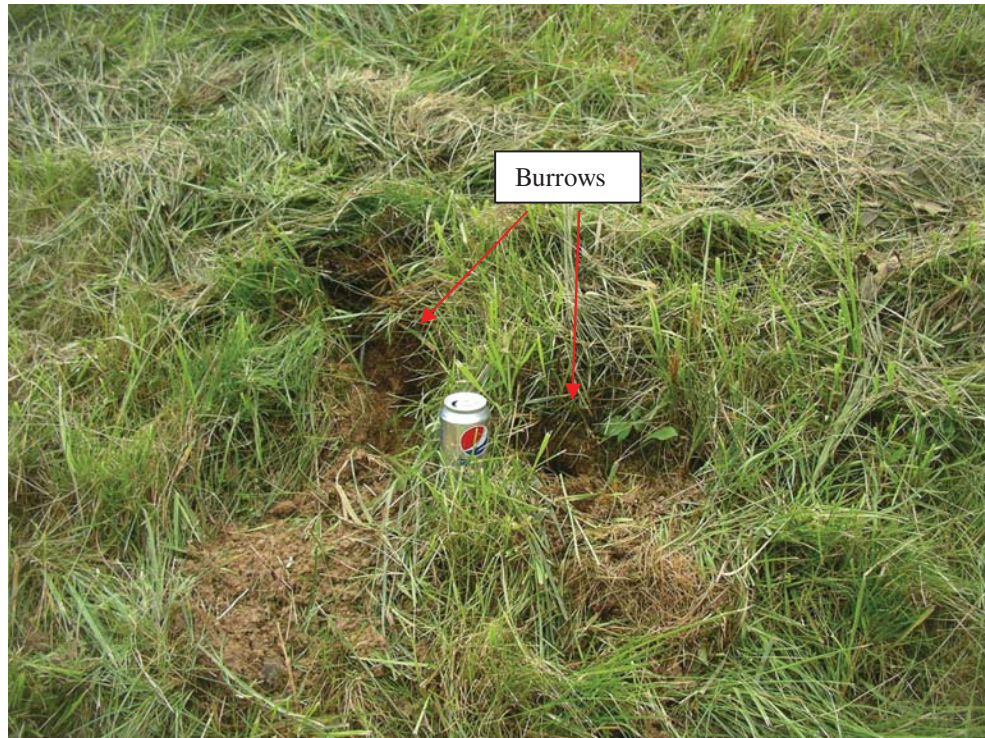
Photograph 5: Burrows were observed on the upstream slope.

1. Several animal burrows, varying from approximately 0.5 to 2.0 inches in diameter, were observed near the central portion and the right side of the upstream slope during this inspection. Reportedly, these burrows had since been filled with compacted soil (Photographs 25 and 26). It is recommended that the embankment be monitored for animal activities on a regular basis. If deemed necessary, a rodent control program may be needed to prevent the propagation of the burrowing animal population and to prevent future damage to the dam.

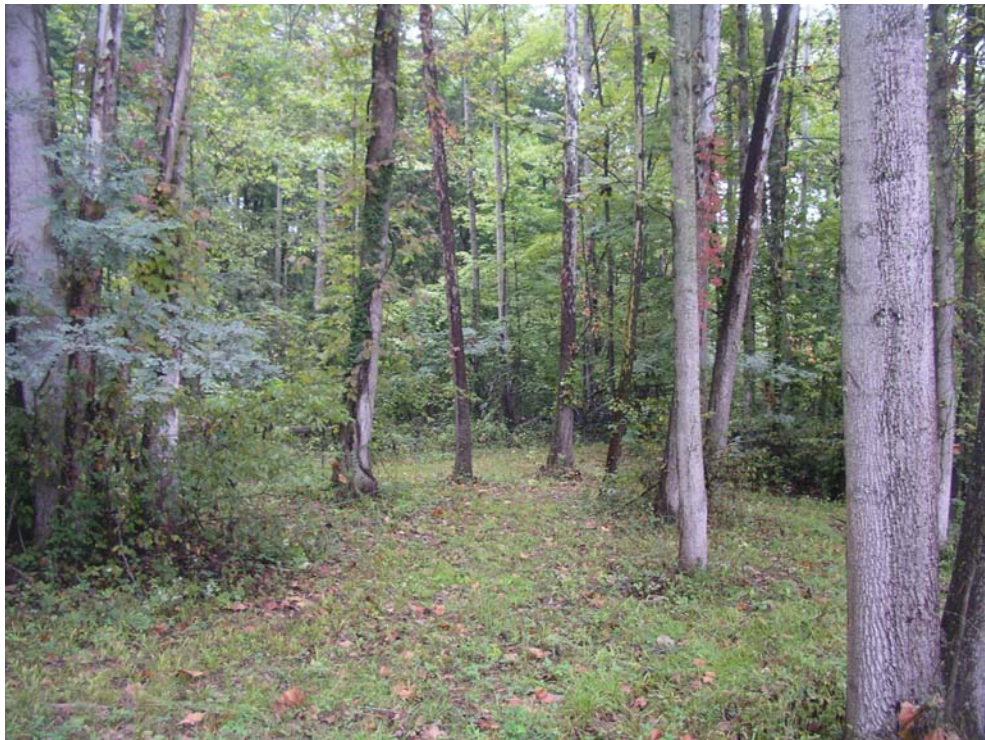
During the inspections prior to 2008, an area of possible seepage was observed along the downstream toe, near the midpoint of the embankment. This area appears to be the location of the original stream channel. During this inspection, this old channel was dry (Photograph 6) and no seepage was noted along the downstream toe (Photograph 7).

Photograph 6: Original stream channel downstream from midpoint of embankment.

4. The area along the downstream toe near the midpoint of the embankment should be monitored for possible seepage. Because of the high hazard associated with the project, it is recommended that this area be monitored on a monthly basis and following significant rainfall events. Any appearance of seepage and subsequent changes in seepage quantity in this area should be brought to the attention of a dam engineer immediately.

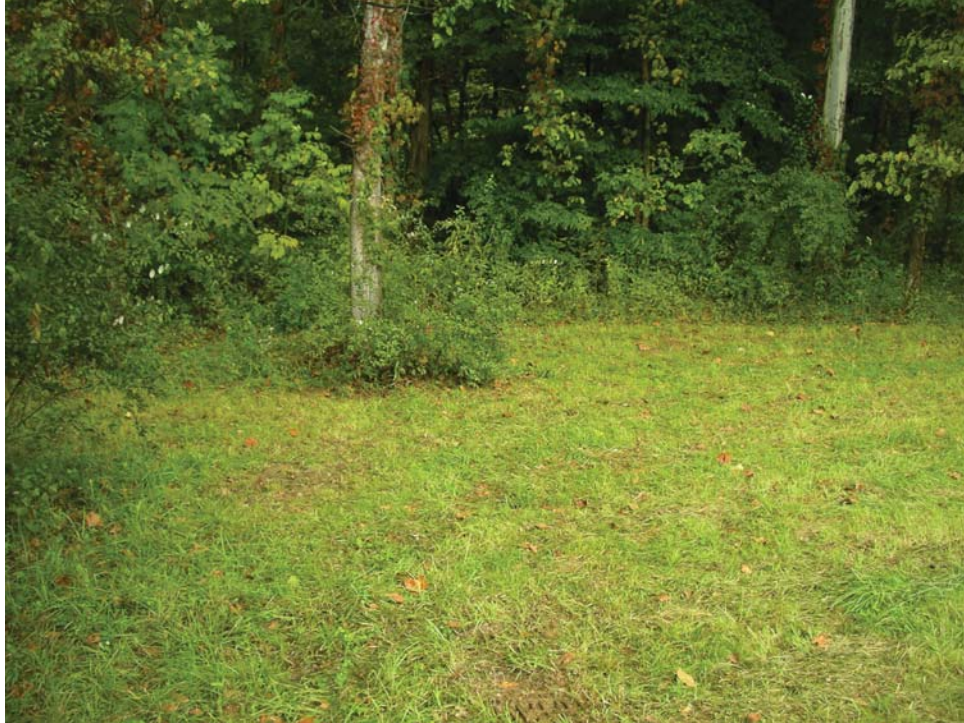
Photograph 7: Downstream toe near midpoint of embankment.

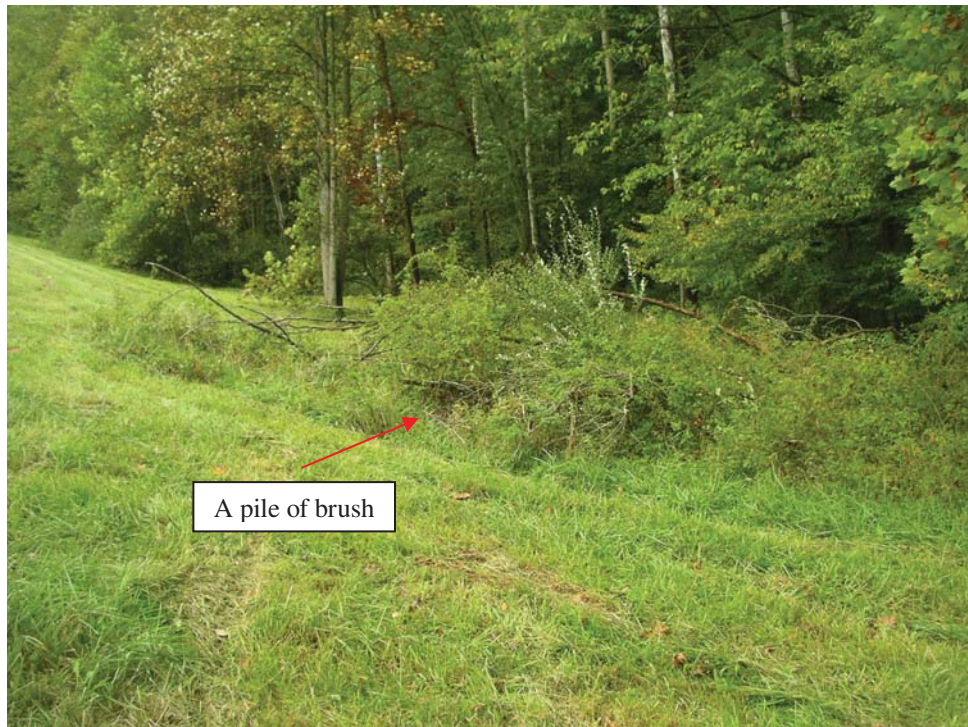
Ponded water was observed immediately downstream of the right groin in the inspections prior to 2008. Runoff from the embankment and right abutment tends to pond in this area. During this inspection, standing water was not observed immediately downstream of the right groin. However, a pile of brush was observed at the right groin area near the toe of the downstream embankment (Photograph 8).

Photograph 8: A pile of brush at the right groin area of the downstream embankment.

Comments: Brush piles were observed at downstream end of the right groin.

3. The pile of brush observed near the toe of the downstream slope, at the right groin area, should be removed. Any excessive vegetation should also be removed from the area.

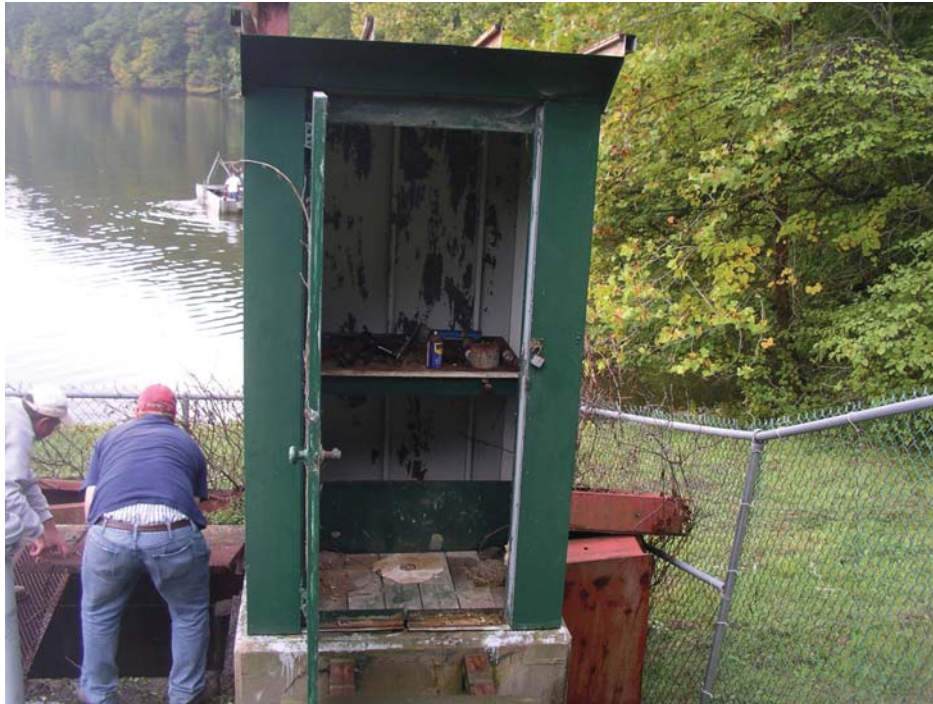
As part of this inspection, the gatewell and the upstream portion of the outlet works, between the inlet of the 42-inch diameter pipe and the gatewell, were inspected under water. A diver from CDS performed the inspections (Photographs 9 and 10). No obvious distress and blockages inside the 42-inch diameter pipe were noted in the inspection report from CDS. However, some large sized fallen trees and debris were reportedly present near the inlet of the intake pipe during the inspection. Additionally, a ¼" by 3" rubber seating strip on the right side of the sluice gate had reportedly become loose. The gate stem was inspected, and all of the frame bolts and adjusting bolts were checked for tightness. No distress was noted. The sluice gate was raised for approximately 15 minutes, and the gate was found to operate well, and no problems were noted. Copies of the inspection reports by CDS are included in Appendix III.

Photograph 9: Gatewell structure.

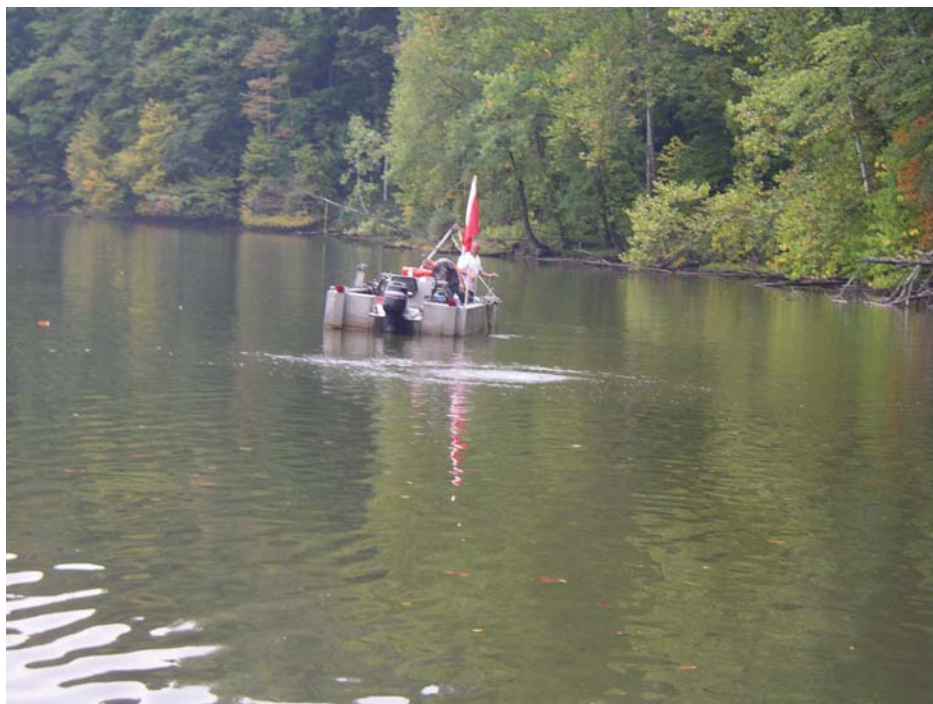
Photograph 10: Diver inspecting the drain pipe.

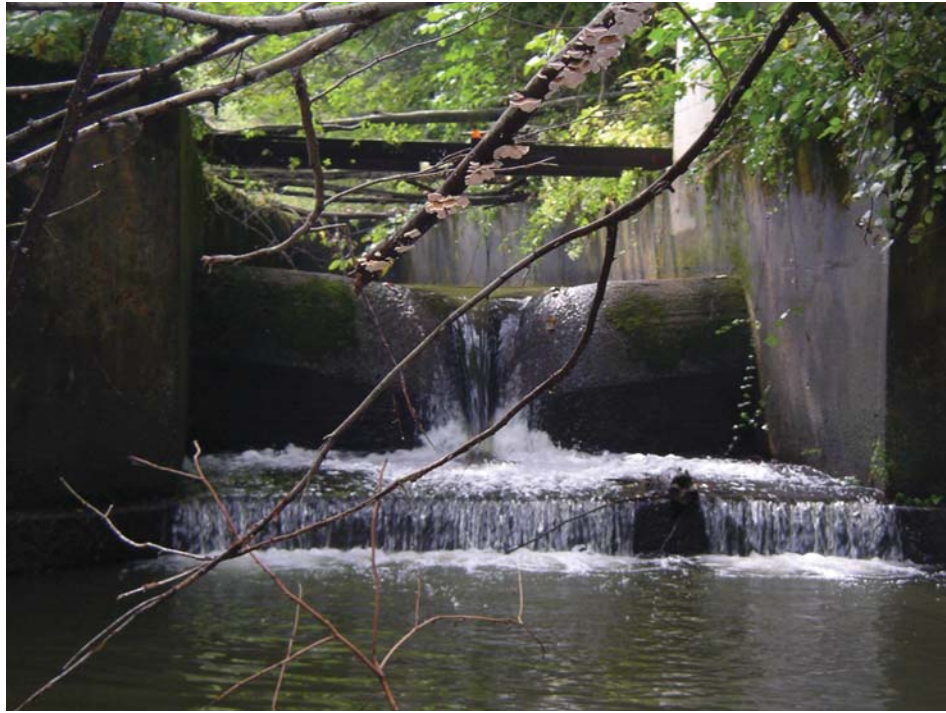
The visible portions of the outlet works appeared in satisfactory condition. The condition of the stilling basin appeared unchanged from previous inspections (Photographs 11 and 12). In previous inspections, a large crack was observed in the left wall near the end of the stilling basin. This crack appeared to be about ½ inch wide and extended from the top of the wall to the bottom (Photograph 13). This crack appeared old and unchanged from the 2010 inspection.

Photograph 11: Stilling basin; view is towards upstream.

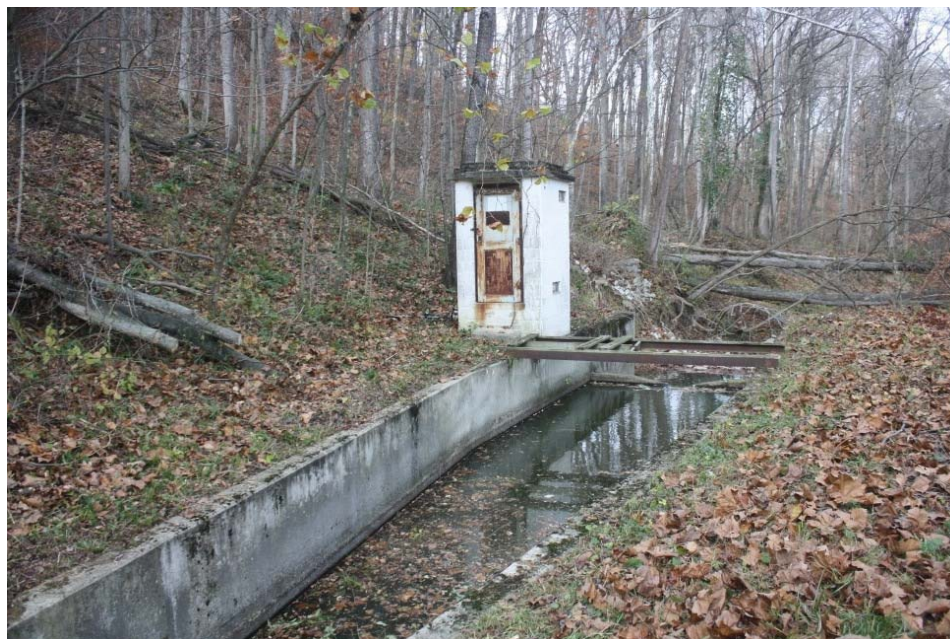
Photograph 12: Stilling basin; view is towards downstream.

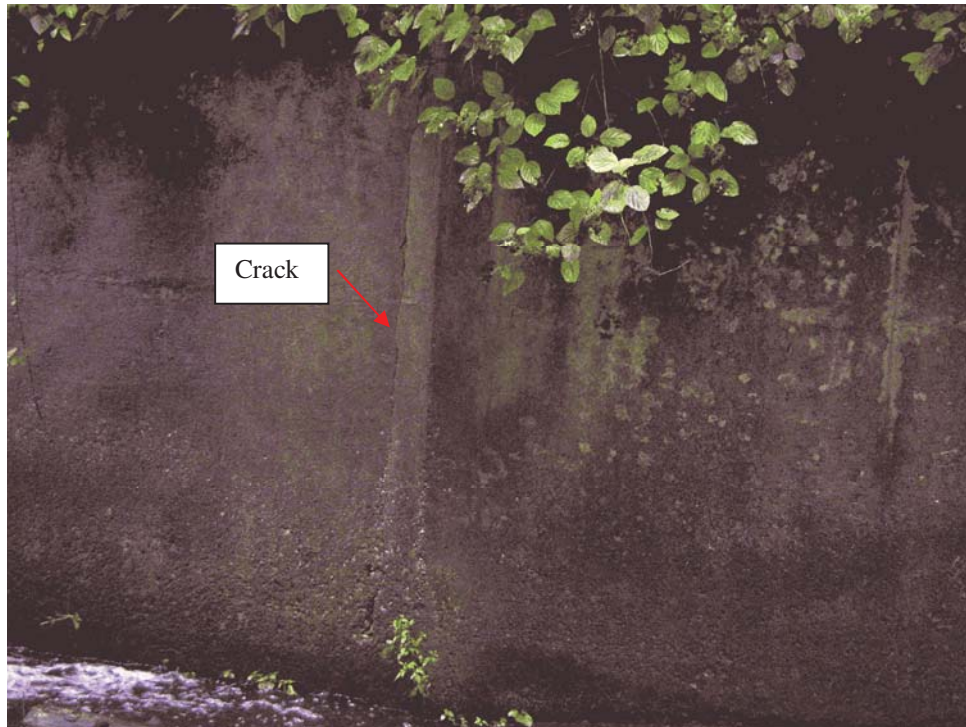
Photograph 13: A crack in left stilling basin wall.

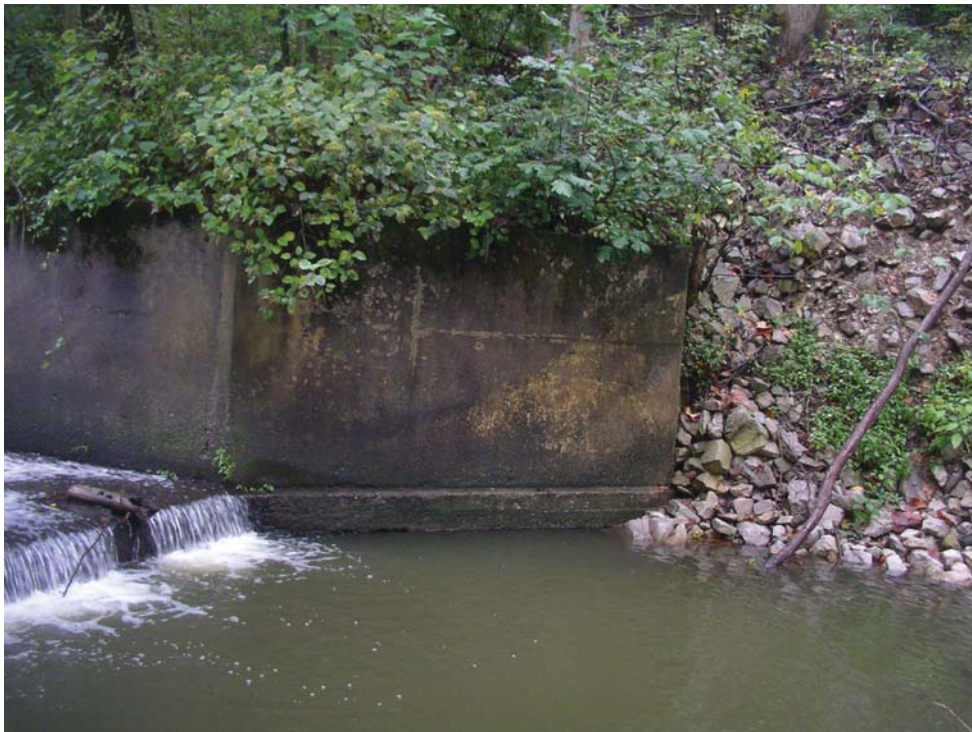
During the 2008 inspection, the stilling basin was dewatered as part of the inspection. An area of scour beneath the channel bottom was noted immediately downstream of the end of the stilling basin concrete pad. This scoured area was repaired by placement of riprap in the fall of 2009. However, it is understood that the rip rap was washed away during winter drawdown in the same year. The scoured area has not yet been backfilled with riprap (Photograph 14).

Photograph 14: Scoured area immediately downstream of stilling basin concrete pad.

5. The scoured areas in the channel bottom immediately downstream of the end of the stilling basin concrete slab should be repaired and replenished with additional riprap. The design velocities for the outflow will need to be evaluated to properly size the riprap.

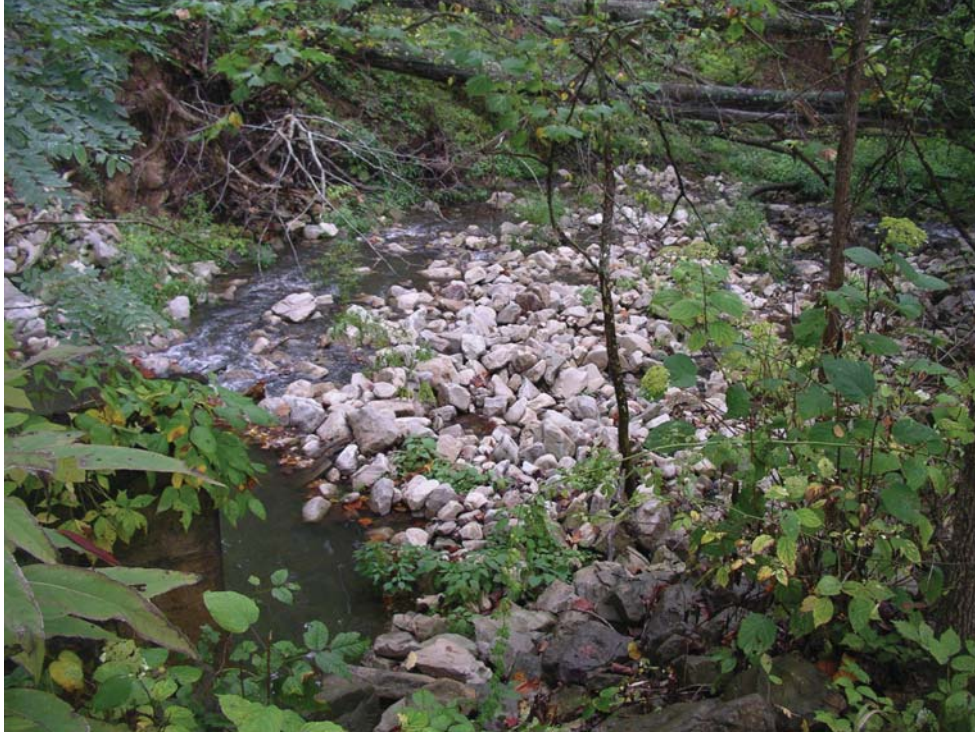
The banks of the outlet channel downstream of the stilling basin were showing signs of erosion and instability (Photograph 15). However, this condition appeared to be unchanged from the 2010 inspection. Some debris and fallen tree branches were observed in the channel which did not appear to block the outflow of water at the time of this inspection.

Photograph 15: Outlet channel downstream of stilling basin.

6. The stability and erosion condition of the banks of the outlet channel downstream of the stilling basin concrete slab should be monitored. Excessive debris and fallen tree branches, which could block the water flow in the outlet channel, should be removed regularly.

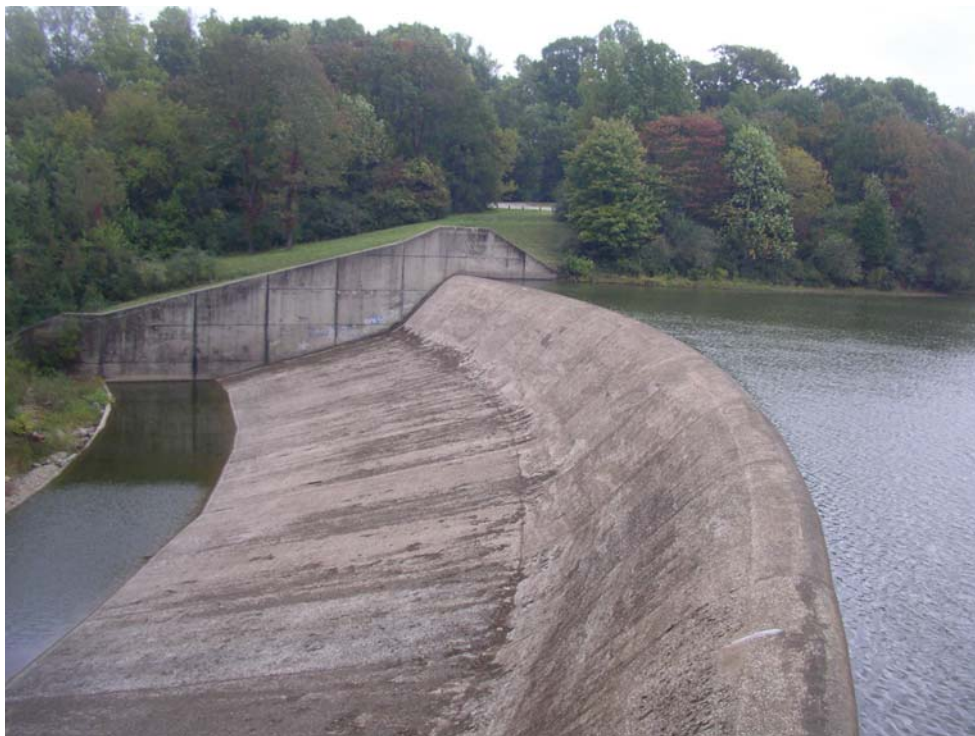
The principal spillway was in acceptable condition (Photographs 16, 17, 18, and 19). There had been some horizontal displacements, approximately  $\frac{1}{2}$  to  $\frac{3}{4}$  inches, in the joints of the training walls over the years (Photograph 20). However, a wider joint, slightly over an inch, was found in the upper end of the right training wall (Photograph 21). This joint widening was probably the result of water penetration and repeated freeze-thaw attacks over time. Generally, there appeared to be no significant changes in the joint displacements since the 2010 inspection.

Photograph 16: Crest of ogee spillway.

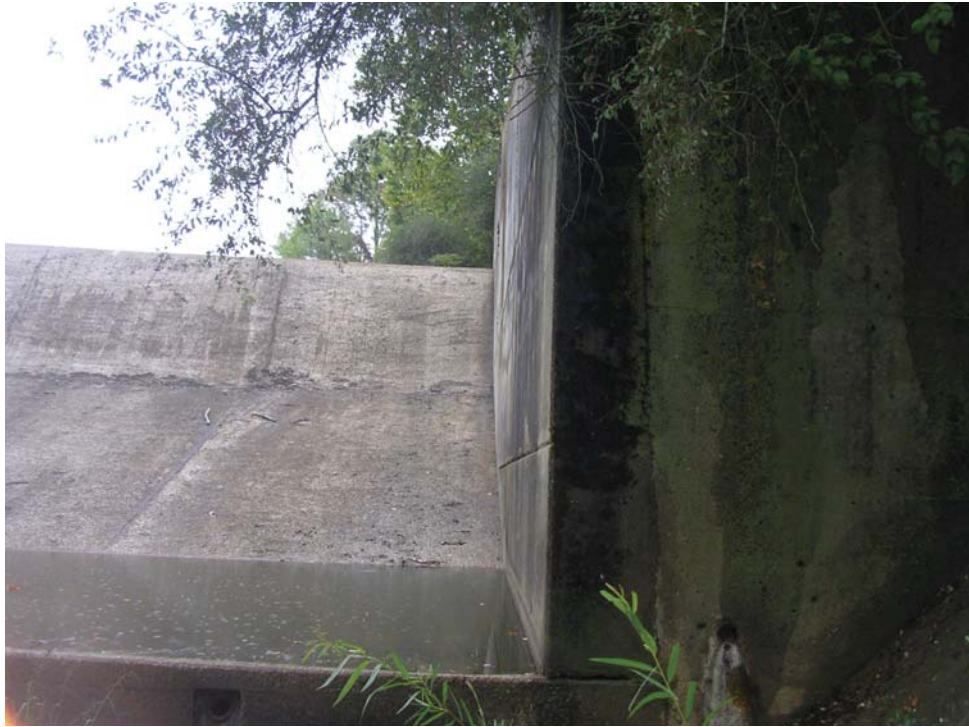
Photograph 17: Left training wall of spillway.

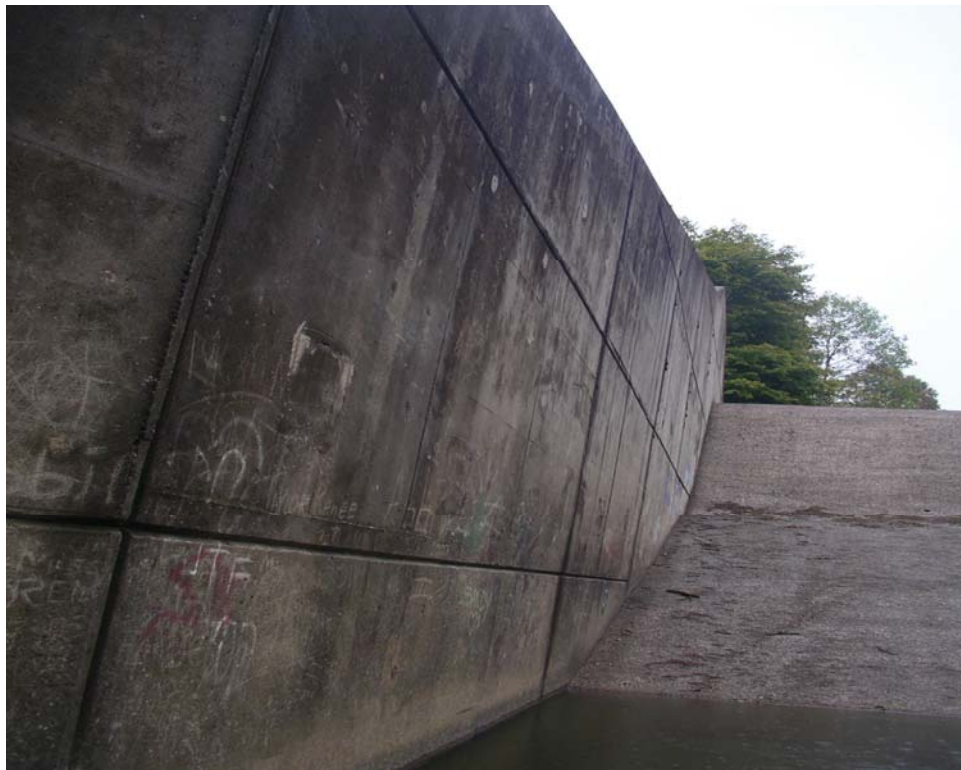
Photograph 18: Right training wall of spillway.

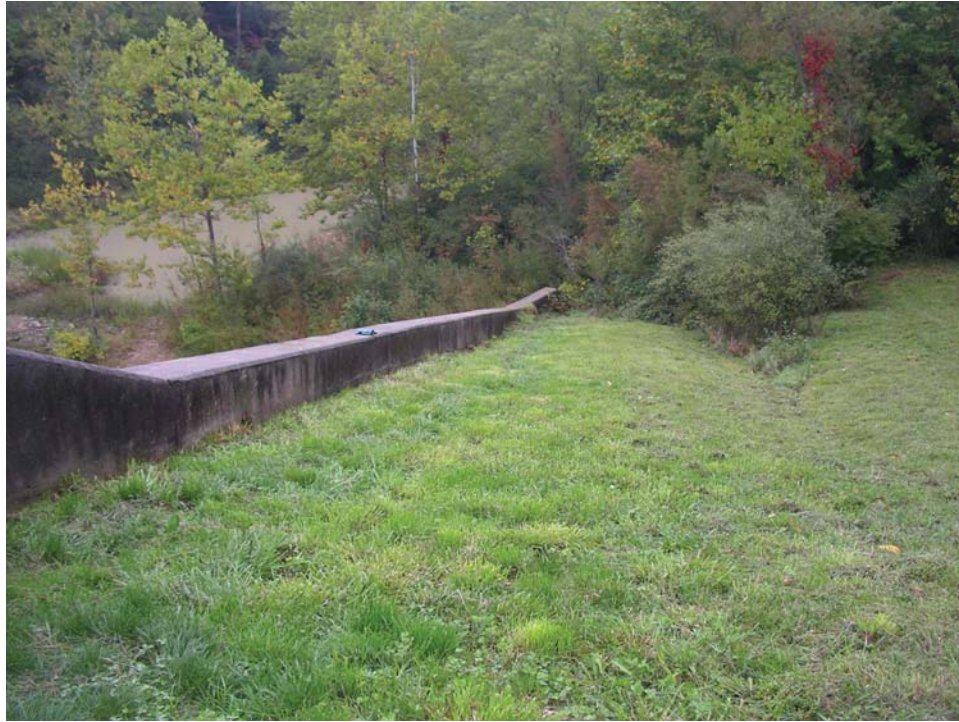
Photograph 19: Sloping ground surface behind right training wall spillway.

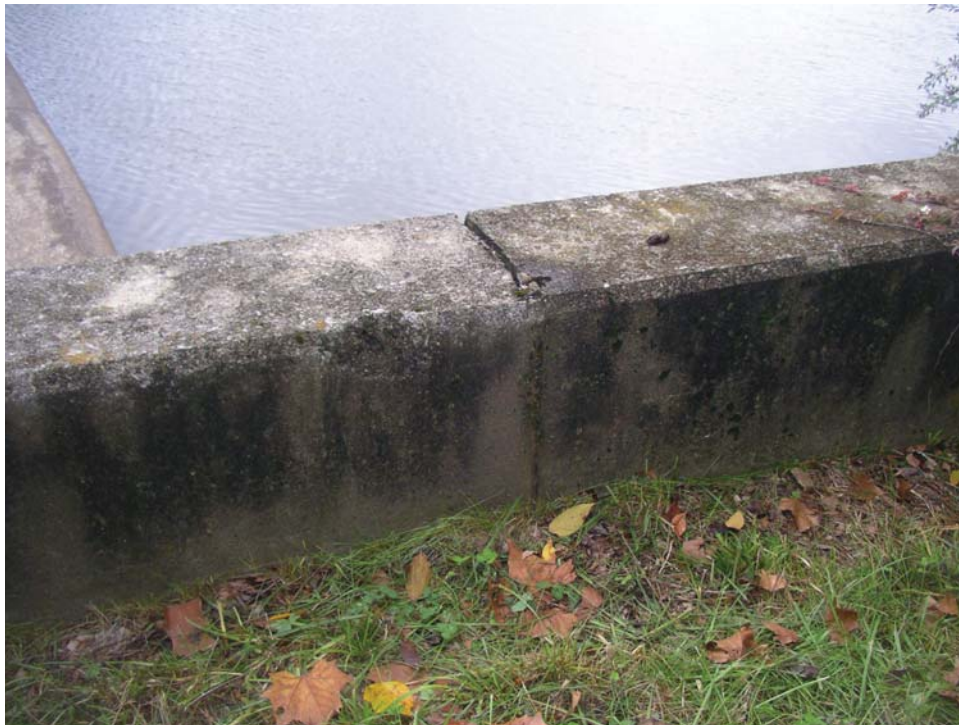
Photograph 20: View of a typical joint displacement in upper end of left training wall of spillway.

11. All joints and cracks in the training walls of the principal spillway should be properly sealed. The principal spillway should be visually monitored for any additional settlement or displacement monthly.

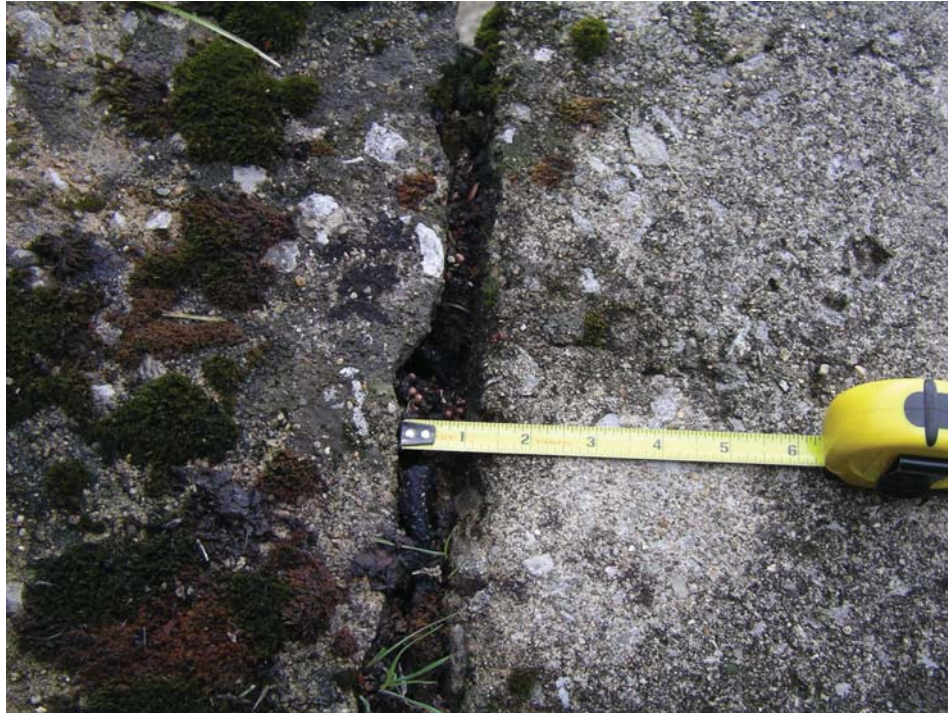
Photograph 21: View of joint displacement in upper end of right training wall of spillway.

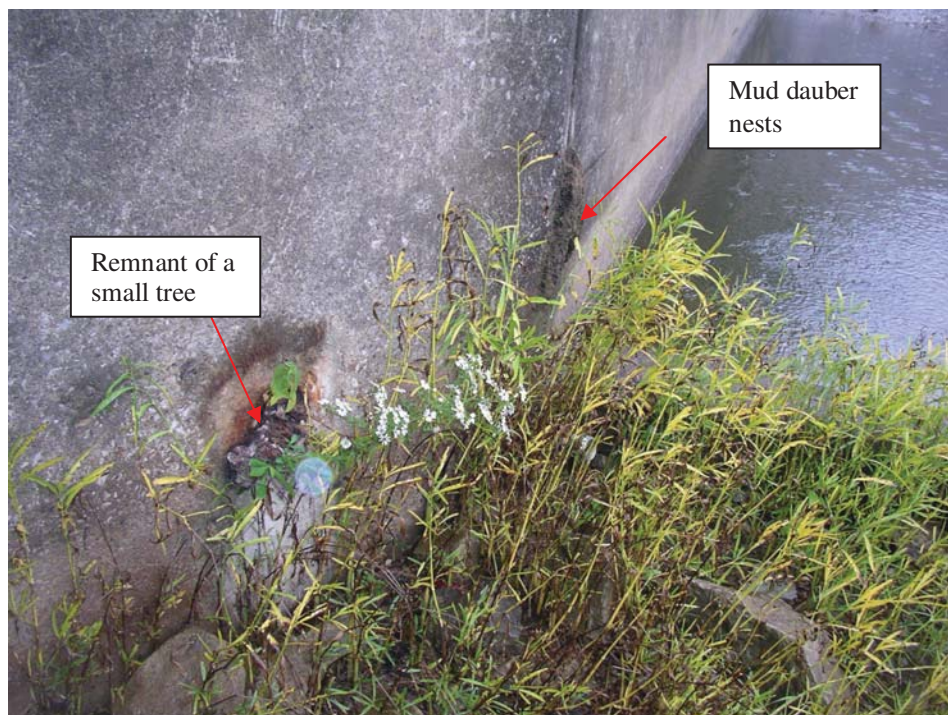
A small tree and what appeared to be wasp nests (“mud dauber’s nests”) were observed on the lower end of the right training wall during the 2010 inspection. In this inspection, the “mud dauber nest” was found to be in the same location as observed in the 2010 inspection. However, the small tree appeared to have been cut off and only a small remnant of the tree remained embedded in the concrete wall (Photograph 22).

Photograph 22: The remnant of a small tree and “mud dauber nests” on lower end of right training wall of spillway.

9. It is recommended that the sluice gate be exercised to its full limit at least once per year.
10. The remnant of a small tree and what appeared to be "mud dauber nests" on the lower end of the right training of the principal spillway should be removed and the concrete surface at this area should be repaired, if necessary.

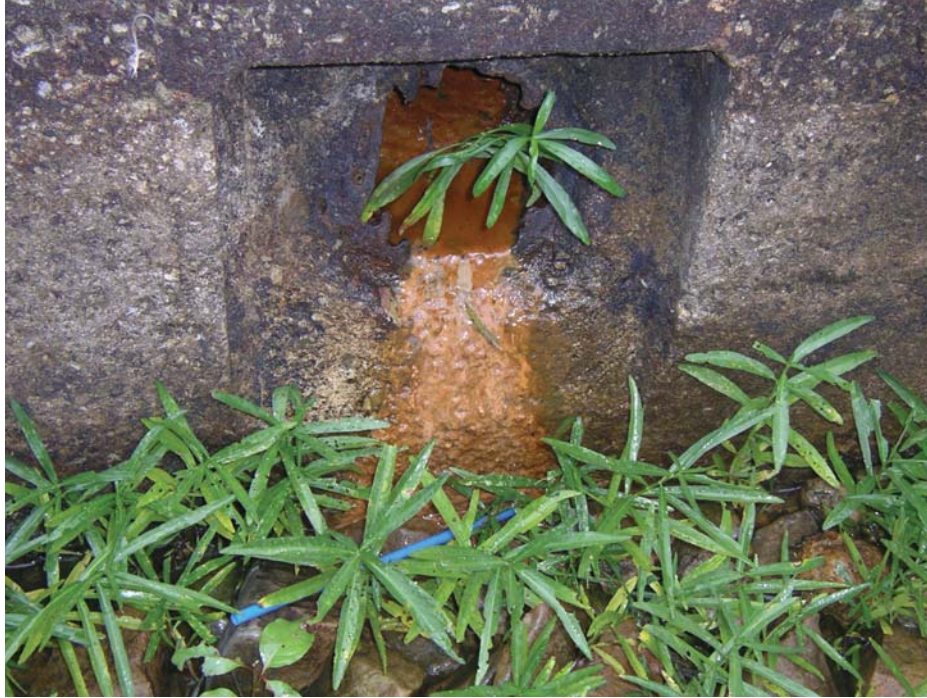
In the 2010 inspection, large masses of a brown “sticky” gelatinous substance were observed at the outlet pipes near the midpoint of the spillway’s end sill. This brown substance appeared to be iron bacteria, which could plug the outlet pipes if they grow excessively. During this inspection, the brown “sticky” gelatinous substance was observed at several outlet pipe locations, primarily near the midpoint of the spillway’s end sill (Photograph 23). It appeared that the brown substance had not been removed or cleared out of the pipes since the 2010 inspection.

Photograph 23: Brown “sticky” gelatinous substance (iron bacteria) at an outlet pipe of spillway.

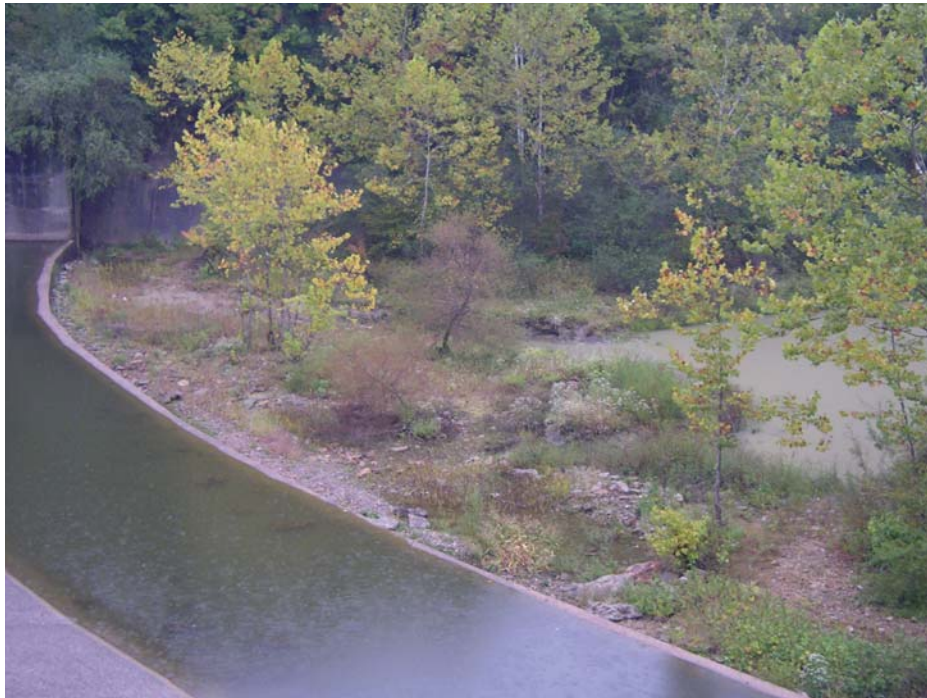
There was minor erosion immediately downstream of the end sill (Photograph 24). Generally, there appeared to be no significant changes in the erosion condition since the 2010 inspection.

Photograph 24: Minor erosion along end sill of spillway.

13. The outlet channel downstream of the ogee's end concrete sill should be monitored for additional erosion, especially after significant spillway discharges. If the erosion condition worsens, the end slab could be endangered as the erosion progresses upstream beneath the slab. Additional riprap may then be needed immediately downstream of the end sill to armor the area.
14. A recent file review indicates that an Emergency Action Plan (EAP) has not yet been prepared as recommended in the 2010 Inspection Report. It is recommended that an EAP be prepared as soon as possible.

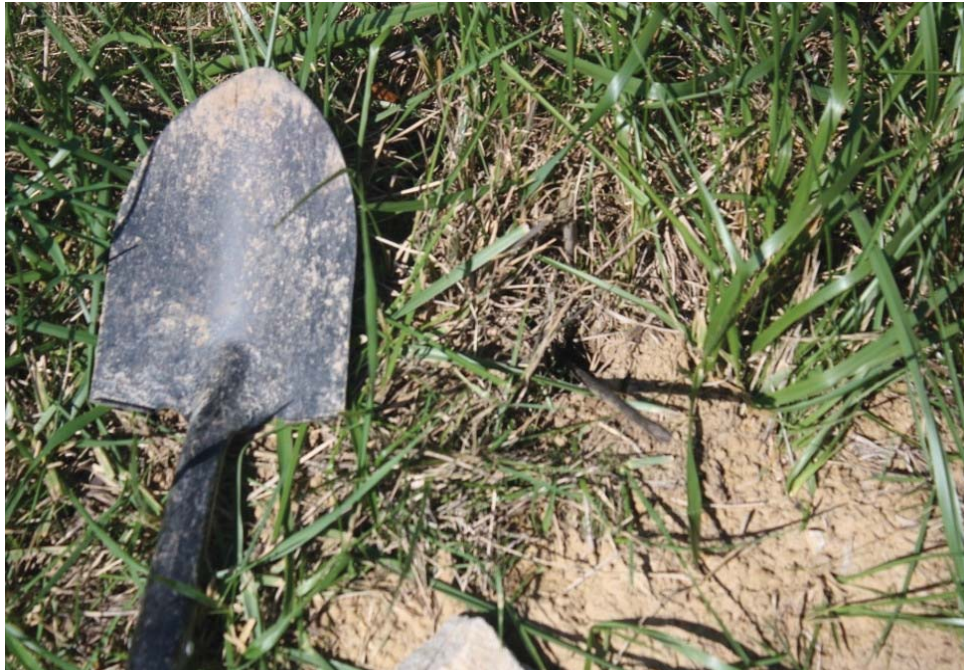
Photograph 25: View of a typical burrow before filling.

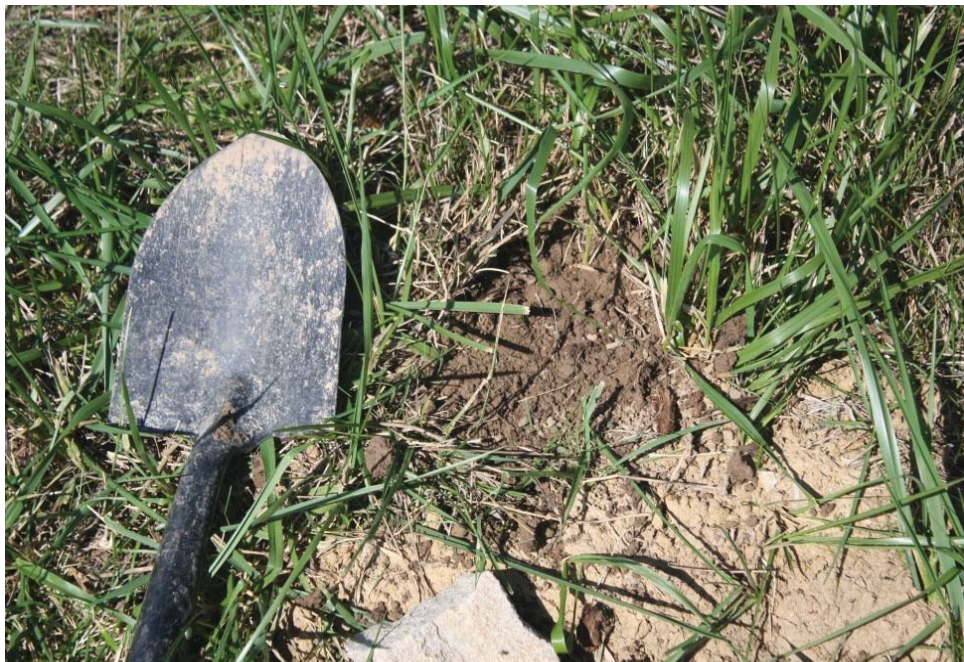
Photograph 26: View of a typical burrow location after filling.
