2006 Inspection Report Lake Lemon Dam Unionville, Indiana

DLZ Job No. 0463-0294.90

October 26, 2006

LAKE LEMON DAM

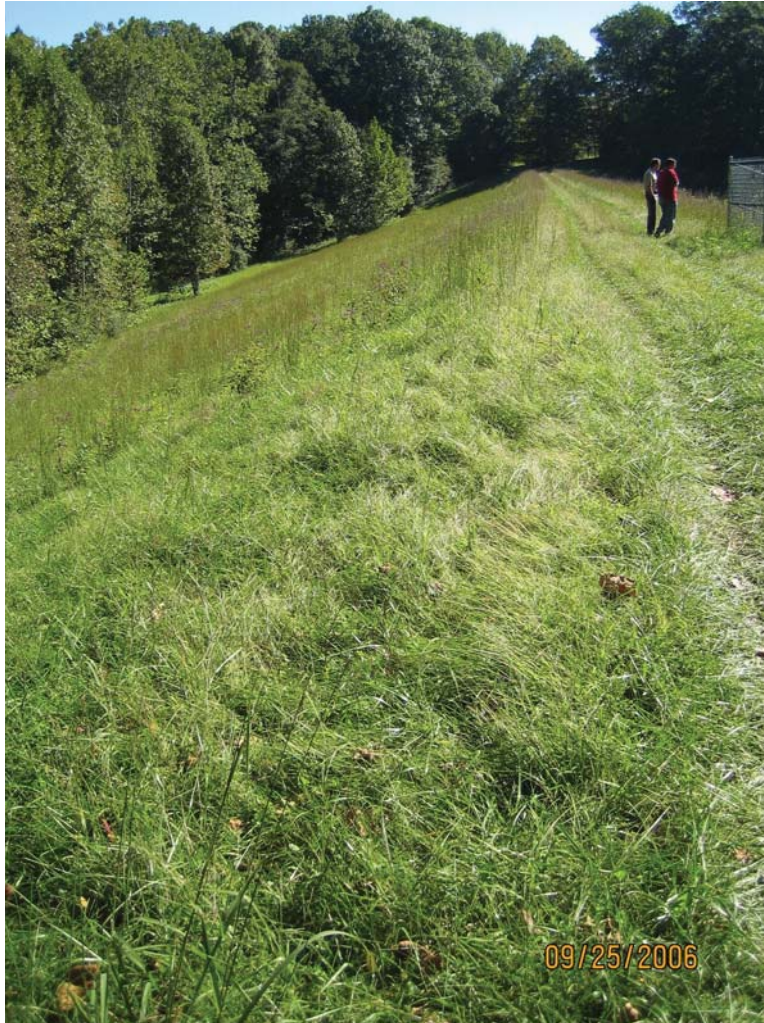
Crest and downstream slope. View is from left abutment to right abutment.

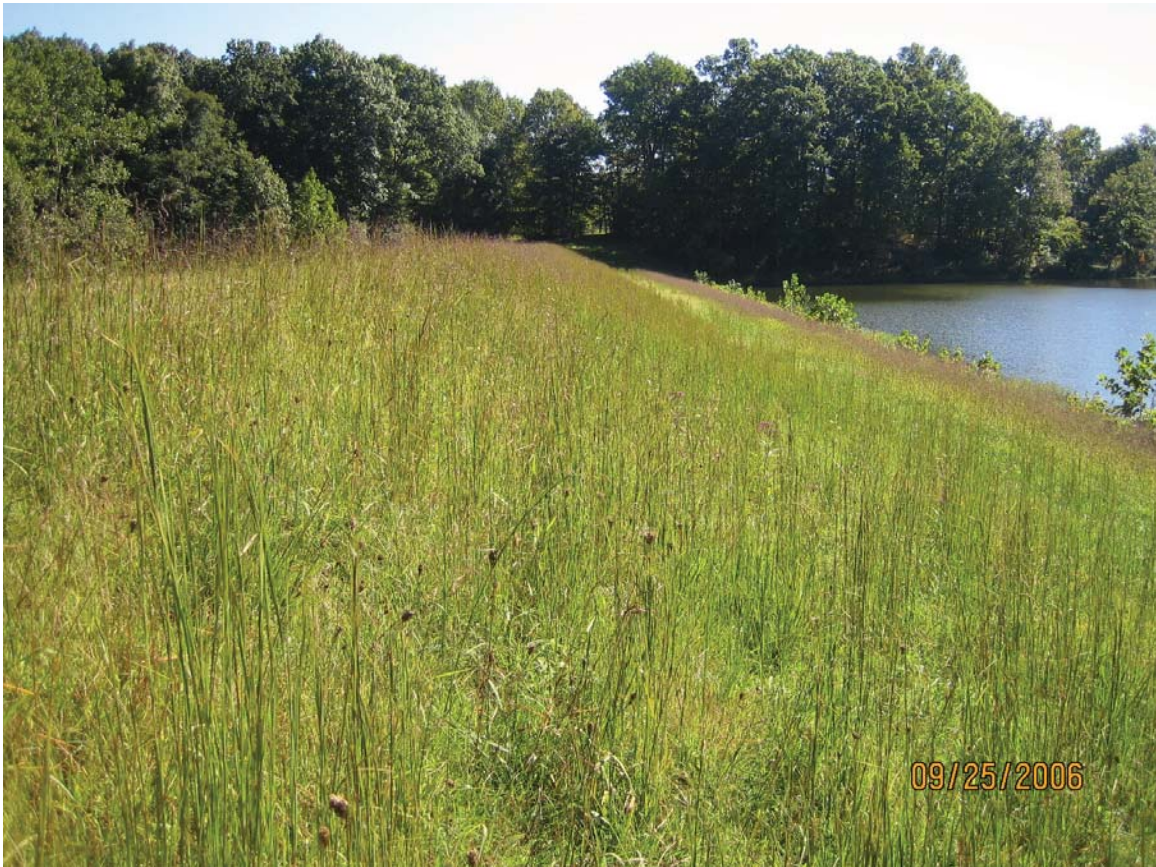
Upstream slope. View is from left abutment to right abutment

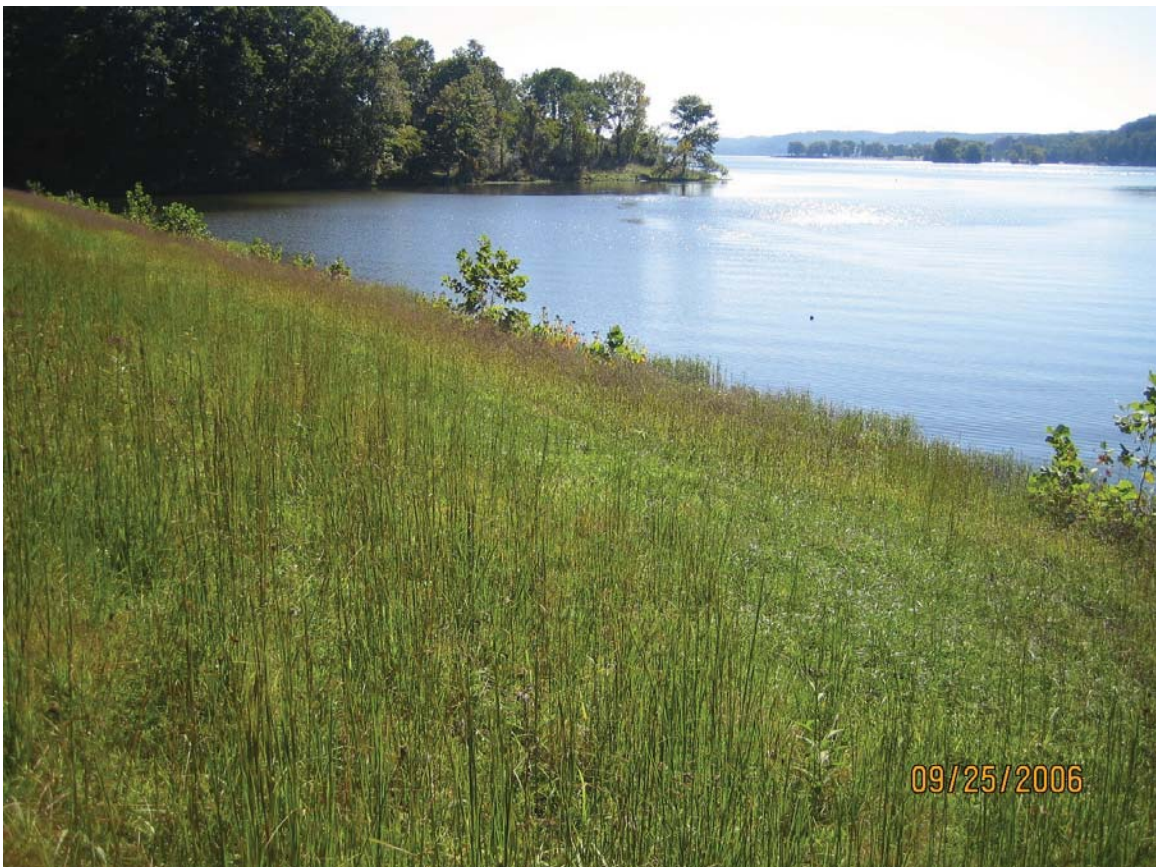
Some small brush and trees were observed along the water's edge, as noted in the 2004 inspection. This brush and the small trees should be removed. In addition, there was some rutting on the crest from vehicular traffic, as was also noted in the 2004 inspection. These ruts should be filled to enhance drainage.

Vegetation along shore.

1. Visually monitor the possible seepage condition at the toe of the embankment. Report any changes to a dam engineer immediately.
2. Remove the small brush and trees in the embankment along the water's edge.

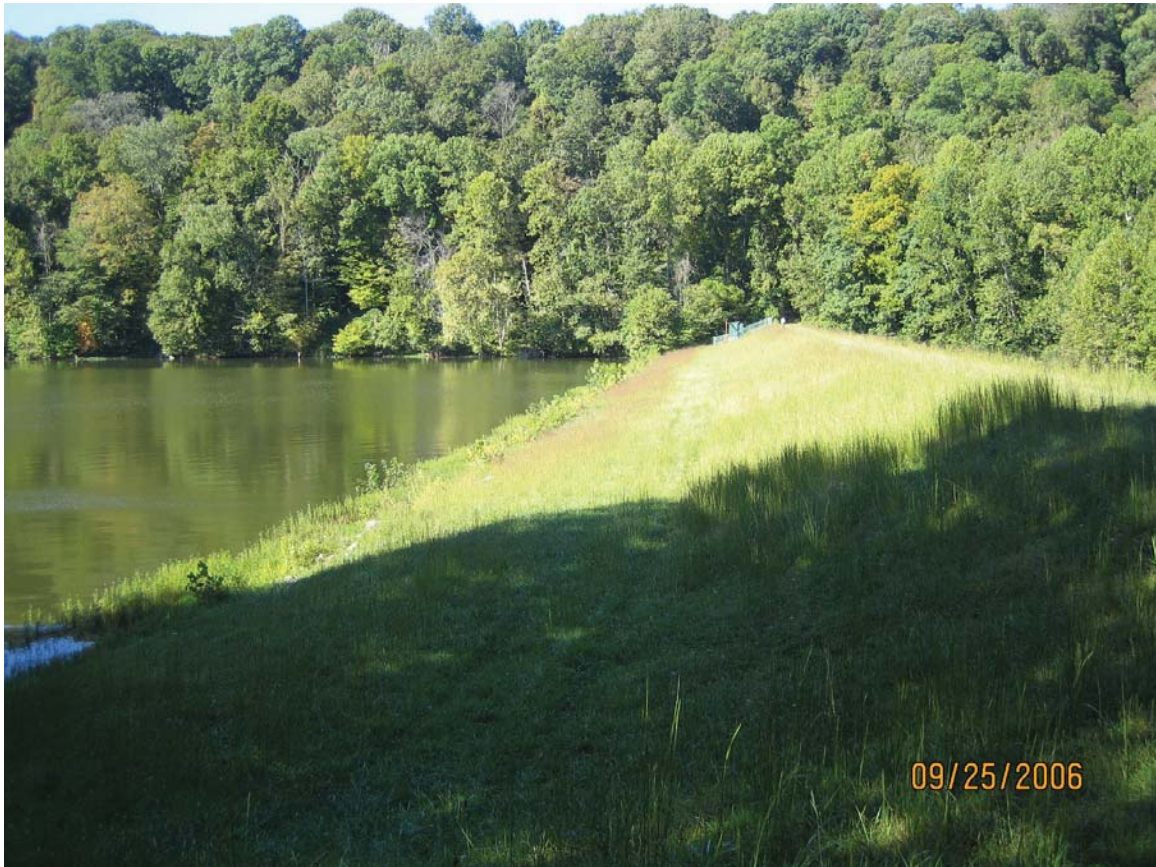
Upstream slope. View is from right abutment to left abutment.

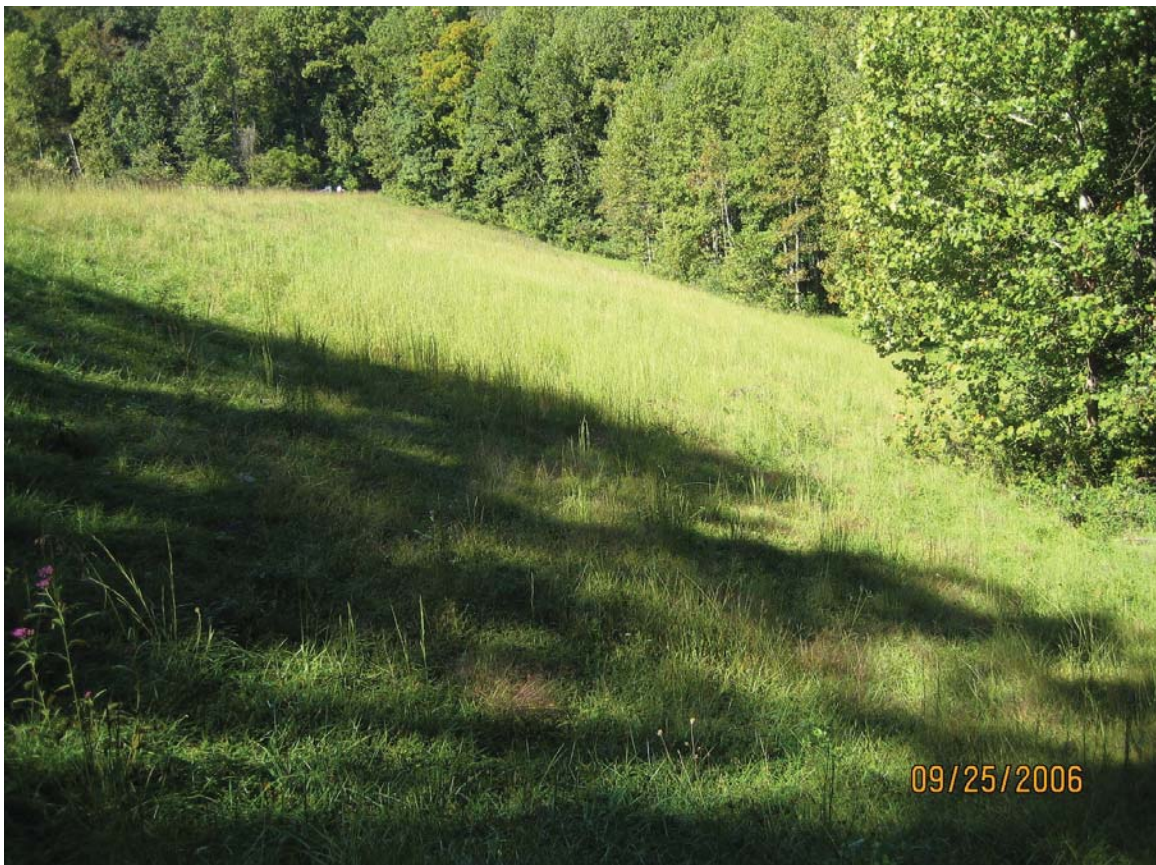
Downstream slope. View is from right abutment to left abutment.

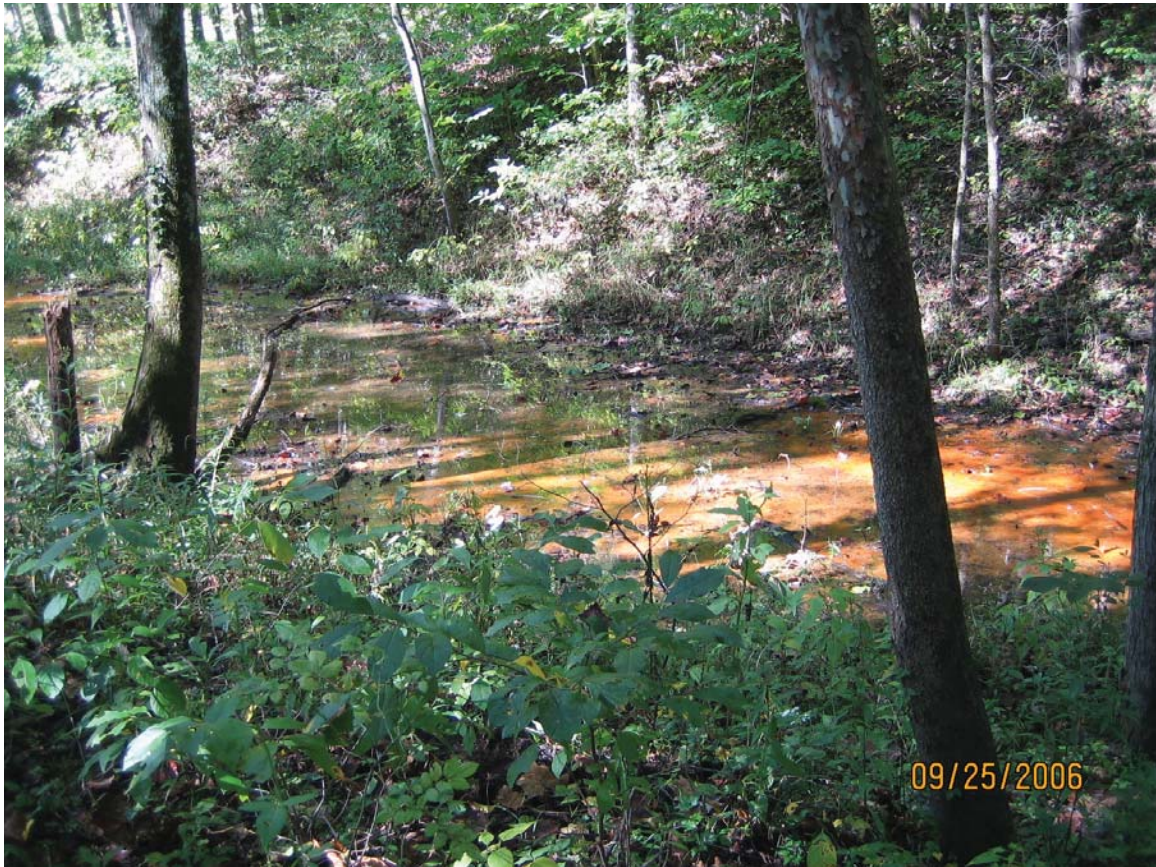
An area of possible seepage was observed along the downstream toe, near the midpoint of the embankment. This area appears to be the location of the original stream channel. No discharge could be seen, but the old channel is wet with iron-stained, brackish water. This possible seepage was noted in the 2002 and 2004 inspections, also. Based on the comments in the 2002 and 2004 inspection reports, it doesn't appear that the seepage has changed significantly since then. This area did appear to contain more standing water than in the 2004 inspection but it is believed that this condition was caused by the heavy rainfall prior to the inspection.

Standing water and seepage in original stream channel.

Comments: Possible seep observed at toe about mid-length of the embankment. Appears to be in the original stream channel. Does seem to appear to be more standing water than 2004 inspection. However, heavy rain preceded inspection. Also, a poor draining area was noted at downstream end of right groin. Standing water was observed in this area but believed to be runoff.

However, because of the high hazard associated with the project, it is recommended that this area be monitored visually on a monthly basis and following significant rainfall events. Any changes in the quantity or appearance of the seepage in this area should be brought to the attention of a dam engineer immediately.

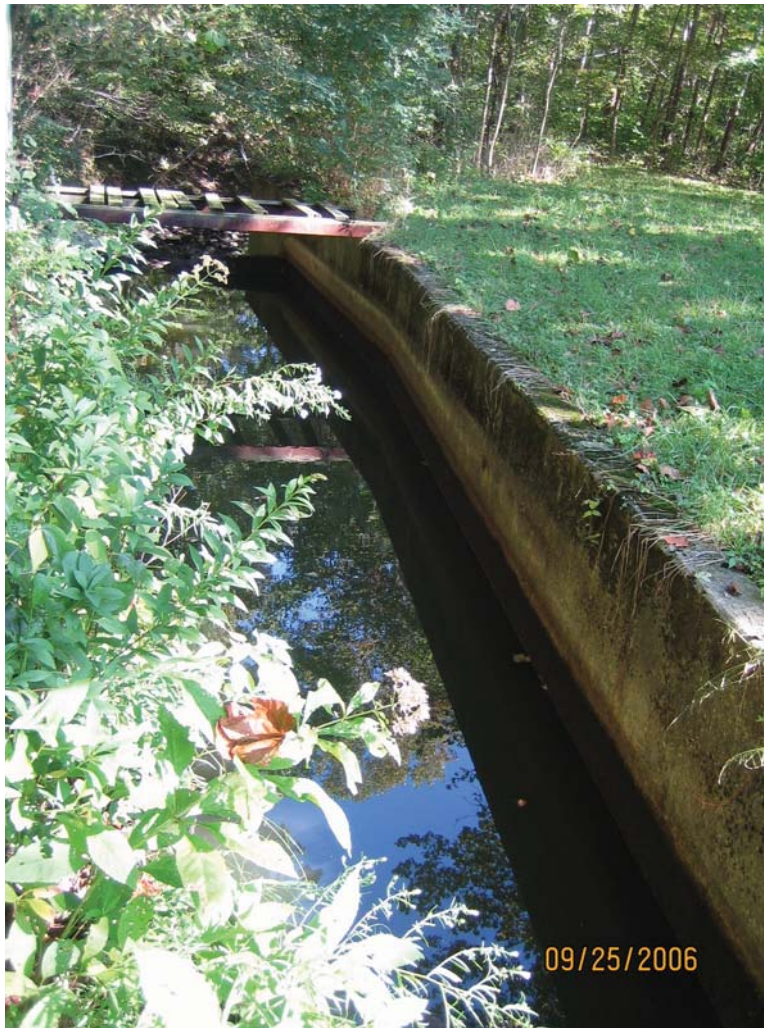
Also, as mentioned above, the stilling basin was dewatered as part of the inspection. The portions of the stilling basin below water also appeared to be in satisfactory condition.

Stilling basin.

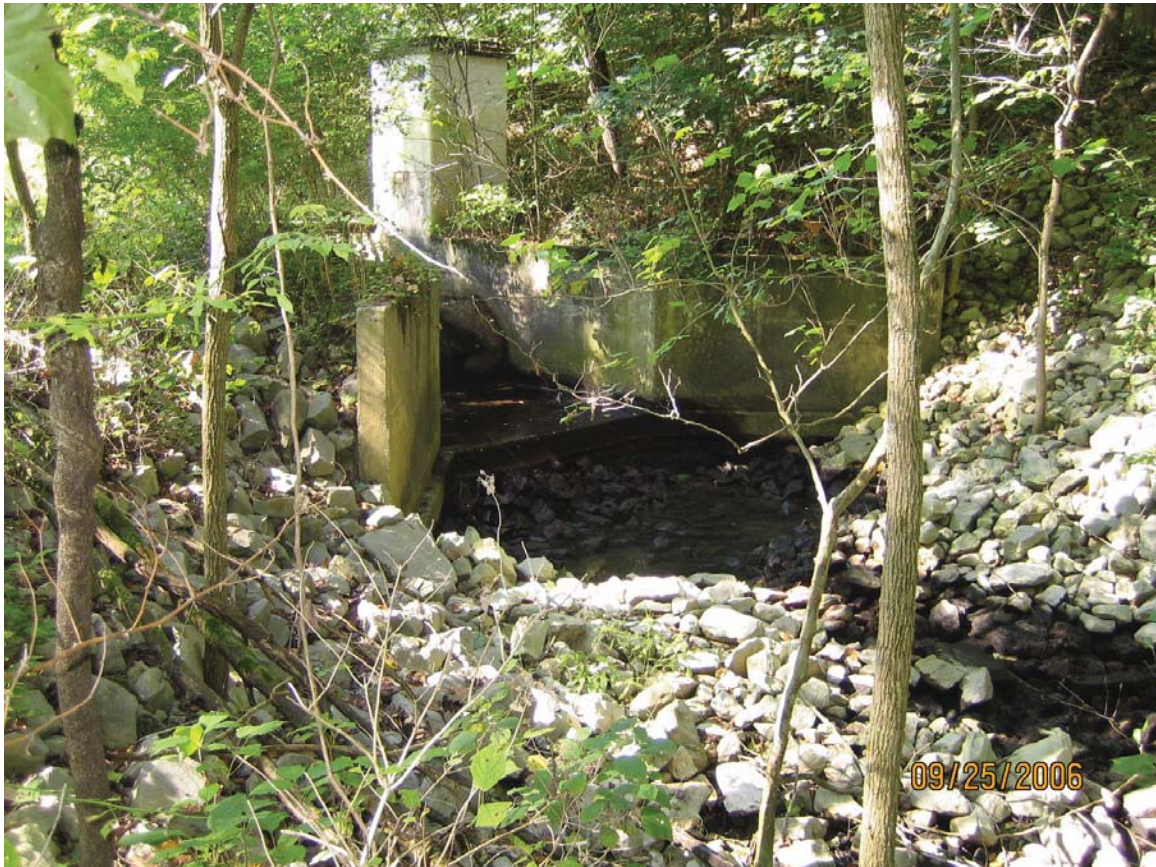
However, after the stilling basin dewatering was performed, an area of scour in the bottom of channel bottom was noted immediately downstream of the end of the stilling basin. This area should be backfilled with large riprap to prevent the scoured area from enlarging and undermining the stilling basin slab. The stilling basin design should be reviewed to determine the velocities at the end of the stilling basin so that the riprap can be properly sized.

Scour and erosion at end of stilling basin.

3. Fill ruts in the crest to facilitate drainage.
4. Remove vegetation from the left wall of the stilling basin.
5. Repair scoured area in the channel bottom immediately downstream of the stilling basin. It is anticipated that large riprap will be needed. The design velocities for the outflow will need to be evaluated to properly size the riprap.

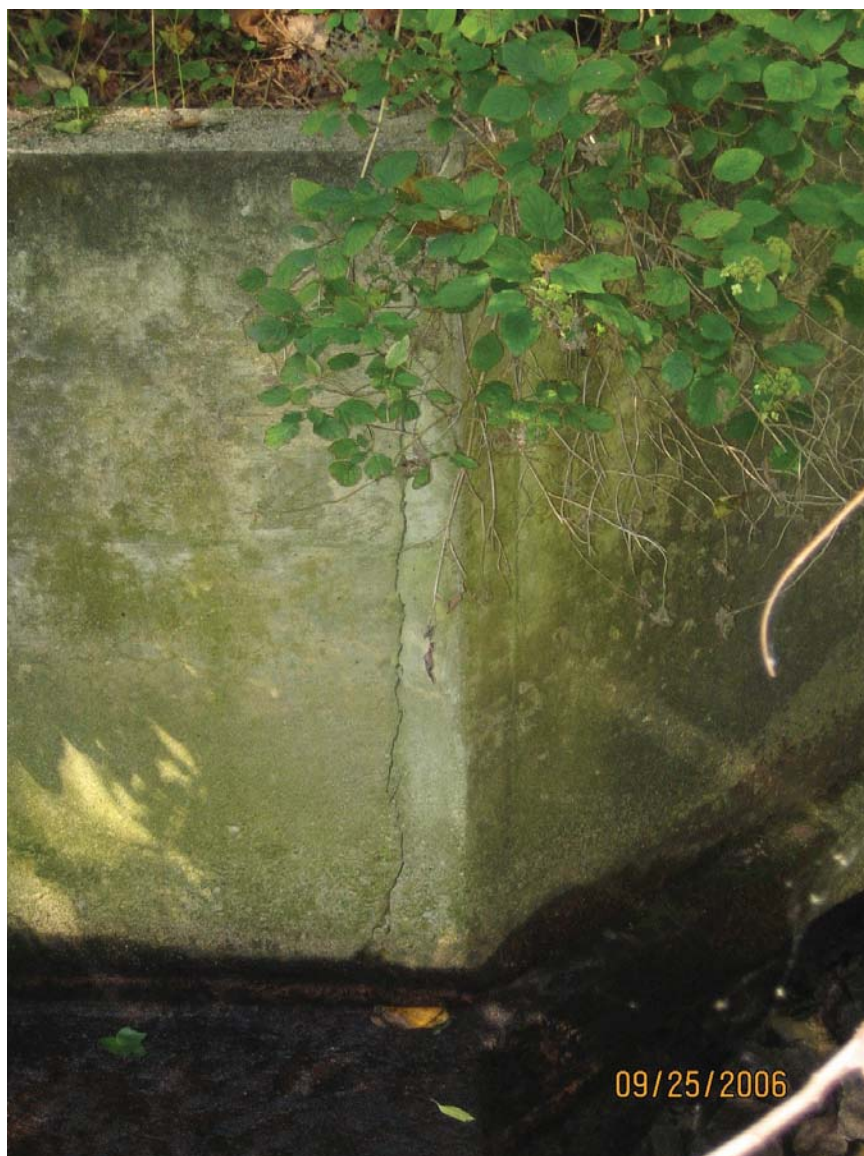
A large crack was observed in the left wall near the end of the stilling basin. This crack was about a 1/2 inch wide and extended from the top of the wall to the bottom. This crack appeared old and doesn't appear to have changed recently.

Crack in left training wall at end of stilling basin. Crack is old and doesn't appear to have moved significantly recently.

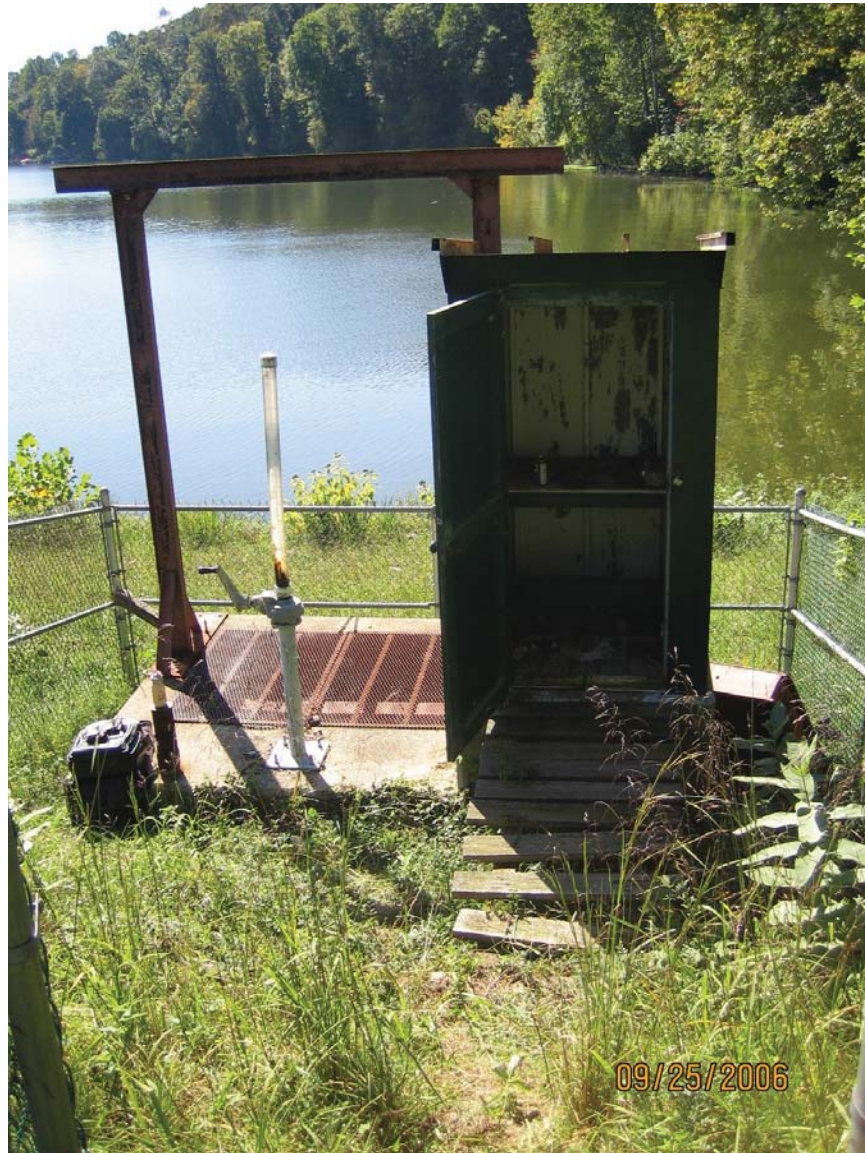
Finally, as part of the gatewell inspection, the gate stem was observed and all the frame bolts and adjusting bolts were checked for tightness. No distress was noted.

Gatewell.

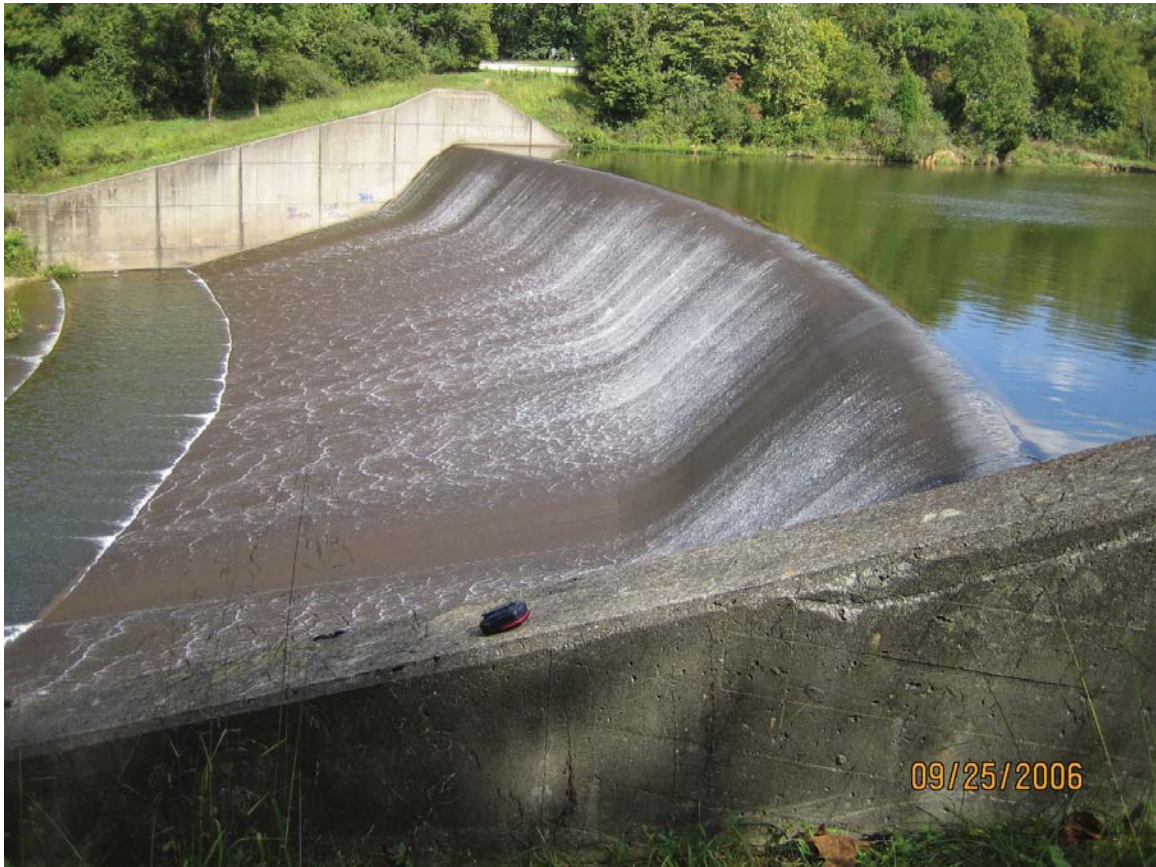
The principal spillway was in acceptable condition. It does not appear to have changed significantly since the last inspection. In the 2004 inspection, minor spalling in the ogee face was observed. However, the lake manager indicated these areas were repaired recently. There has been some displacement in the joints over the years ($\frac{1}{2}$ to $\frac{3}{4}$ inches) but the overall condition of the spillway appears to be acceptable.

Ogee spillway crest.

Comments: Spalling visible in 2004 inspection was repaired in last two years. Some joints offset 1/2" to 1" and joint filler being squeezed out. These conditions are old and the spillway appears to be in satisfactory condition.

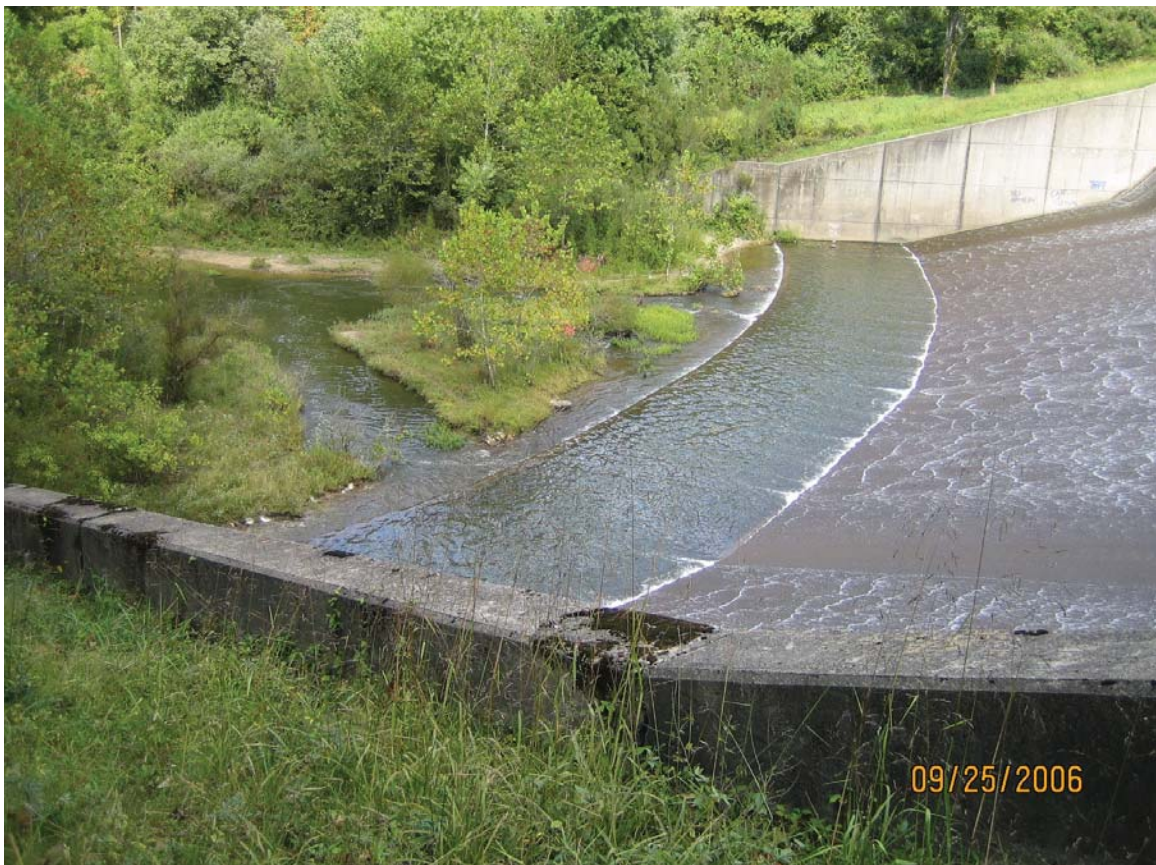
Downstream toe of ogee spillway.

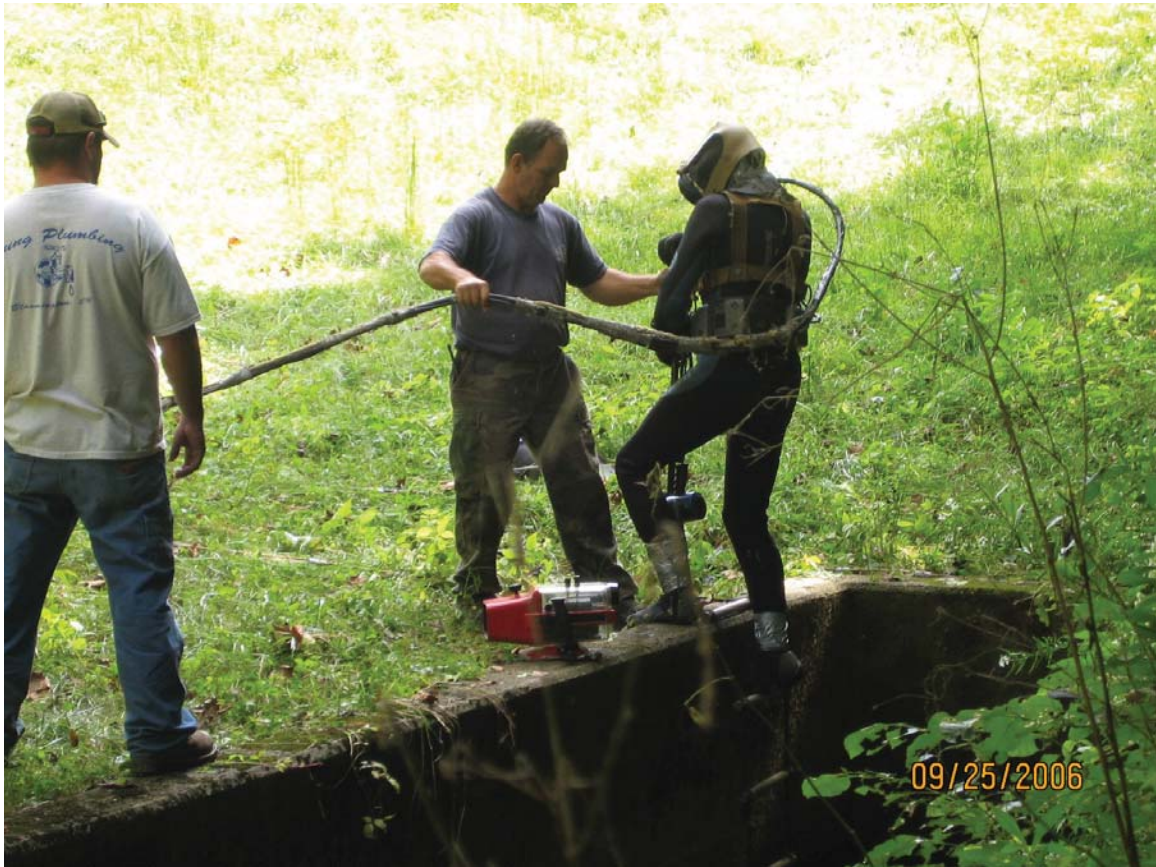
Diver preparing to enter outlet pipe.

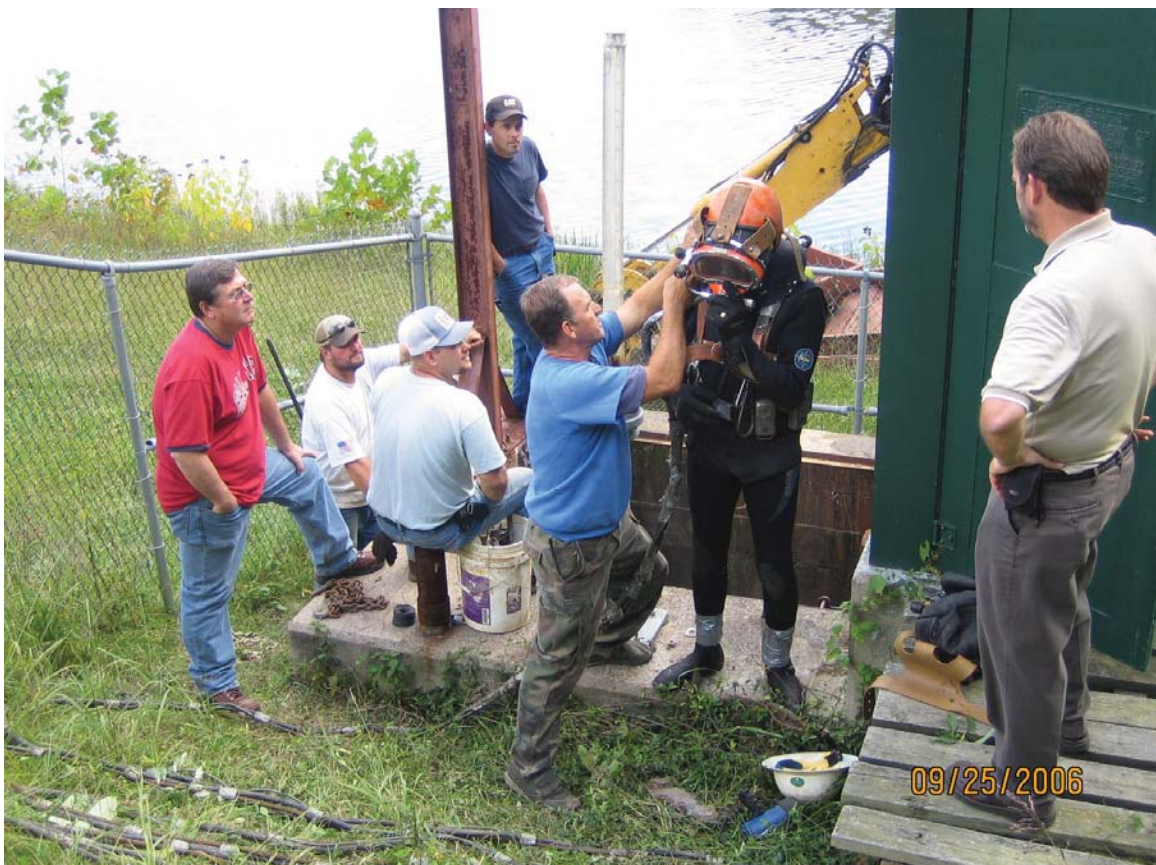
Diver preparing to enter gatewell.

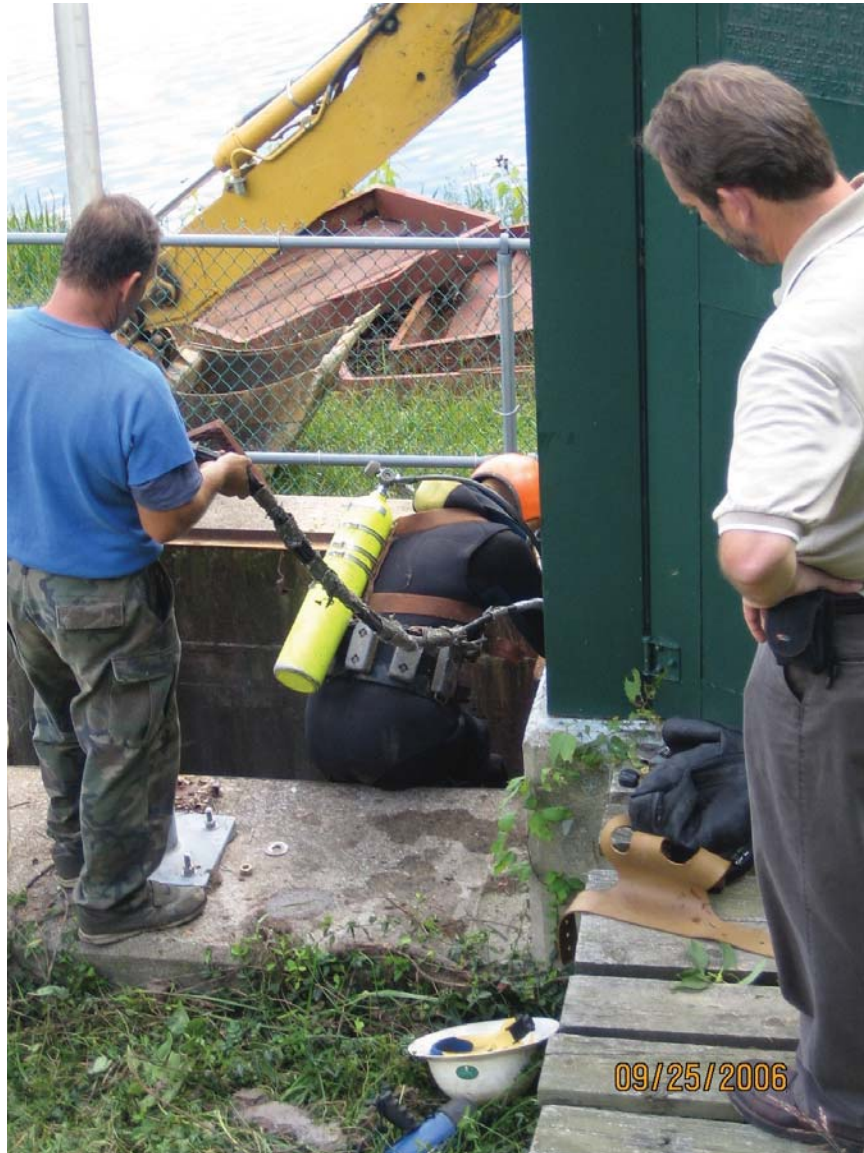
Diver entering gatewell.

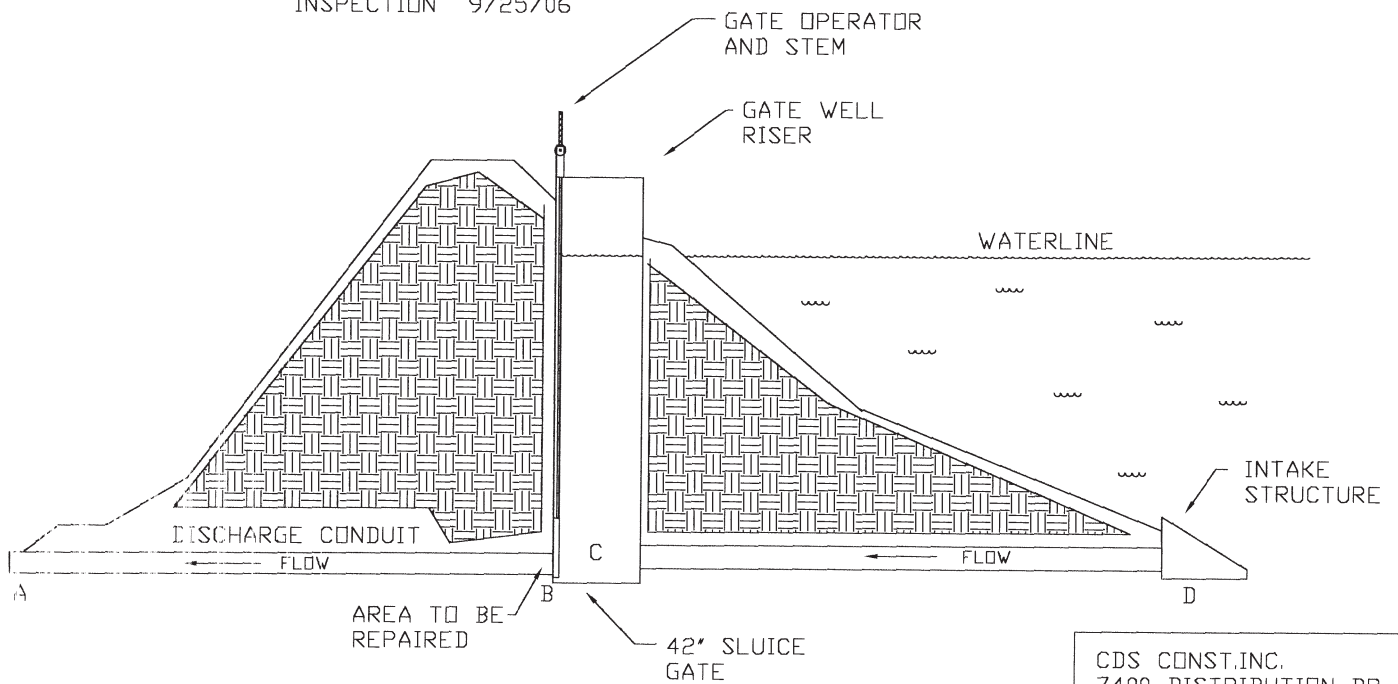
LAKE LEMON

The first dive was from location A to B on the attached drawing. This portion of the inspection was video taped. Because of high turbidity levels the discharge conduit was partially emptied for the inspection. As you can see on the video, there is an area approximately 38" downstream from the sluice gate that should be repaired in the future. This pipe joint on the downstream side of the thimble has lost packing on about one third of the circumference. The joint is still in place with no apparent leakage or damage. If not repaired, during high flow for extended periods could cause cavitation in the conduit walls. This could possibly be repaired at a later date, due to the fact that the conduit is normally dormant. This was the only area of concern in the discharge conduit.
