2008 Inspection Report Lake Lemon Dam Unionville, Indiana

DLZ Job No. 0863-0621.90

December, 2008

2008 INSPECTION REPORT LAKE LEMON DAM UNIONVILLE, INDIANA

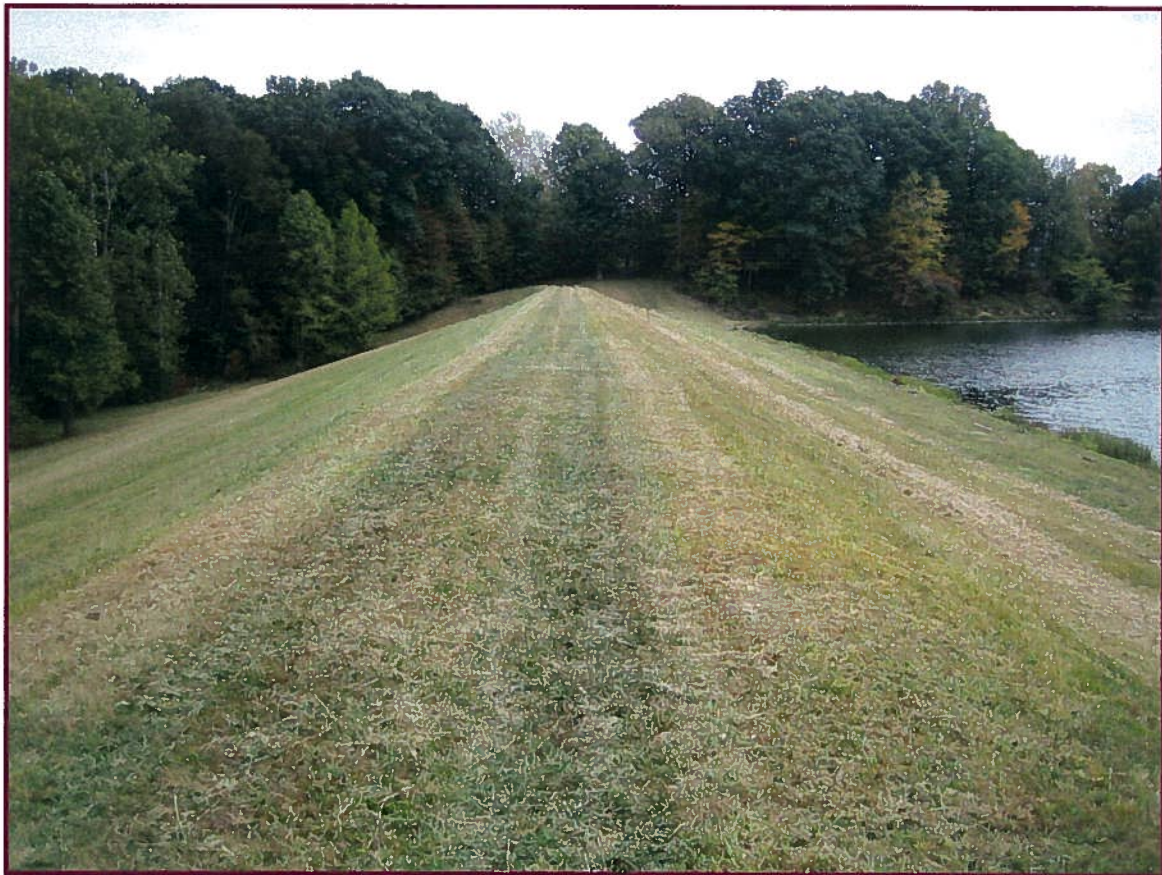
Embankment crest. View is towards right abutment.

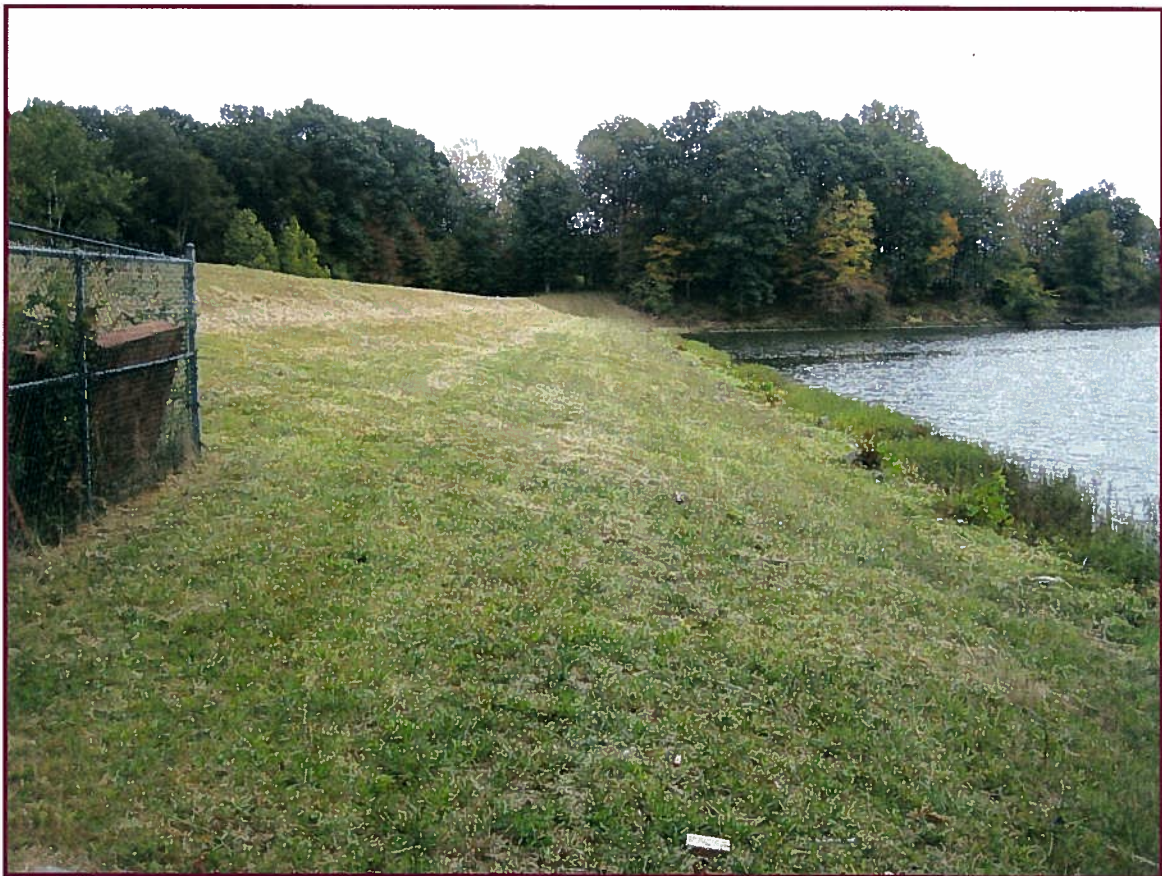
Upstream embankment slope. View is towards right abutment.

Brush and weeds along waterline in 2006 have been removed. Slope had been recently mowed and looked in very good condition.

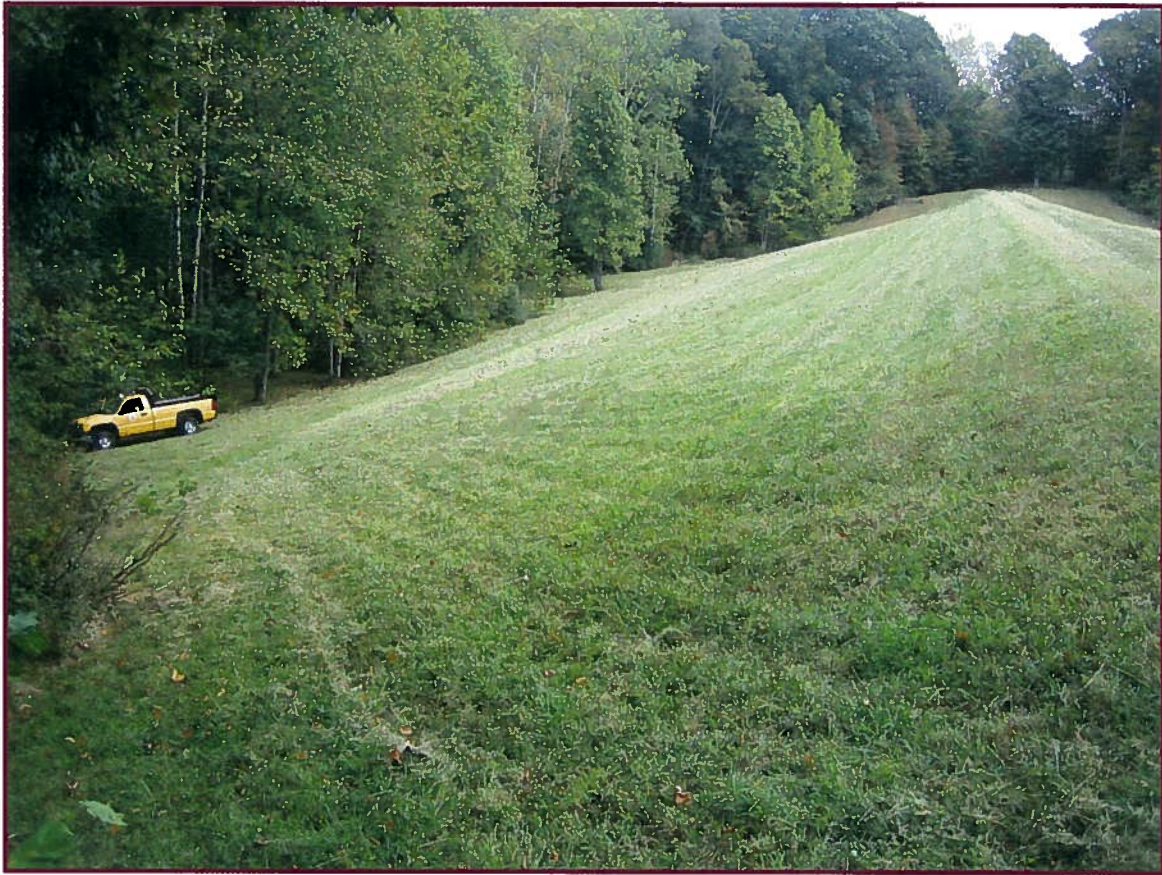
Downstream embankment slope. View is towards right abutment.

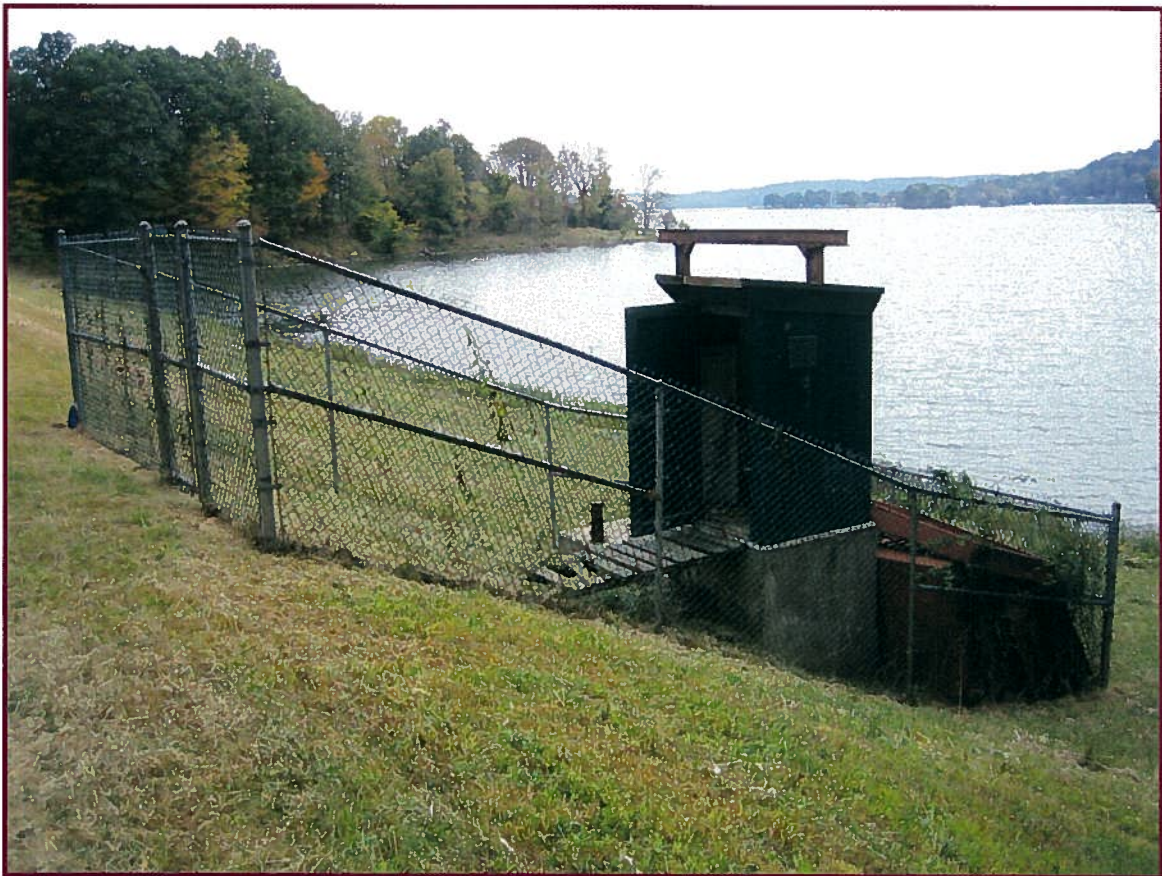
Gate structure.

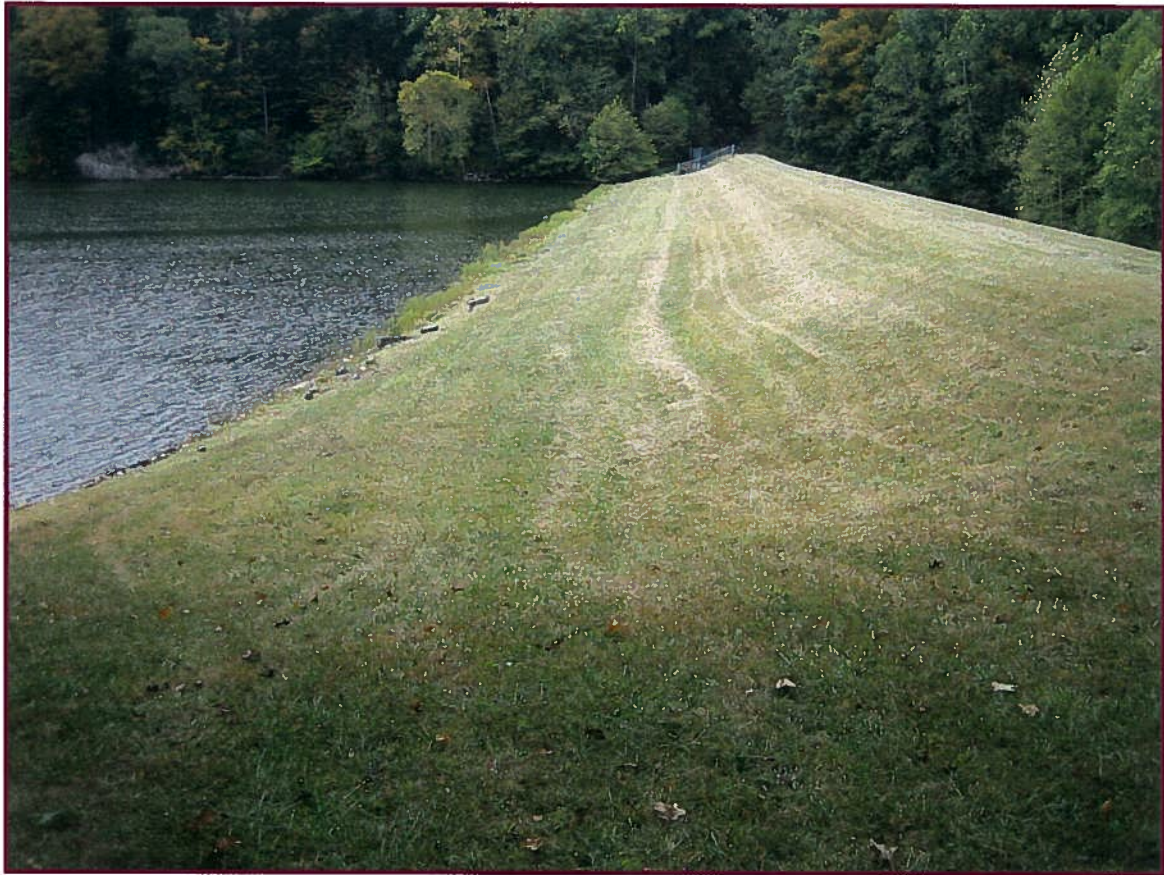
Upstream embankment slope. View is towards left abutment.

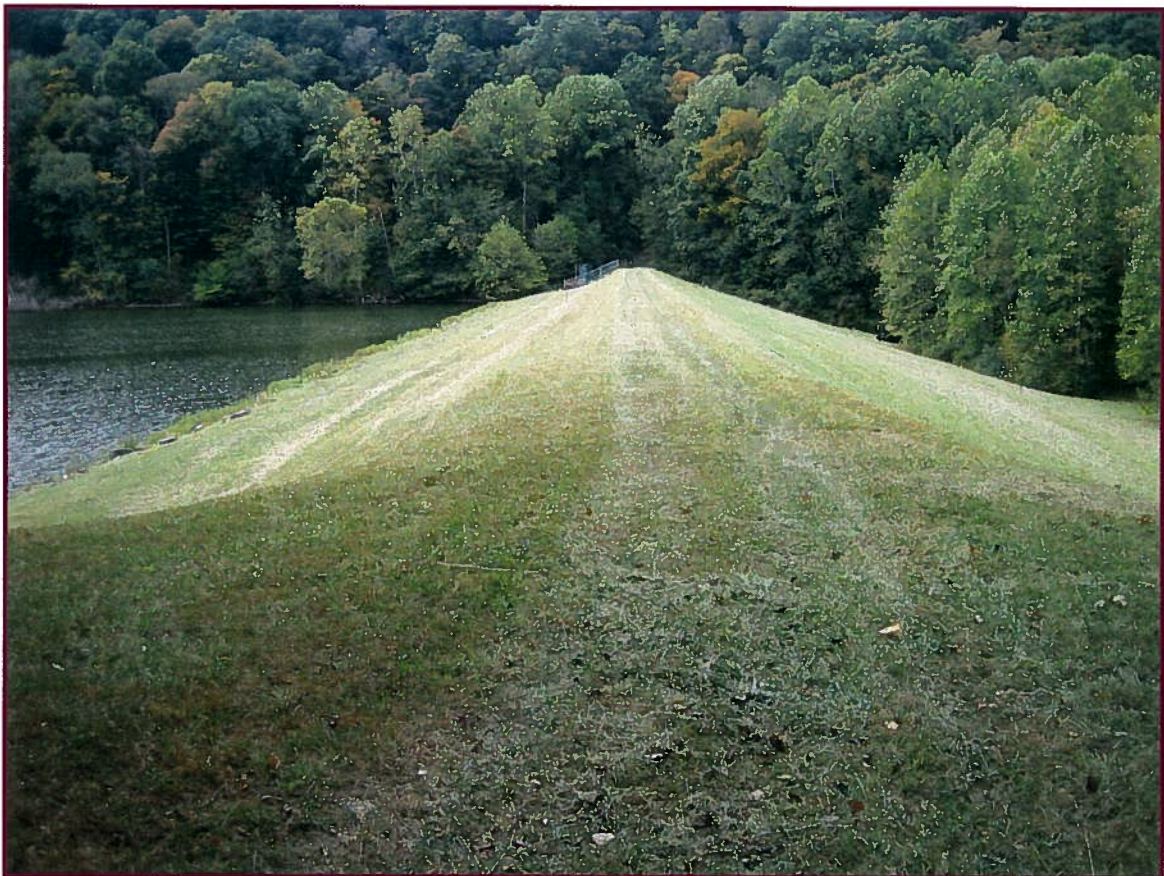
In the 2006 inspection, some small brush and trees were observed along the water's edge. However, this vegetation has since been removed. In addition, rutting on the crest from vehicular traffic was noted in the 2004 and 2006 inspections. These ruts were filled in 2007, but additional rutting occurred during the inspection of the dam that took place at the time of the large rainfall event in June 2008. These new ruts should be filled to enhance drainage of the crest.

Embankment crest. View is towards left abutment.

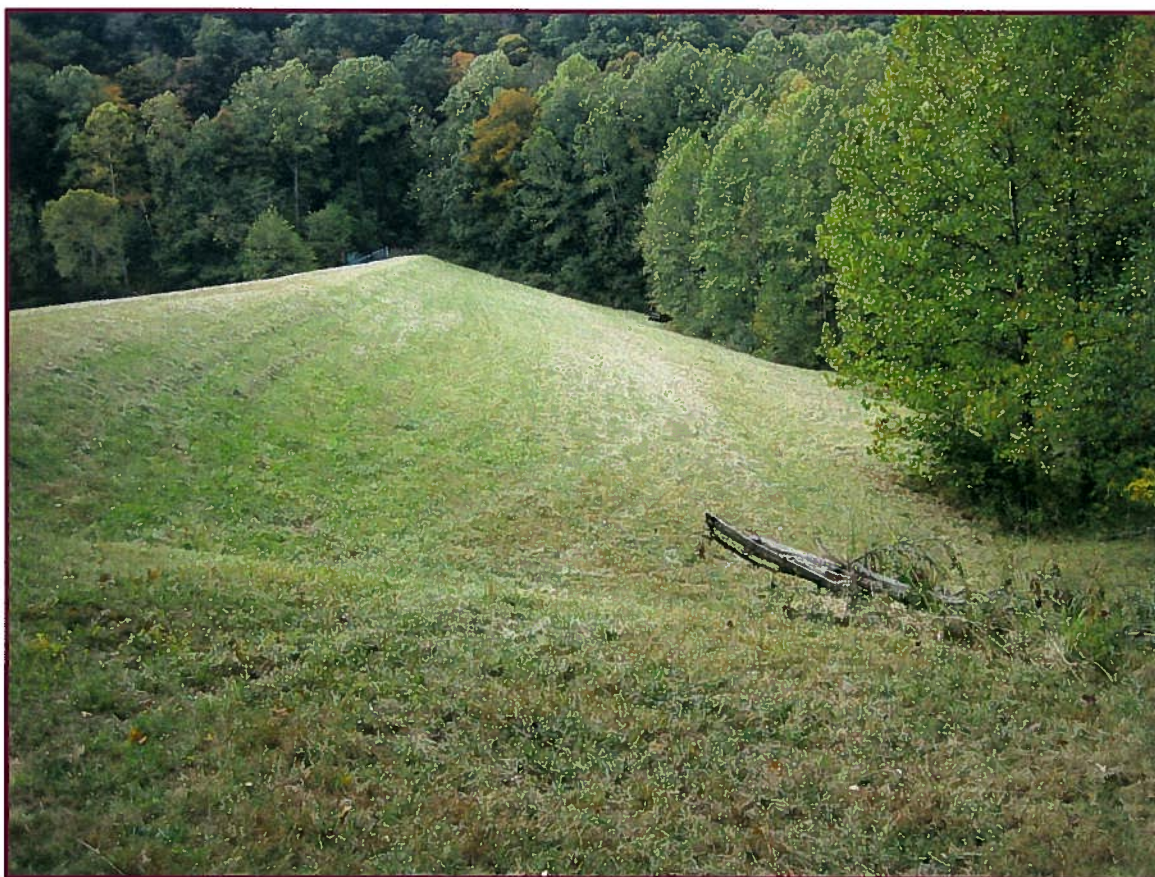
Downstream embankment slope. View is towards left abutment.

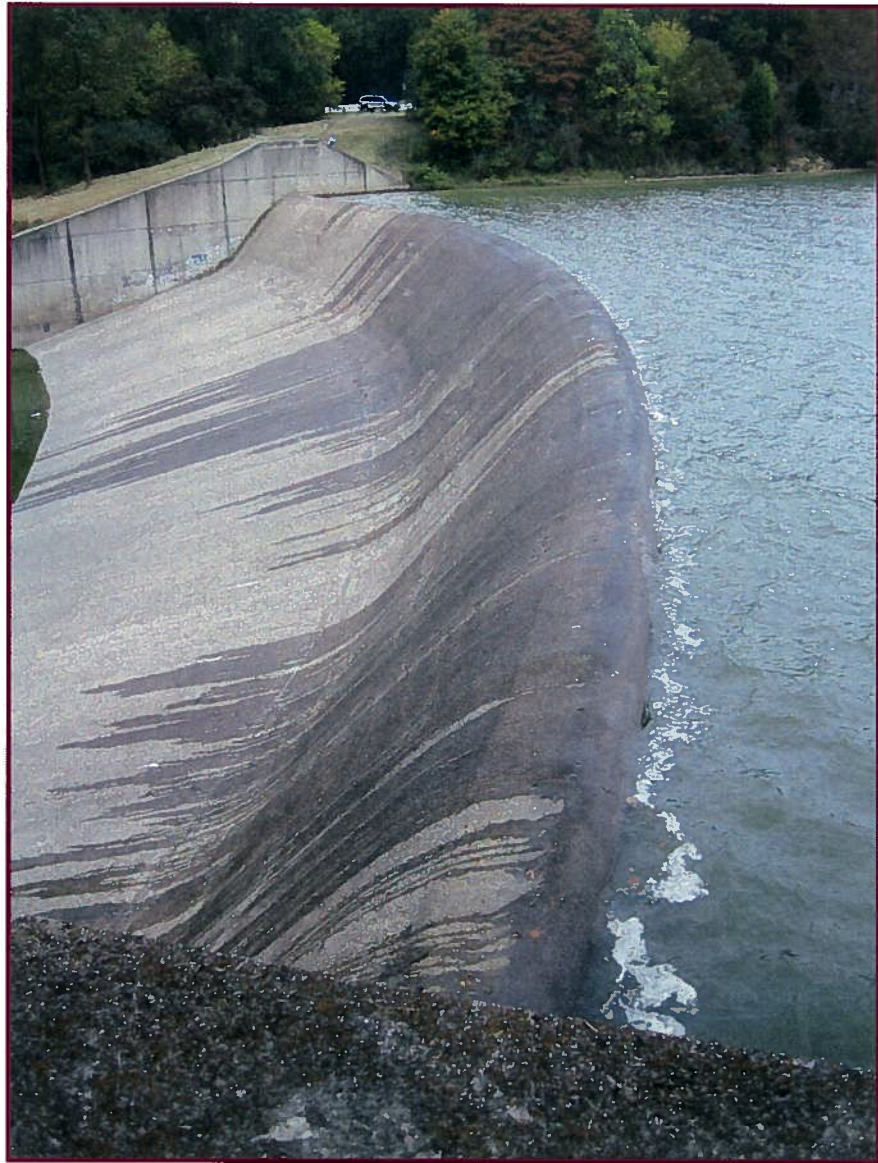
The principal spillway was in acceptable condition. It does not appear to have changed significantly since the last inspection. There has been some displacement in the joints over the years ($\frac{1}{2}$ to $\frac{3}{4}$ inches) but the overall condition of the spillway appears to be acceptable.

Crest of ogee spillway.

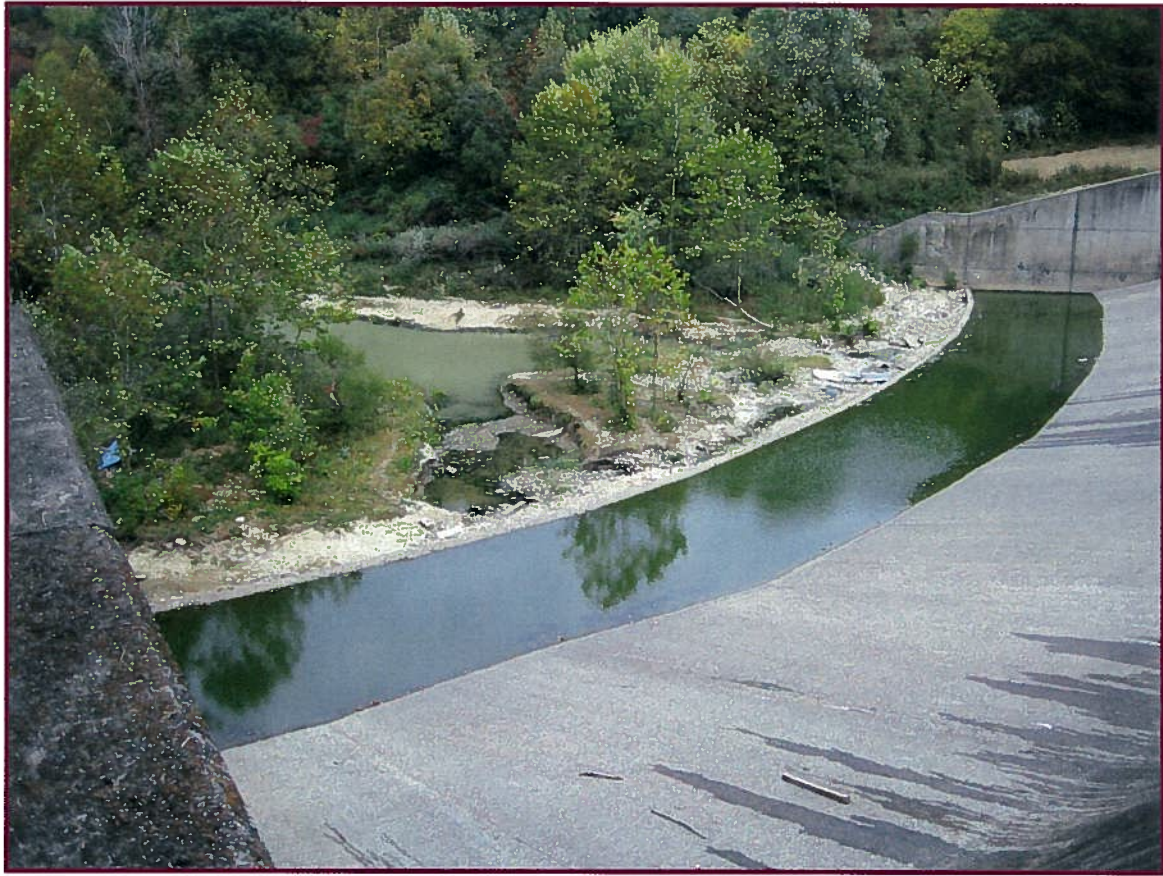
Stilling basin at toe of ogee spillway.

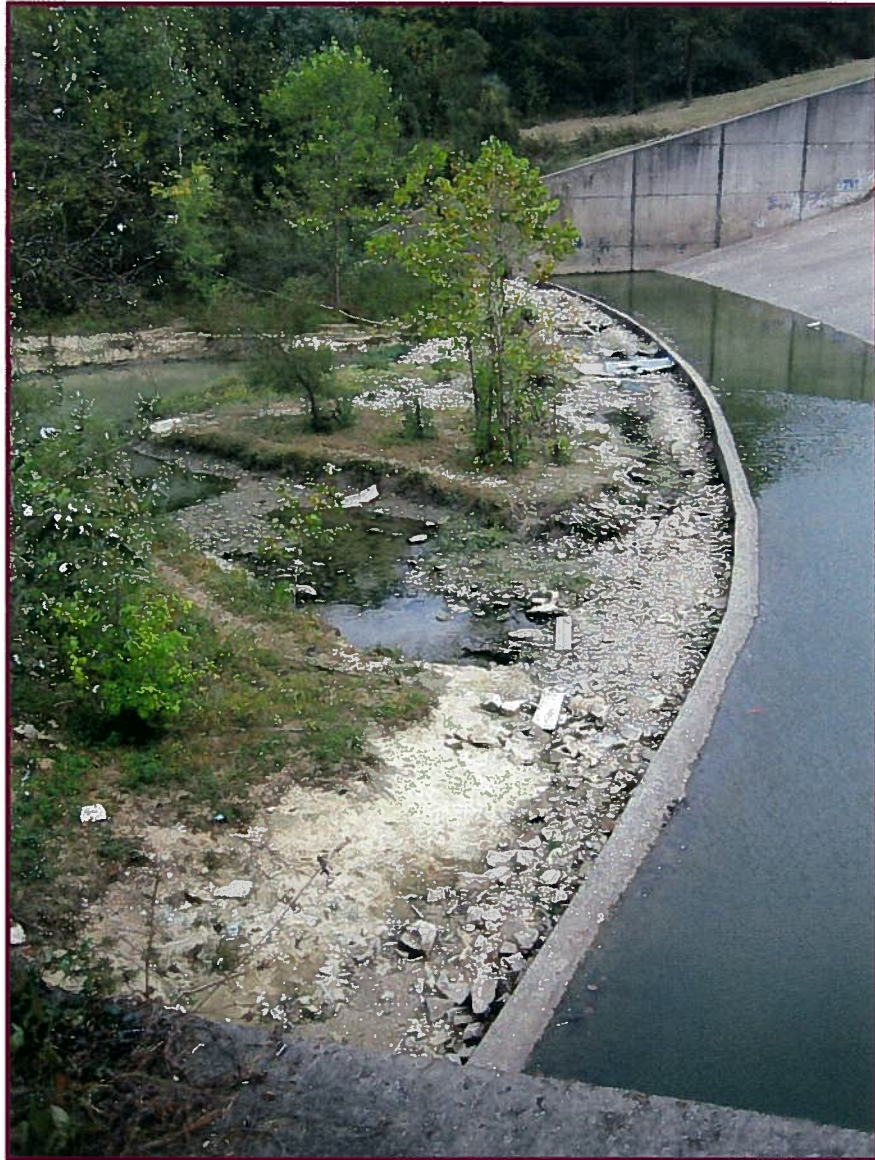
The only minor concern we noted during the inspection of the principal spillway was the possible minor erosion immediately downstream of the ogee's end wall. If this condition worsens, the end slab could be endangered as the erosion progresses upstream beneath the slab. We recommend that this erosion condition be monitored, especially after significant spillway discharges. If the condition worsens, it is anticipated that properly-sized riprap could be placed immediately downstream of the end wall to armor this area.

Minor erosion along end wall.

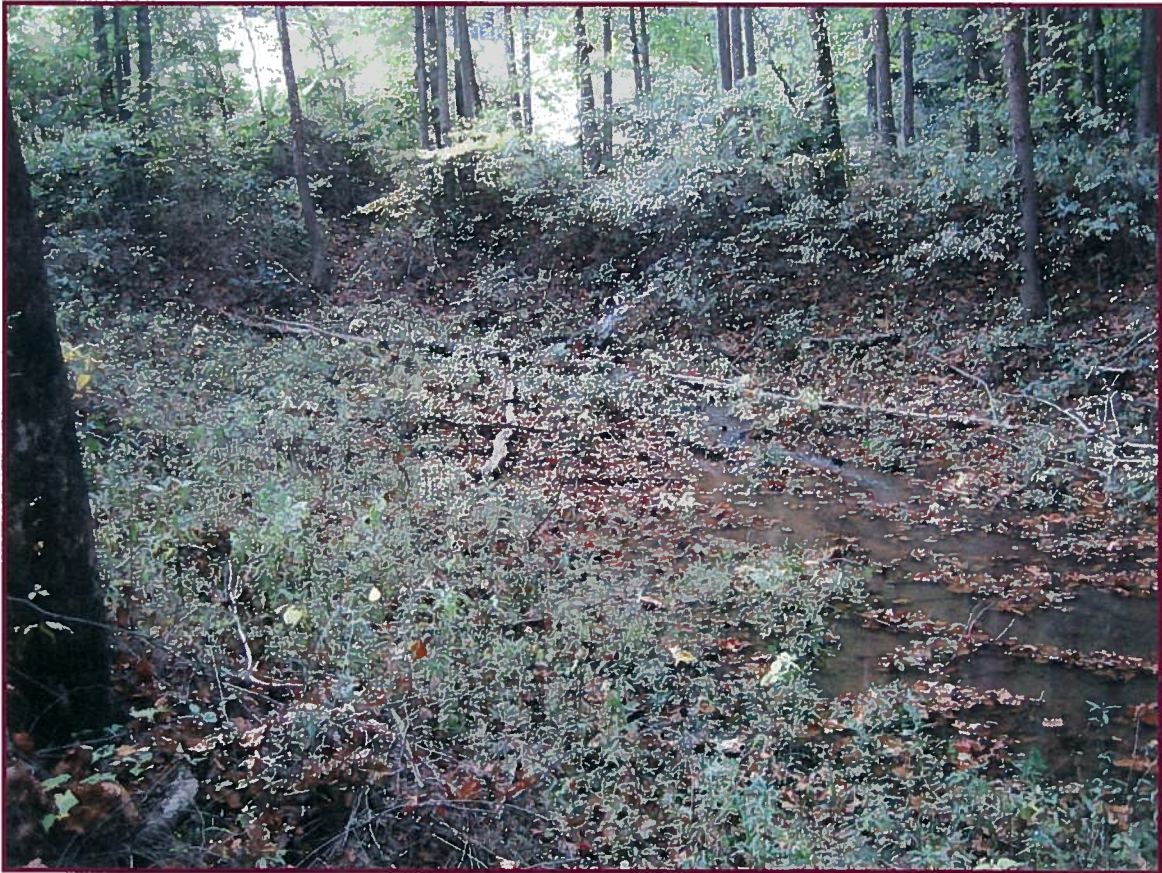
In previous inspections, an area of possible seepage was observed along the downstream toe, near the midpoint of the embankment. This area appears to be the location of the original stream channel. No discharge could be seen, but the old channel is wet with iron-stained, brackish water. This possible seepage was noted in the 2002, 2004, and 2006 inspections, also. This seepage area appears to be unchanged since the 2006 inspection. However, because of the high hazard associated with the project, it is recommended that this area be monitored visually on a monthly basis and following significant rainfall events. Any changes in the quantity or appearance of the seepage in this area should be brought to the attention of a dam engineer immediately.

Possible seepage area near location of original stream channel.

Comments: Possible seep observed at toe about mid-length of the embankment. Appears to be in the original stream channel. Does not appear to have changed since the 2006 inspection. The poor draining area noted at downstream end of right groin in 2006 appears unchanged.

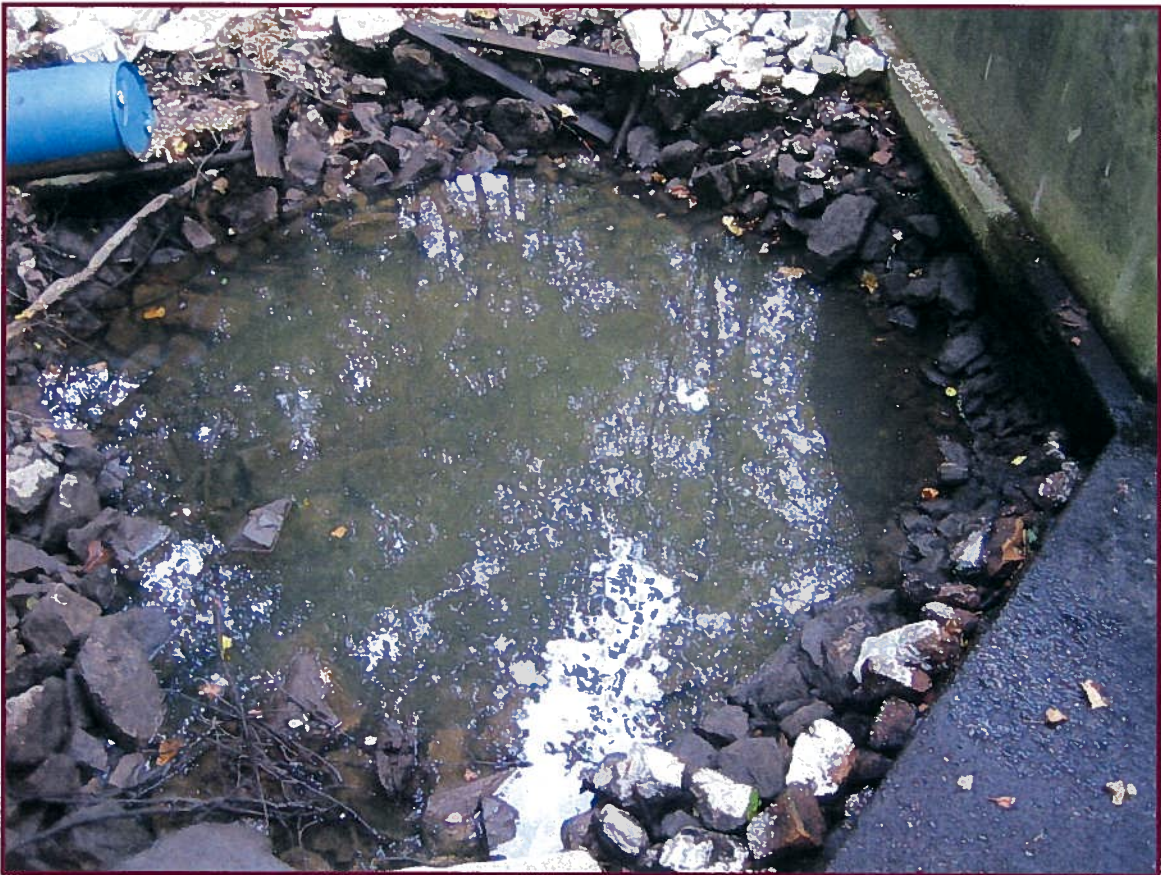
However, after the stilling basin dewatering was performed, an area of scour in the bottom of channel bottom was noted immediately downstream of the end of the stilling basin. This scoured area had been repaired in 2007. However, it's understood that this new scour occurred during winter drawdown last year, following the repair work. This area should be backfilled again with large riprap to prevent the scoured area from enlarging and undermining the stilling basin slab. The stilling basin design should be reviewed to determine the velocities at the end of the stilling basin so that the riprap can be properly sized for the anticipated velocities.

Scour area immediately downstream of stilling basin.

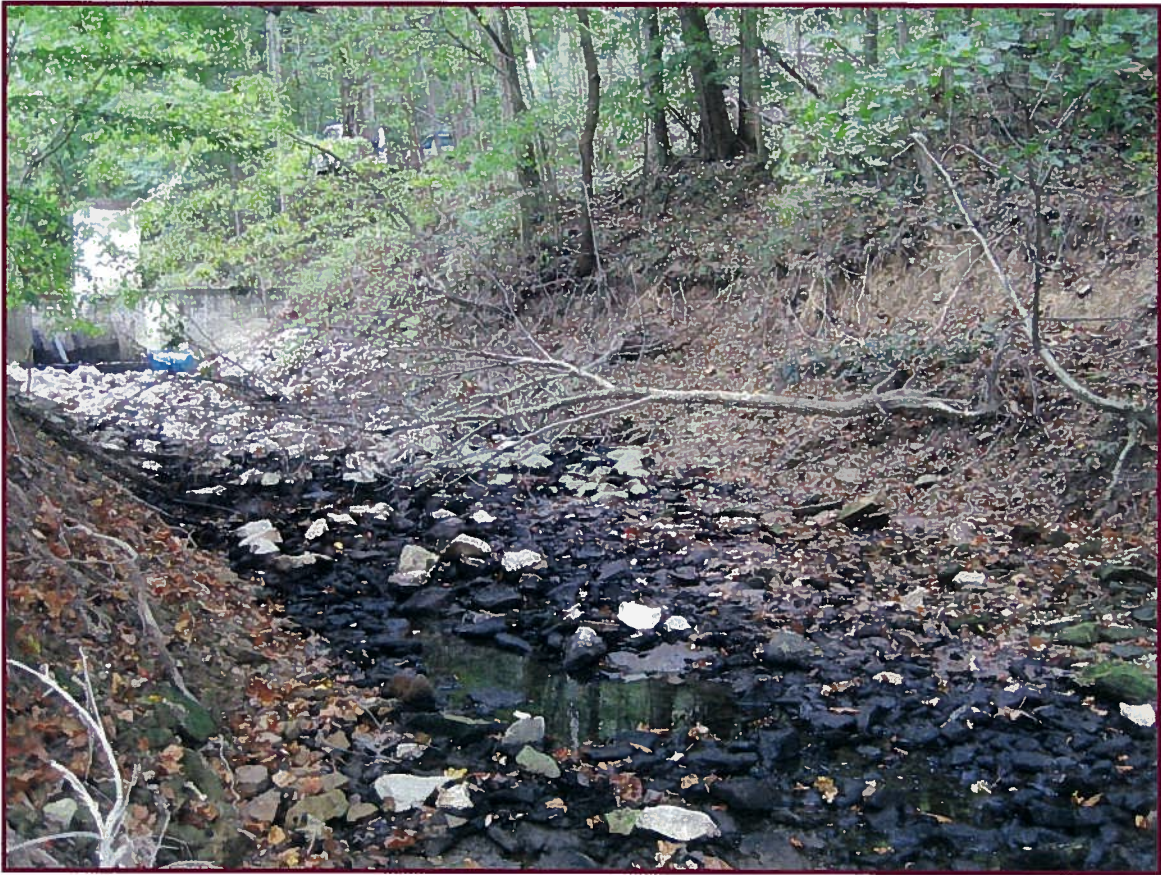
The banks of the outlet channel downstream of the stilling basin are showing signs of erosion and instability. This condition should be monitored. If debris in the channel affects the outflow, the debris should be removed.

Outlet channel. View is upstream.

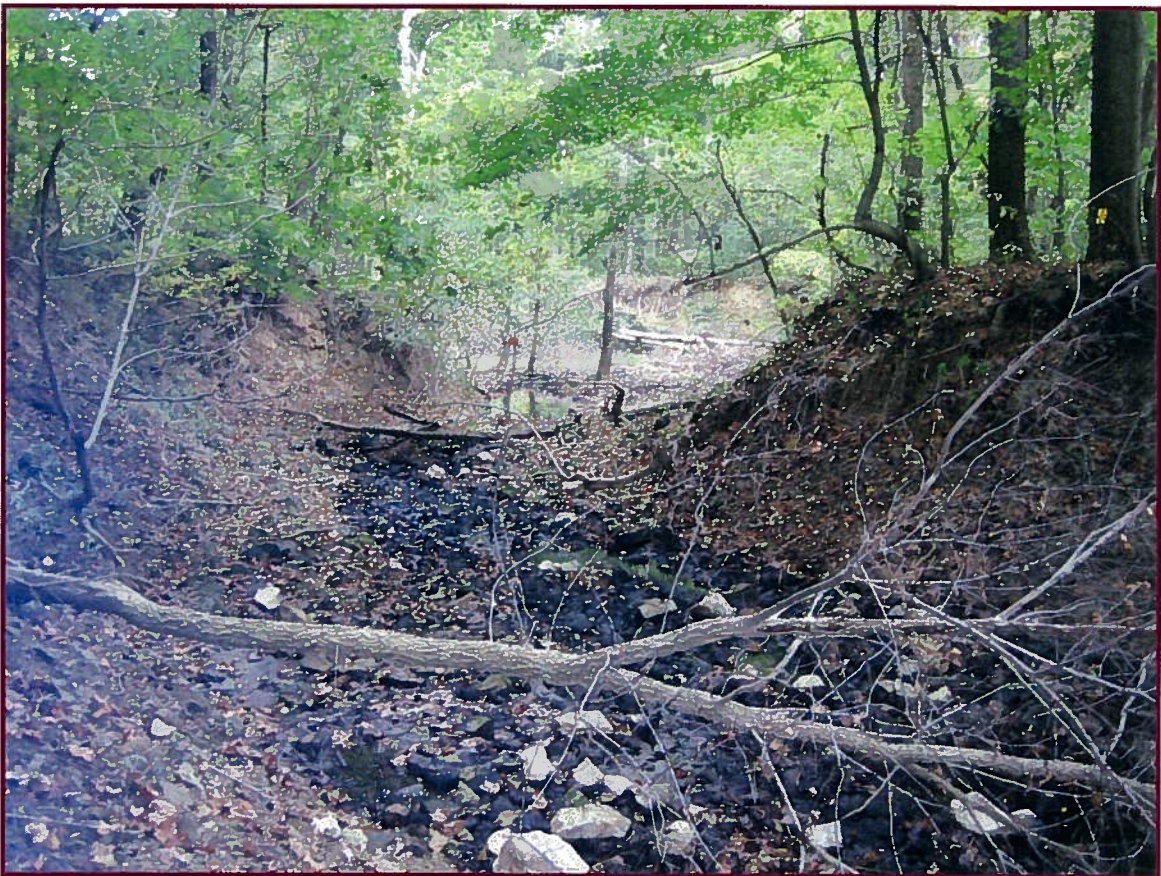
Outlet channel. View is downstream.

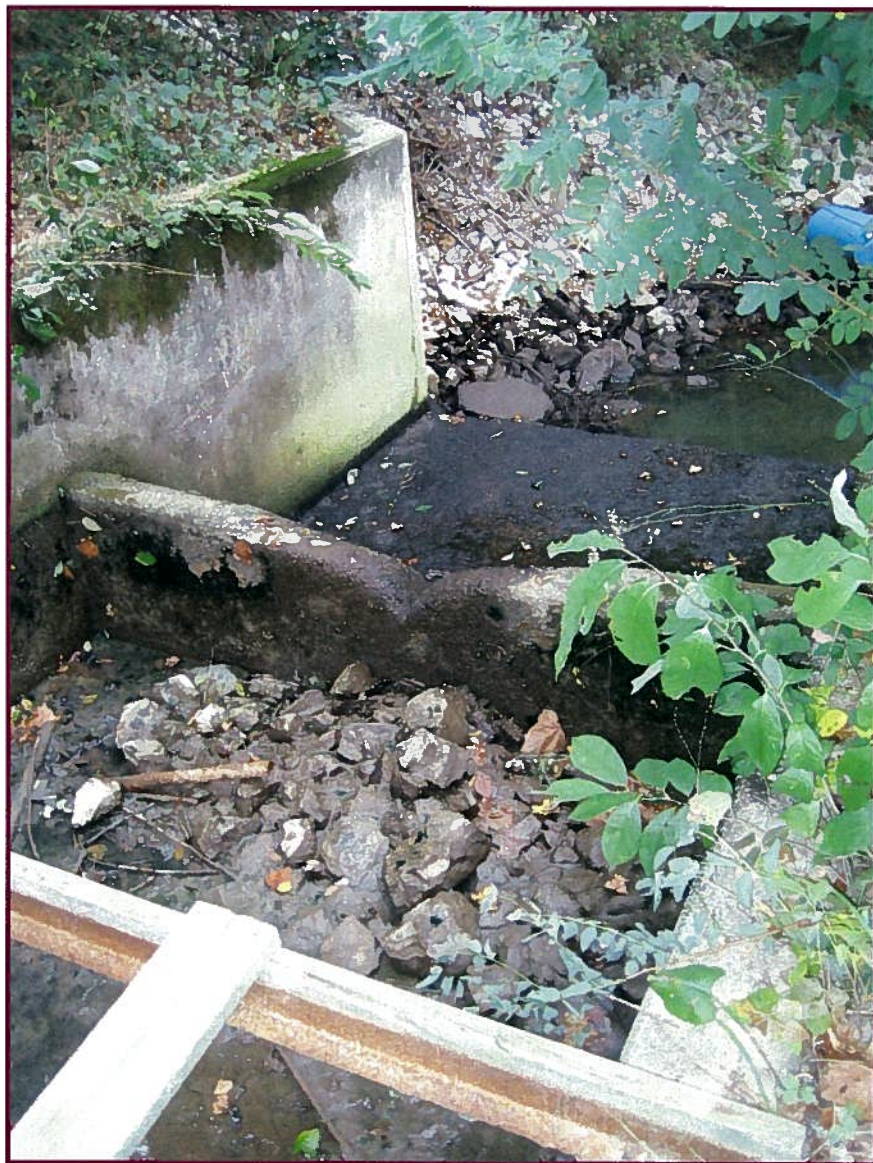
Also, as mentioned above, the stilling basin was dewatered as part of the inspection. The portions of the stilling basin below water also appeared to be in satisfactory condition.

Downstream end of dewatered stilling basin.

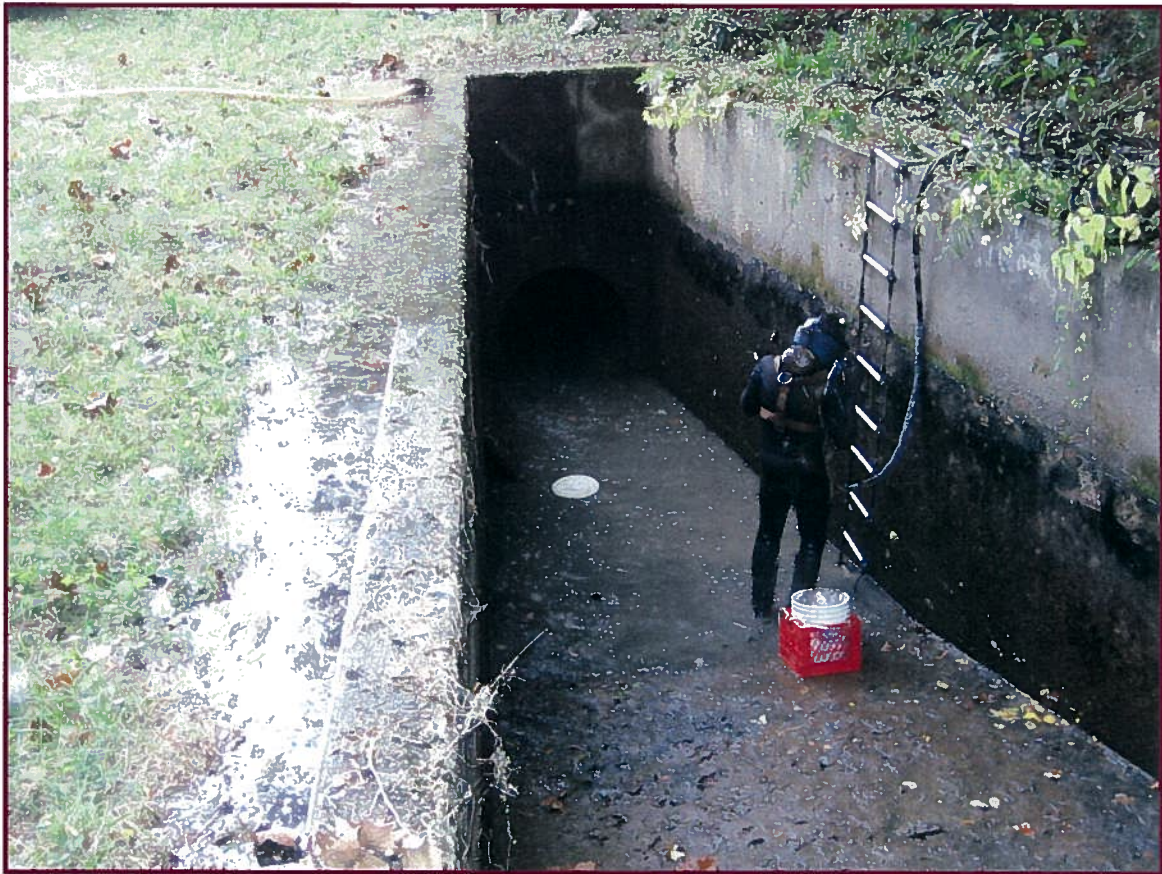
During the 2006 inspection of the downstream portion of the outlet pipe only one visible deficiency was noted. Approximately three feet downstream of the gate, filler had been lost from a small section of the pipe joint. During the 2008 inspection, the diver repaired the joint with hydraulic cement. The diver indicated the repair went well and no problems were reported. The diver also noted that the gate leaked slightly on the right side when in the closed condition.

Diver preparing to enter outlet pipe for inspection and to perform minor joint repairs as recommended in 2006 inspection.

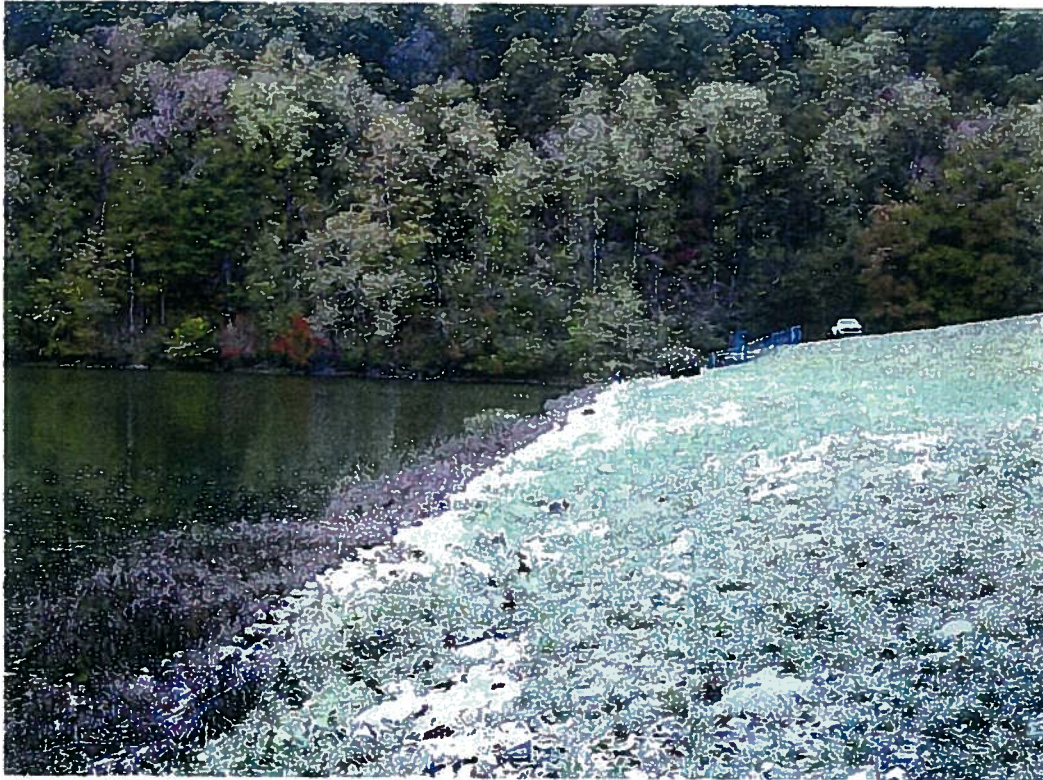
Photo 1

Small brush and trees removed from embankment at water's edge

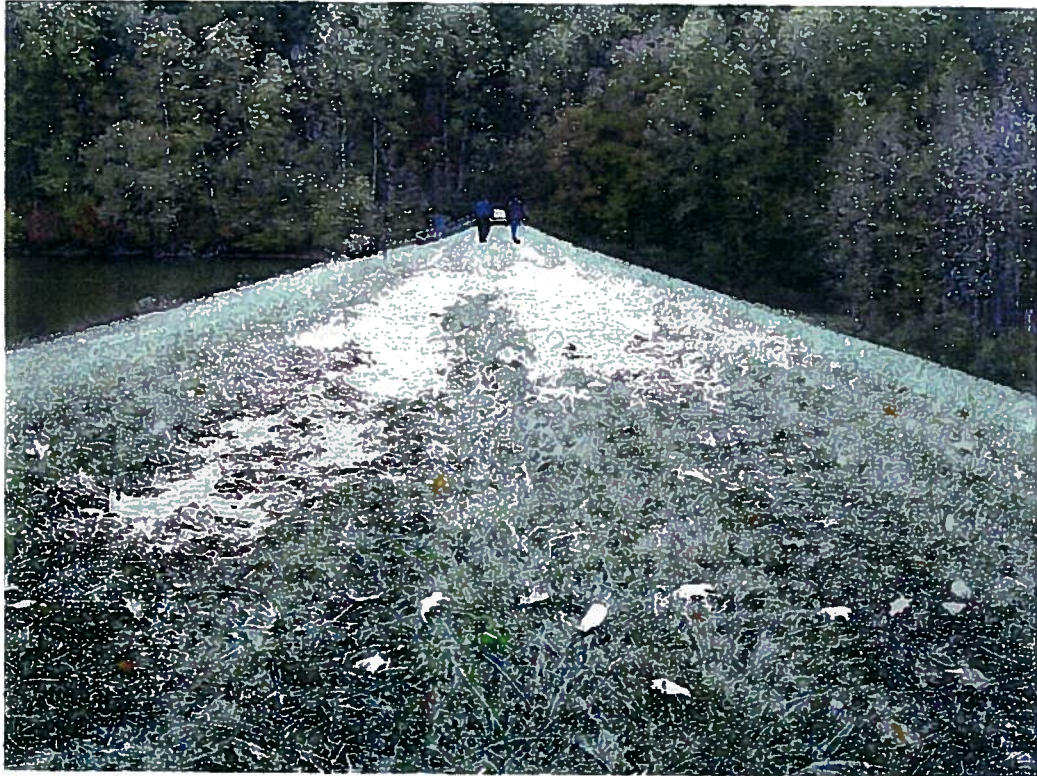
Photo 2

Ruts along crest filled and seeded

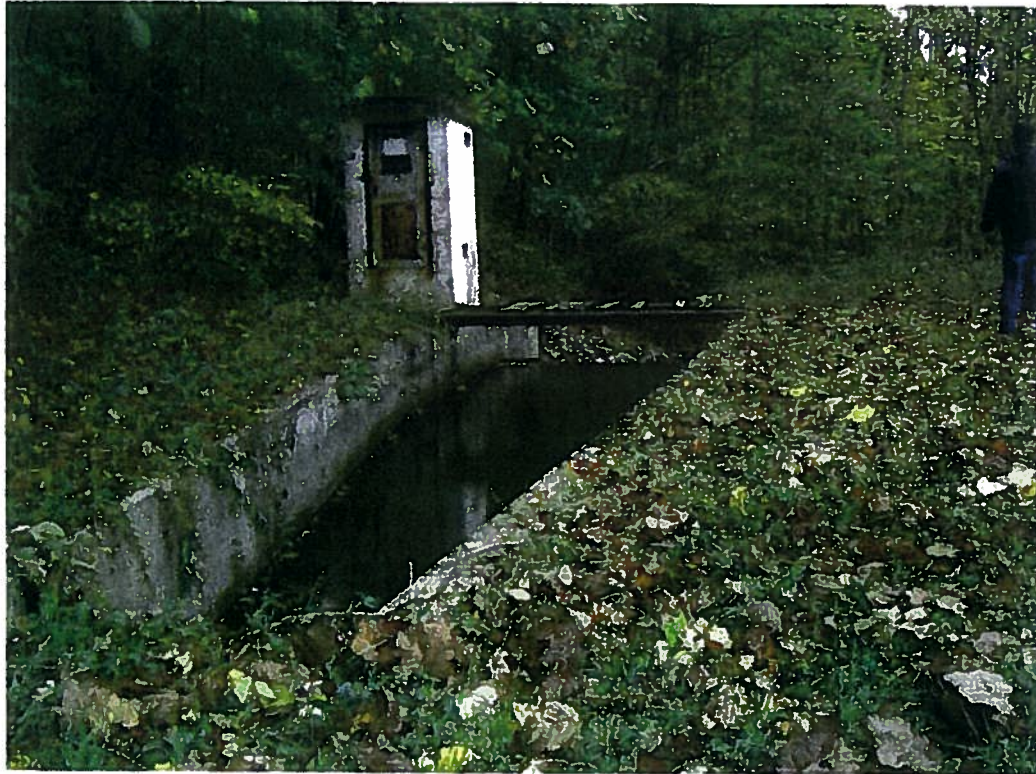
Photo 3

Vegetation removed from perimeter of still basin

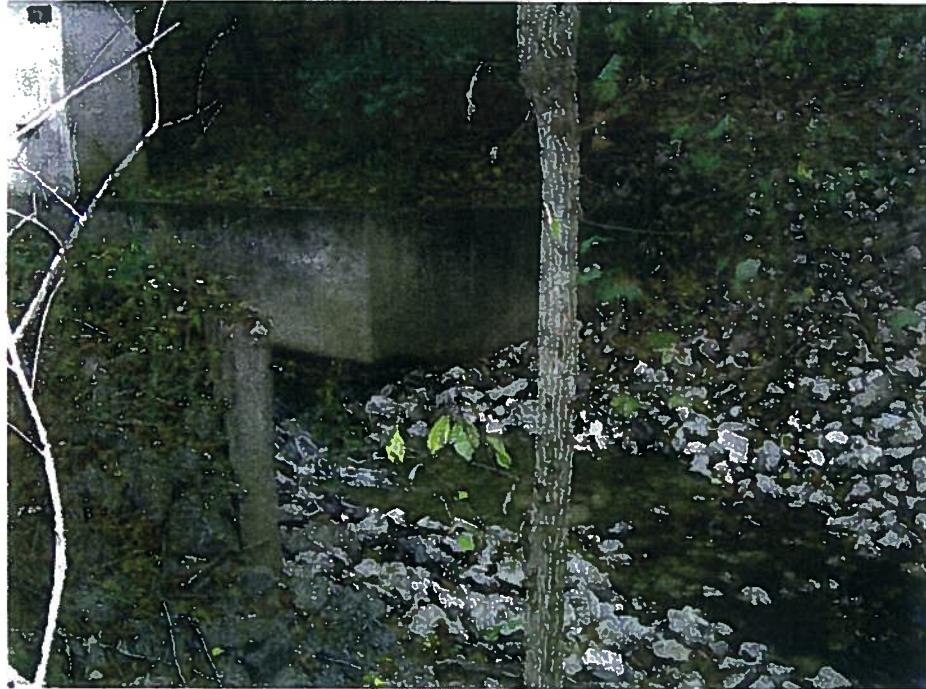
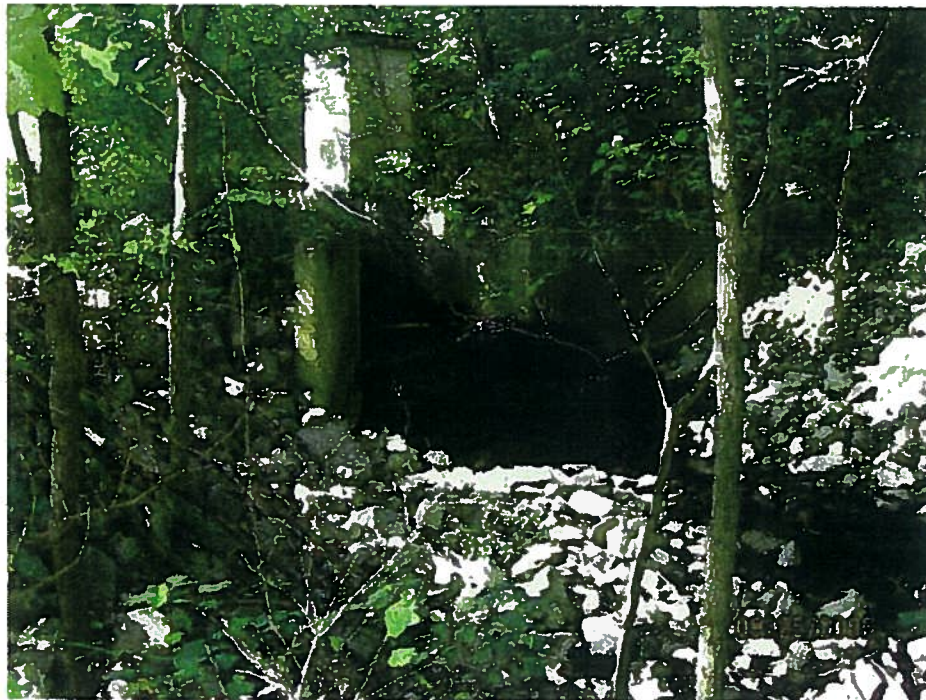
Lake Lemon Dam
Photo Record of Dam Maintenance Improvements
11/26/2007
Photos 4 & 5

Areas of scour repaired by placement of riprap (*after above/before below*)

Scour area has been repaired by placement of riprap as illustrated by attached photos 4 & 5.
