2014 Lake Lemon Dam Inspection

Unionville, Indiana

Lake Lemon Conservancy District

November 2014

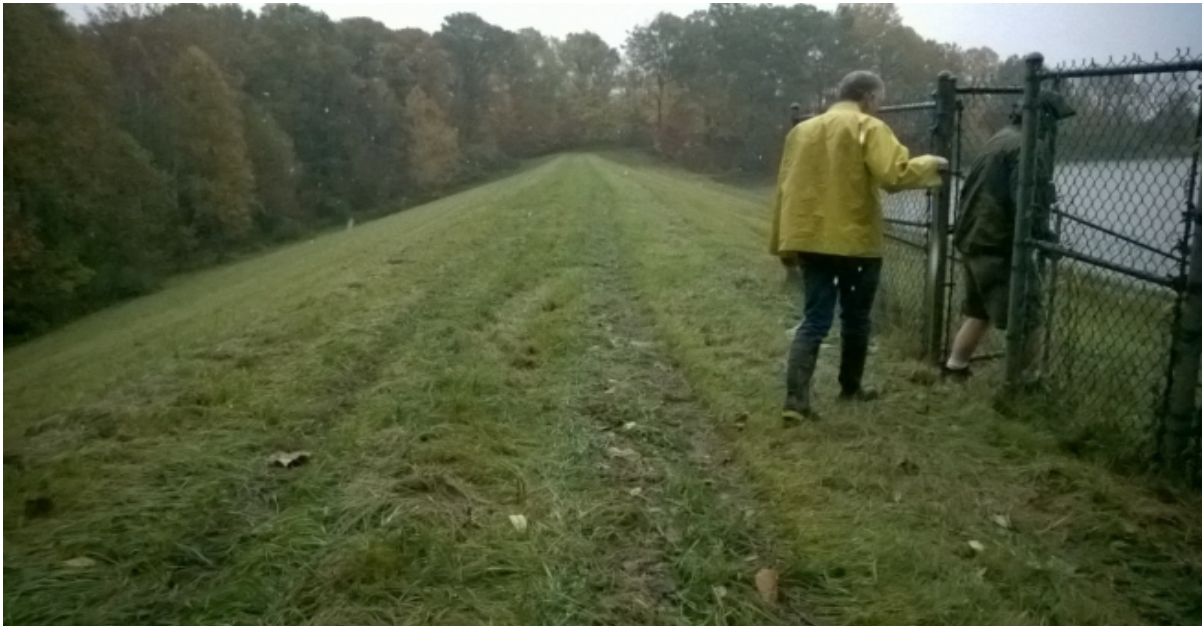
Photograph No. 1

Looking at northeast at the embankment crest towards the right abutment.

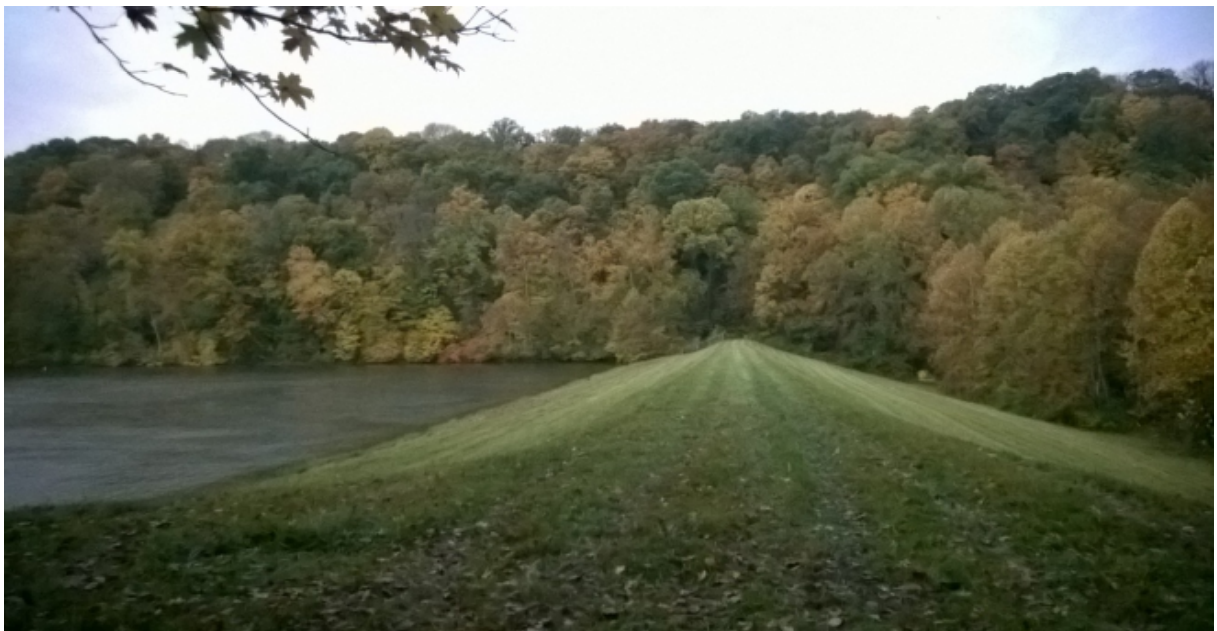
Photograph No. 2

Looking at southwest at the embankment crest towards the left abutment.

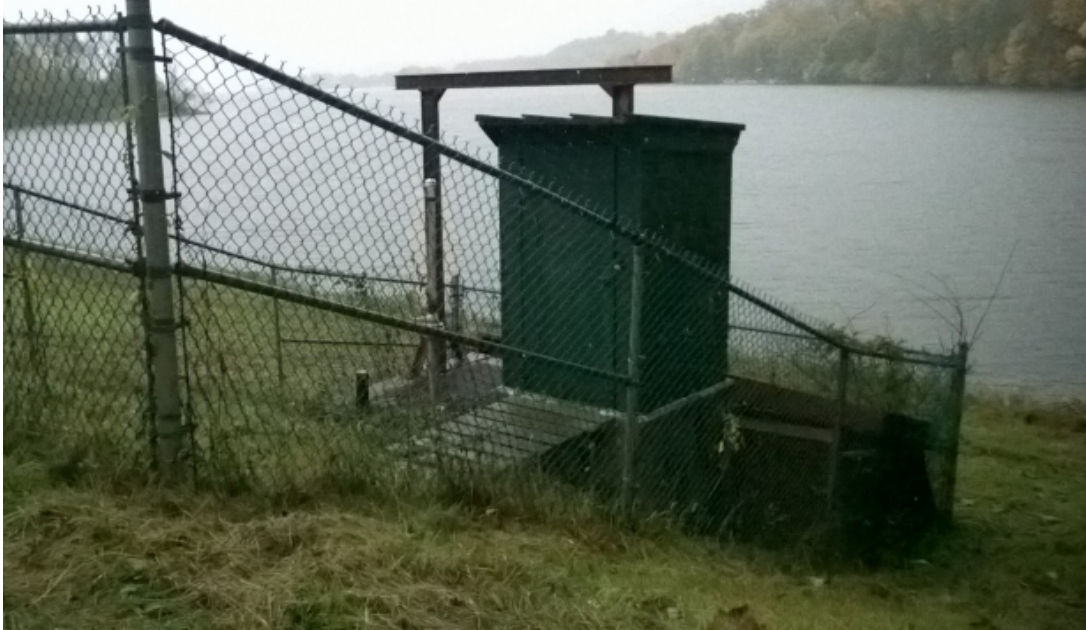
Photograph No. 3

Looking southeast the gatewell structure.

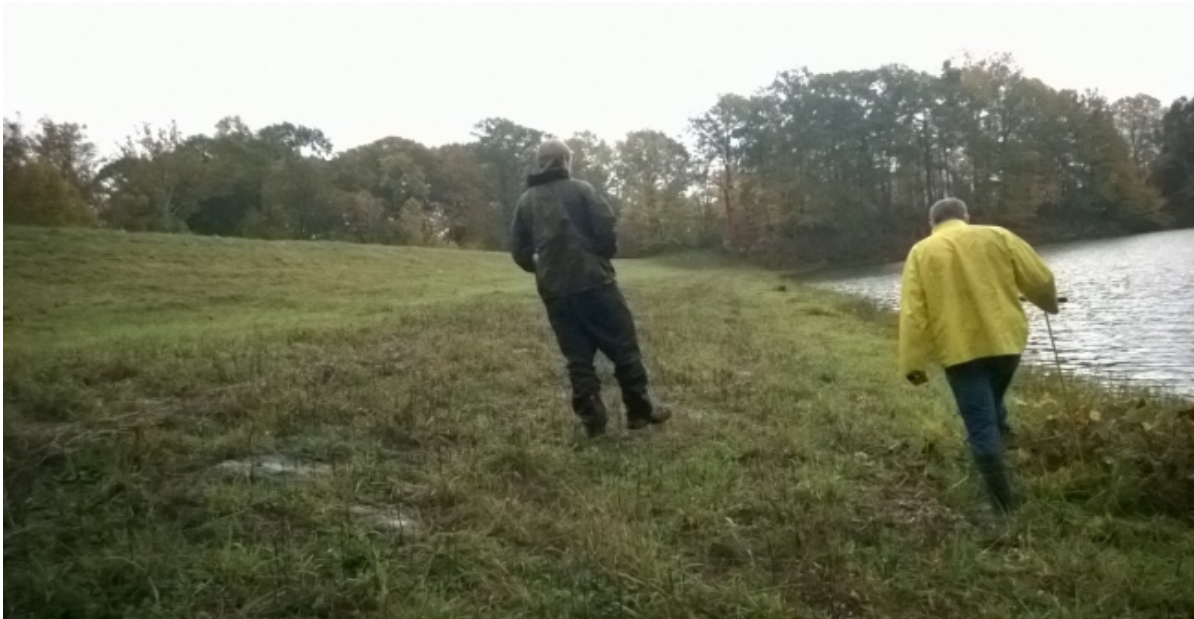
Photograph No. 4

Looking at the upstream embankment slope towards the right abutment.

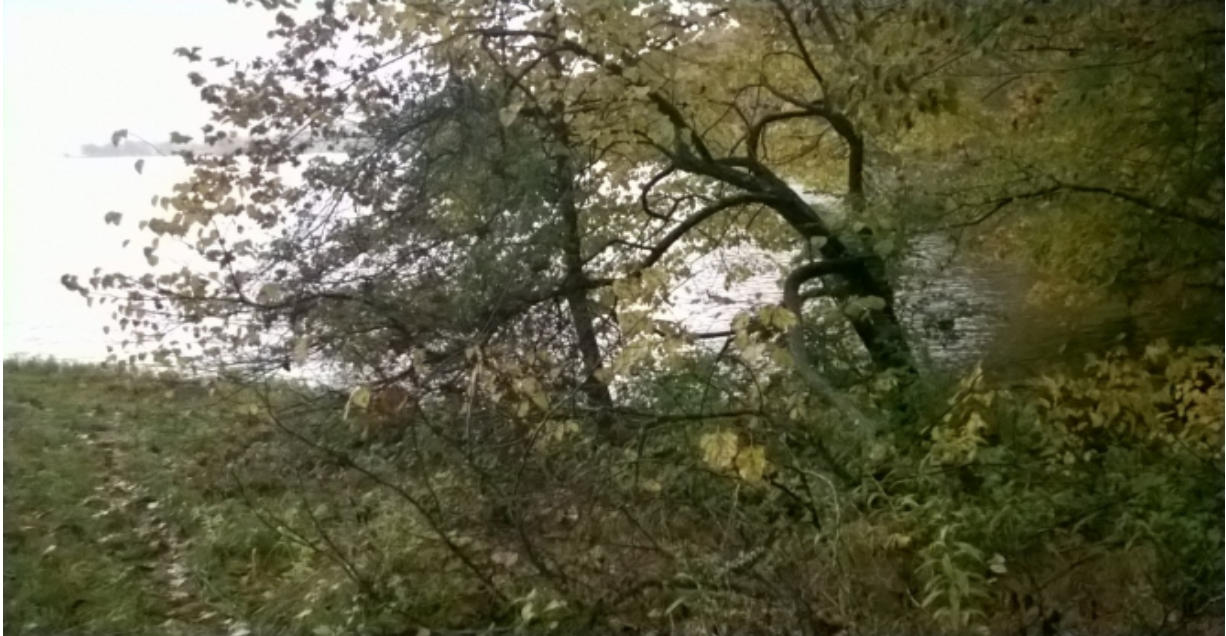
Photograph No. 5

Vegetation was found extending onto both the left and right abutments at both the upstream and downstream faces. Any vegetation growing on the embankment faces should be fully removed, including brush piles. Clearing all vegetation will enable more thorough inspection of abutment and downstream embankment areas. The abutment areas form 'valleys' that concentrate surface water

Looking southwest at vegetation encroaching the left abutment.

- ii. Vegetation at the left and right abutments on both the upstream and downstream sides near the valley areas should be removed. (Photograph 5 and 13)

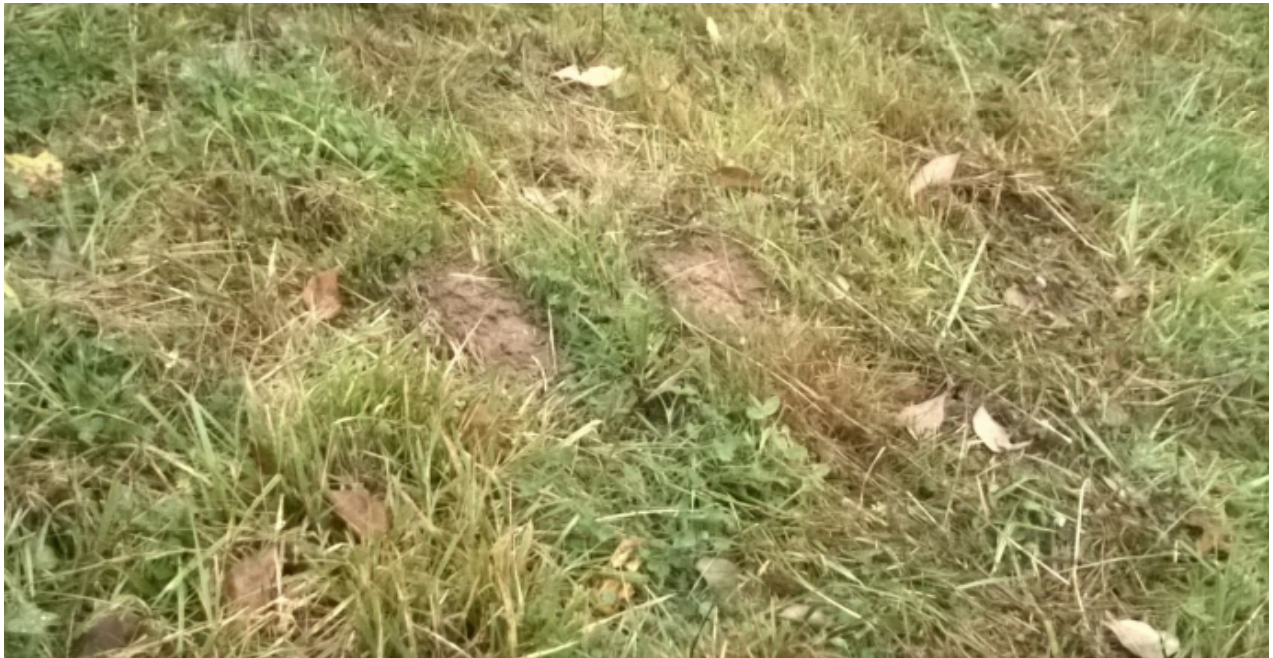
Photograph No. 6

Surficial excavations, apparently created by animals, were found on the right upstream slope of the embankment. However, the excavations were shallow and did not appear to be burrows. If burrows are found they should be filled with competent, well compacted material. If burrows cannot be readily filled with compacted soil, Portland cement grout can be poured into burrows to remediate them. The embankment should be regularly monitored for animal burrows because they can create seepage pathways if not filled.

Mole activity at the upstream embankment.

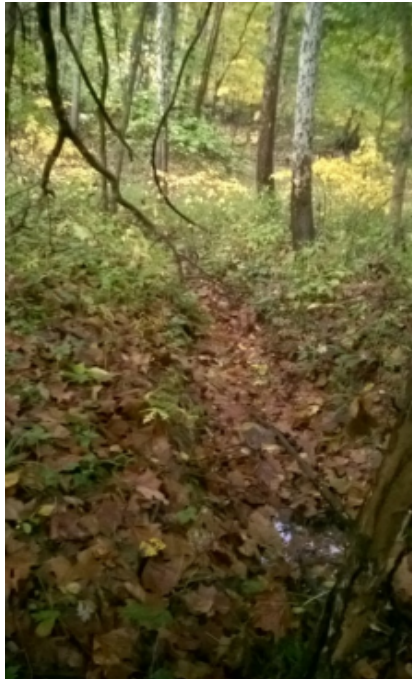
Photograph No. 7

Eroded channel located slightly north of the downstream embankment.

1. The area along the downstream toe near the midpoint of the embankment and the surrounding area should be monitored for possible seepage. Due to the high hazard associated with potential seepage, it is recommended this area be monitored on a monthly basis and following significant rainfall events. Report any appearance of erosion, seepage, turbidity, and subsequent changes in seepage quantity in this area to the engineer immediately. (Photographs 7, 8, and 10.)

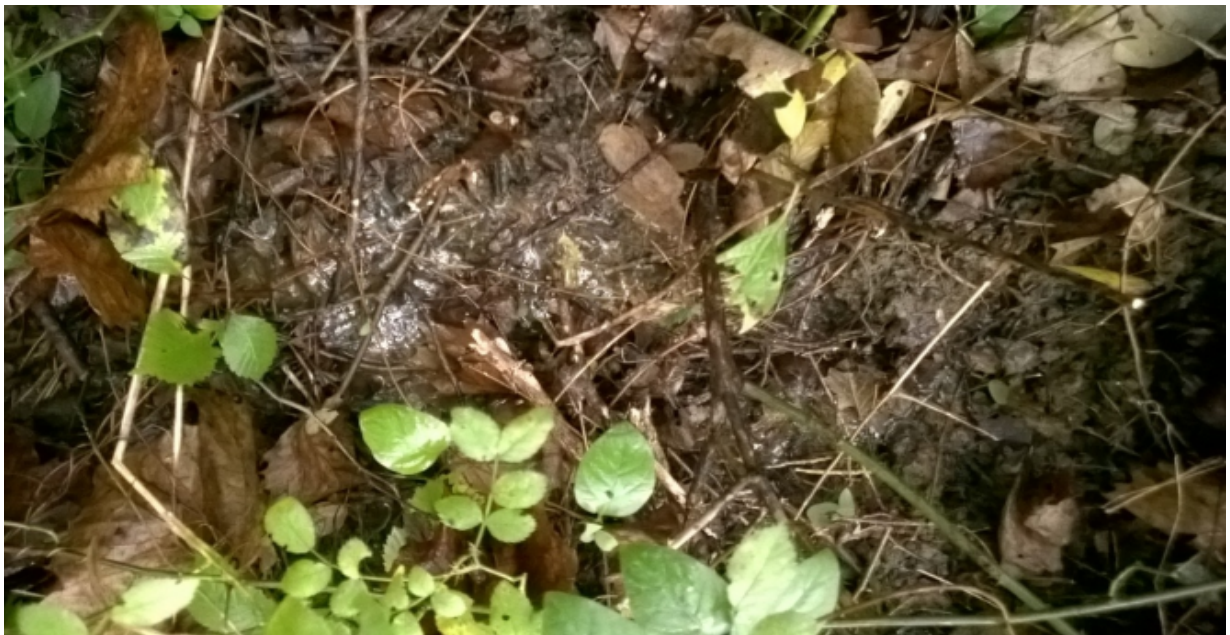
Photograph No. 8

An area of possible “clear” seepage was observed along the downstream toe, near the midpoint of the embankment. This area appeared to be the location of the former stream channel. The clear water source could not be verified due to overgrown vegetation in the area. While the source of the clear water could not be confirmed, that water may have been due to surface runoff from the rainy weather conditions at the time of inspection. Ponded water was also found beyond the downstream toe of slope, just north of the former stream channel location. The ponded water was draining to the former stream channel through a small gully. It was not possible to determine if this gully was the result of seepage or surface runoff. A small water flow was draining from the former stream channel area into the main stream. Water flow from any of these areas below the dam is concerning. If this flow exists during dry weather, corrective actions may be required to manage and control seepage and the potential for internal embankment erosion.

Possible clear seepage located at the downstream embankment toe.

It is recommended that all vegetation near the former stream channel area on the downstream embankment be removed so that this area can be monitored visually on a monthly basis. Seepage or soft ground should be reported immediately to the dam engineer. To enable the quantification of seepage from the former stream channel area, a small temporary earthen embankment should be placed across the former stream channel and a V-notch weir plate be embedded in that embankment to serve as the single drain outlet from the former stream channel area. By monitoring the height of water flowing through the V-notch, a relative assessment of flow can be made. Any changes in seepage appearance or flow should be brought to the attention of a dam engineer immediately.
