**LAKE LEMON DAM  
UNIONSVILLE, INDIANA**

Date Photographs Taken: 10/14/2014  
Inspector: Martin Brungard, P.E., D.WRE  
Page 5 of 11

# SUGGESTED DAM INSPECTION REPORT (Refer to pages 5 and 6 for instructions.)

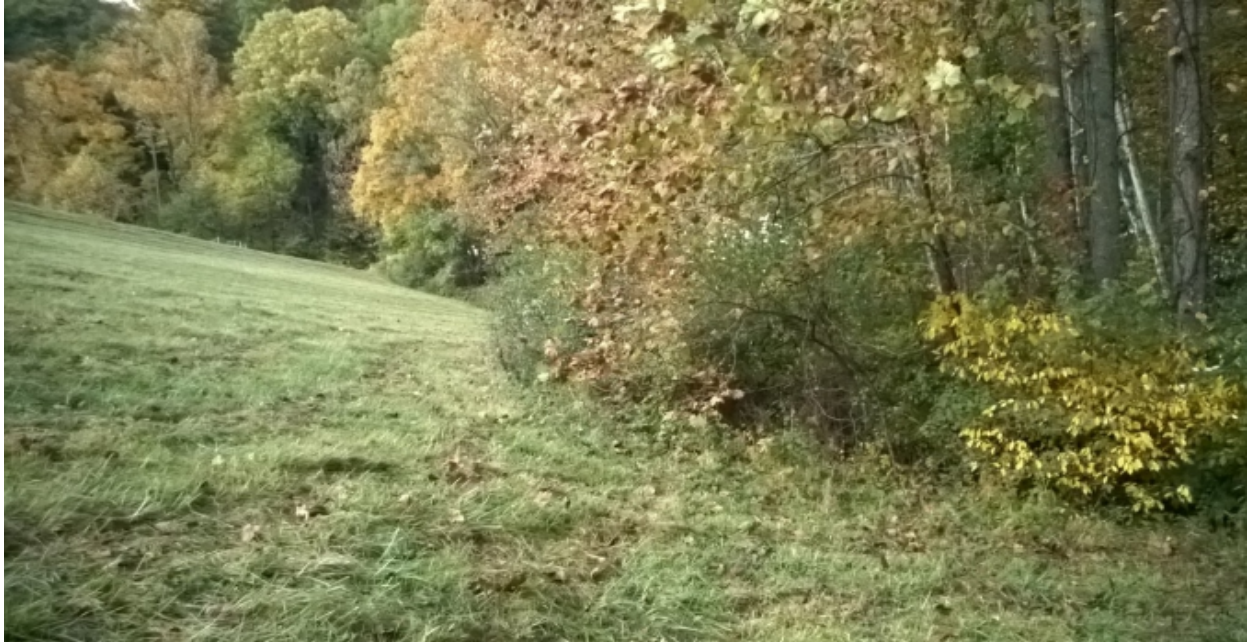
**Photograph No. 9**

Looking southwest at vegetation enroaching the downstream embankment toe where potential seepage is located.

Vegetation was observed at the left and right abutment areas and at the toe of the downstream slope.

Clear water noted at downstream slope toe area. Due to the rainy conditions and vegetation at the downstream slope at the time of inspection the water source could not be verified.

- ☒ (3) Clear Trees and/or Brush From: upstream and downstream sides, and at the left ogee spillway wall at the upstream and downstream sides.
- ☒ (4) Initiate Rodent Control Program and Properly Backfill Existing Holes: Properly backfill existing holes at upstream embankment.

- ☐ (5) Repair: \_\_\_\_\_
- ☐ (6) Provide Surface Drainage For: \_\_\_\_\_
- ☒ (7) Monitor: Monitor possible seepage along the downstream toe of embankment including channel erosion and ponding at old channel location.

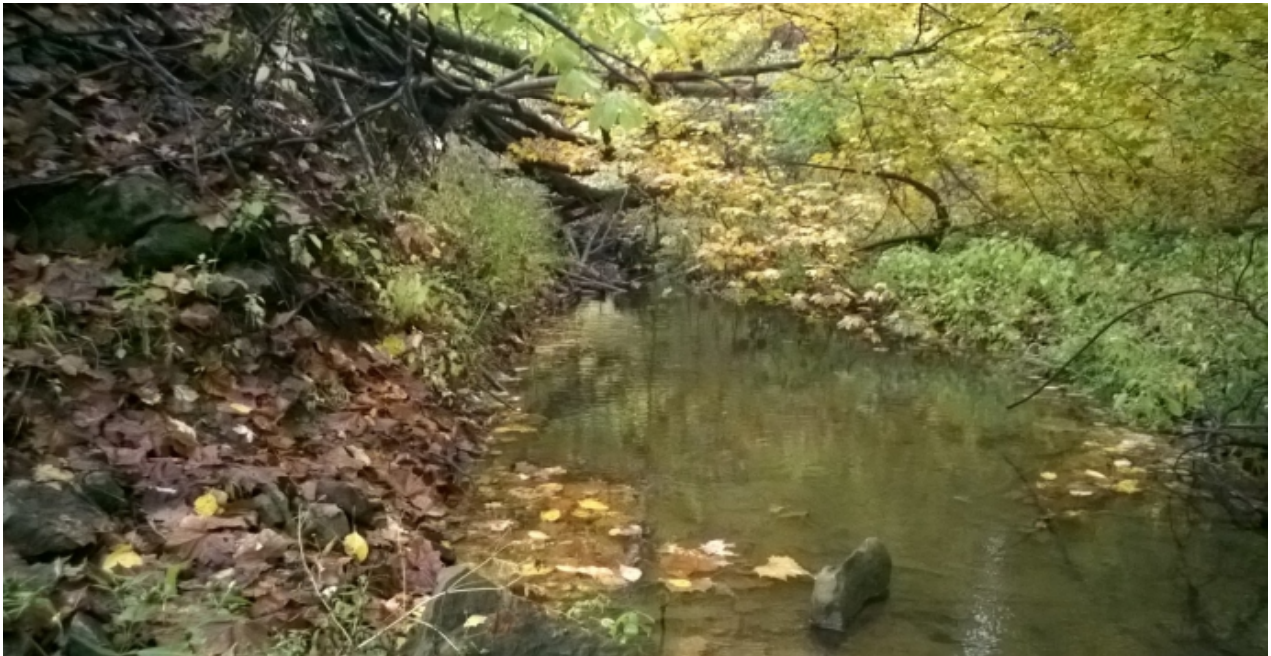
**Photograph No. 10**

Ponding located at the original stream channel location north of the downstream toe.

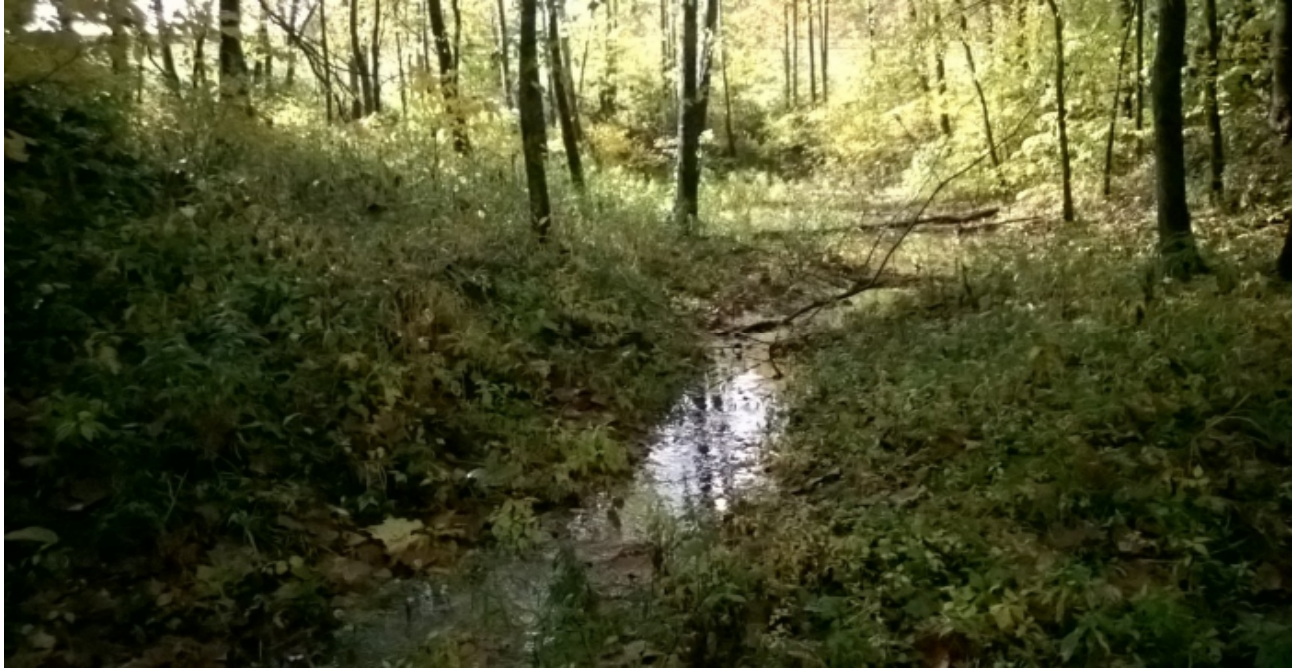
**Photograph No. 11**

Slight turbidity of channelized water located downstream of the ponding located near the downstream toe.

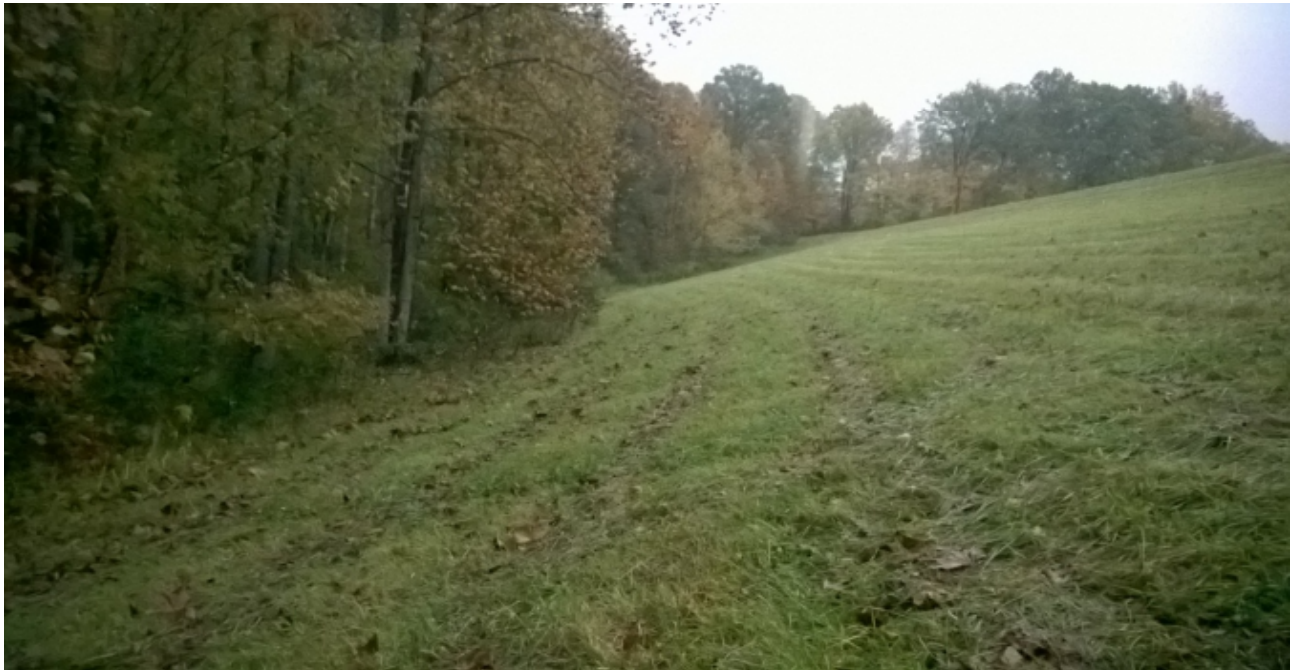
**Photograph No. 12**

Looking northeast at the downstream embankment slope.

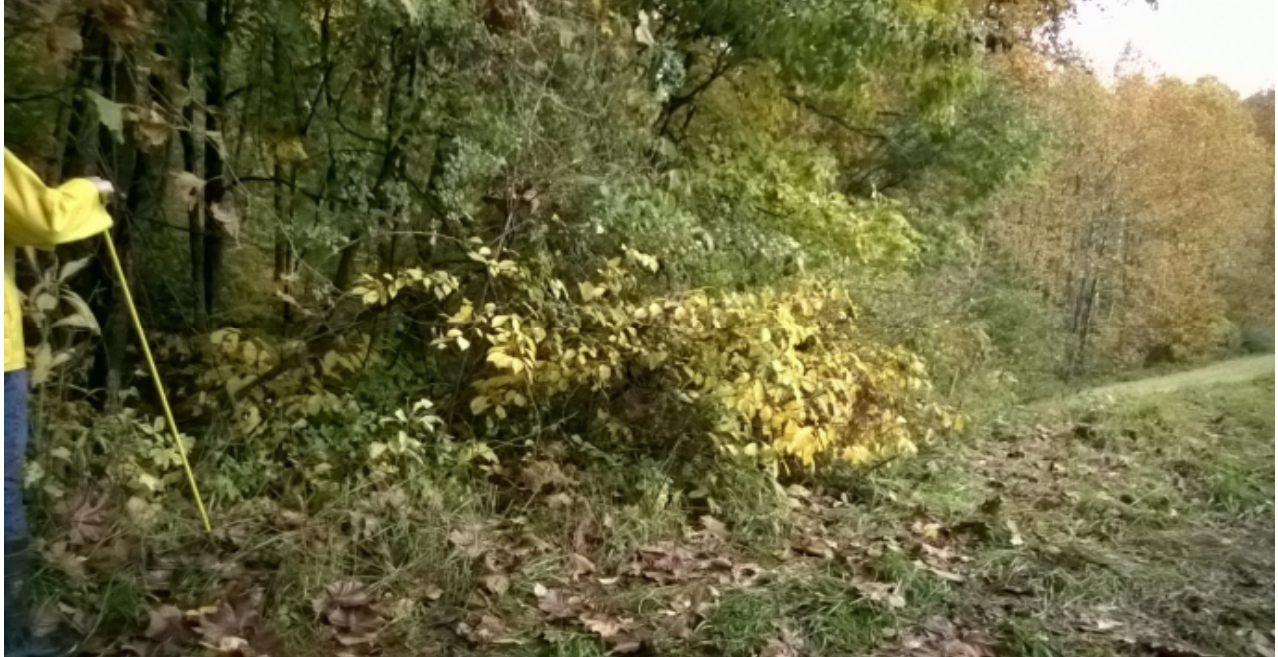
**Photograph No. 13**

Looking northwest at the vegetation encroaching the left abutment at the downstream embankment.

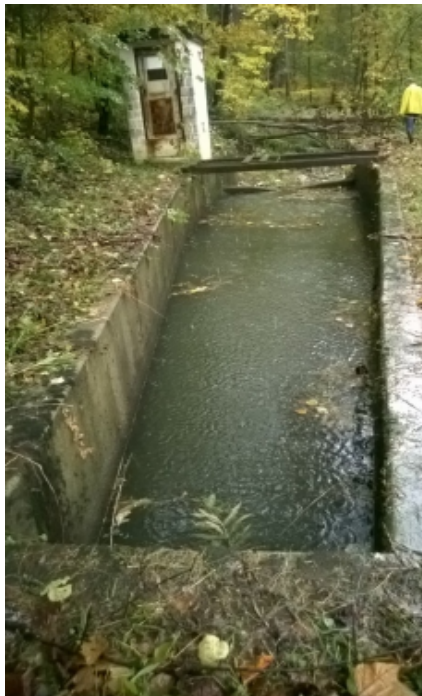
**Photograph No. 14**

Looking downstream at the stilling basin.

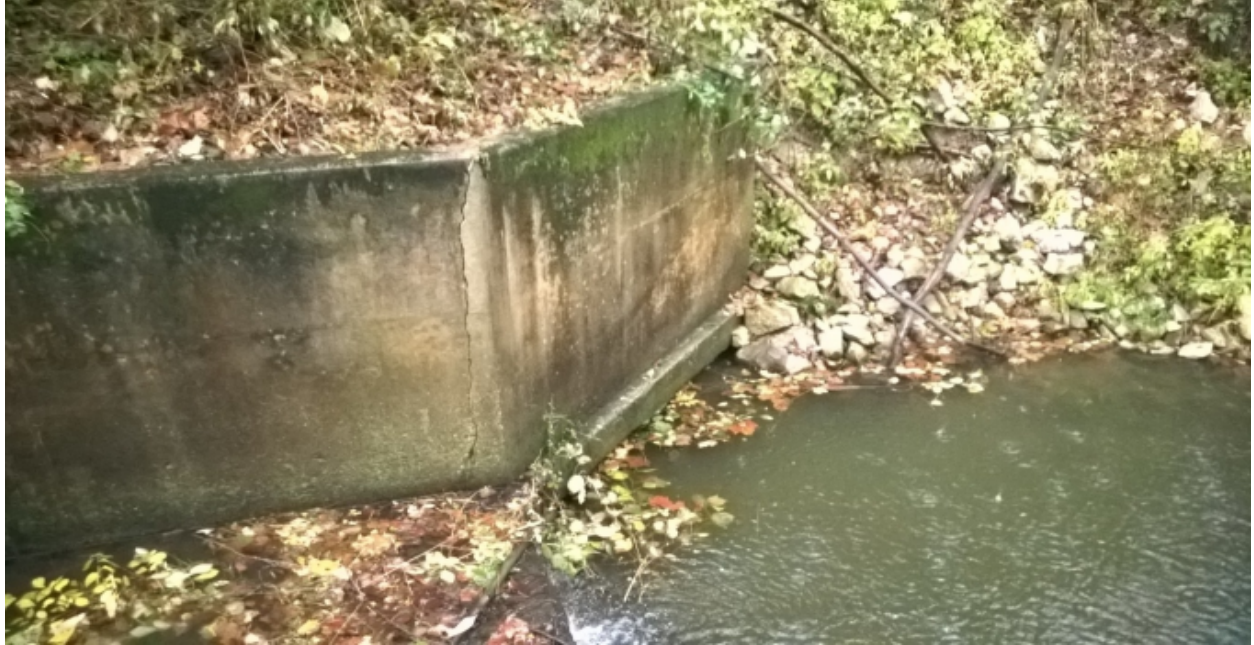
**Photograph No. 15**

Scoured area immediately downstream of the stilling basin concrete pad.

A large crack was observed in the left wall near the end of the stilling basin. The channel immediately downstream of the stilling basin appears to be scoured. The footings downstream of the stilling basin also appear to be undermined.

- ☒ (1) Provide Additional Erosion Protection: Fill the channel bottom immediately downstream of the stilling basin using concrete or riprap.
- ☐ (2) Mow: \_\_\_\_\_ ☐ Remove vegetation along downstream toe near midpoint of the embankment, left abutment at both the

- ☒ (8) Other: Monitor the gully located at the left abutment area for additional erosion and potential seepage.
- ☒ (9) Other: Monitor animal activities on the embankment, erosion conditions downstream of the stilling basin and any movement of the spillway.

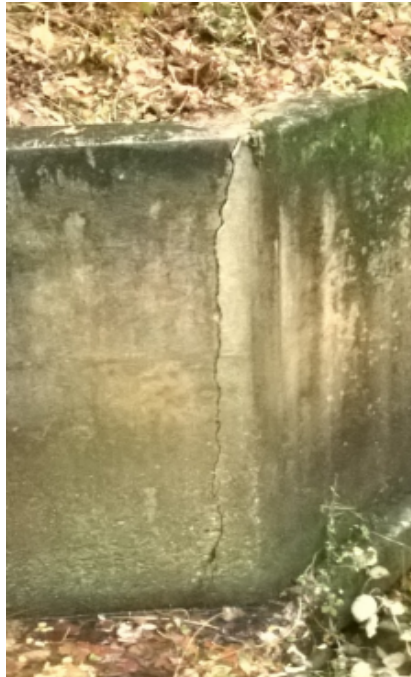
**Photograph No. 16**

Crack found in the left stilling basin wall.

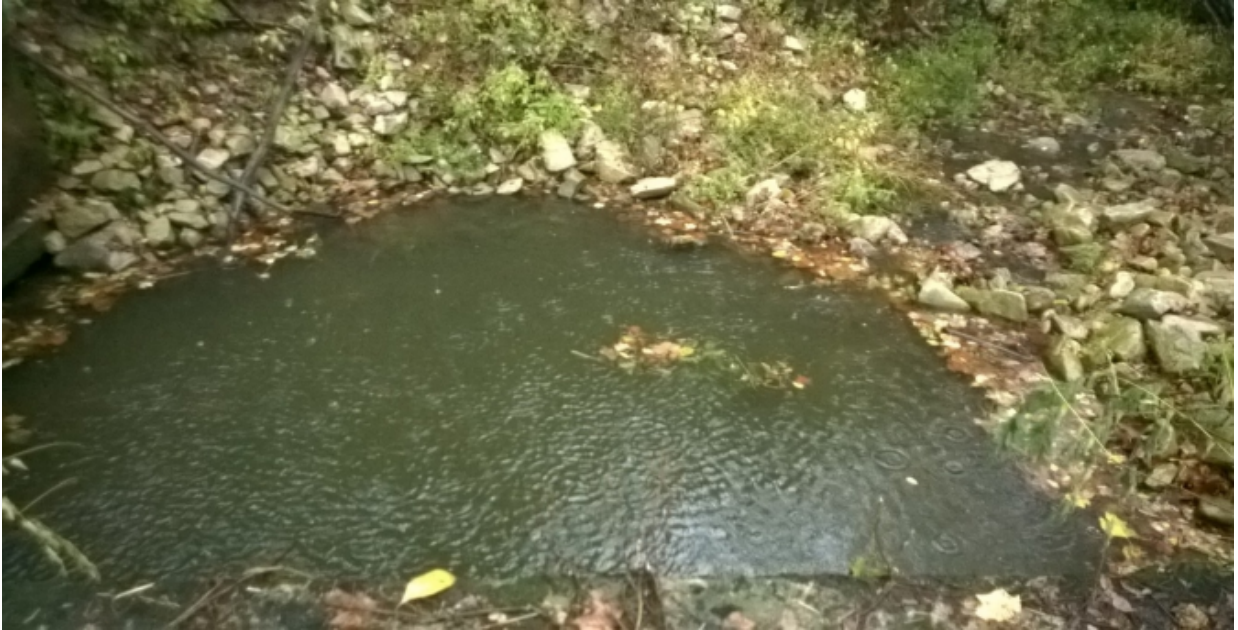
**Photograph No. 17**

Looking at outlet channel downstream of stilling basin.

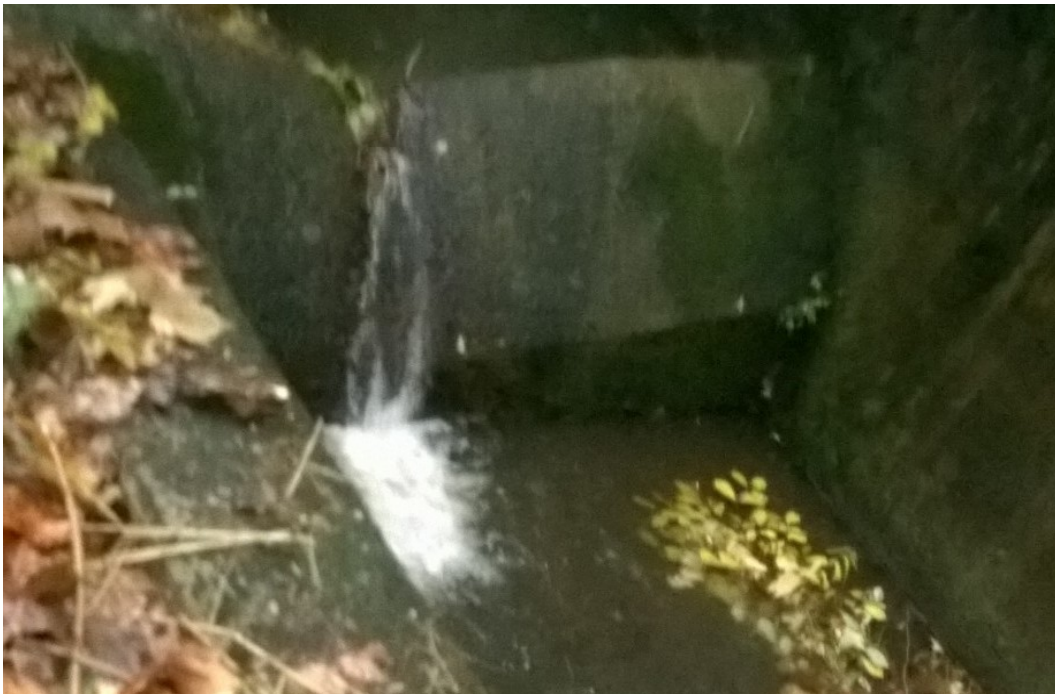
**Photograph No. 18**

Looking upstream at stilling basin.

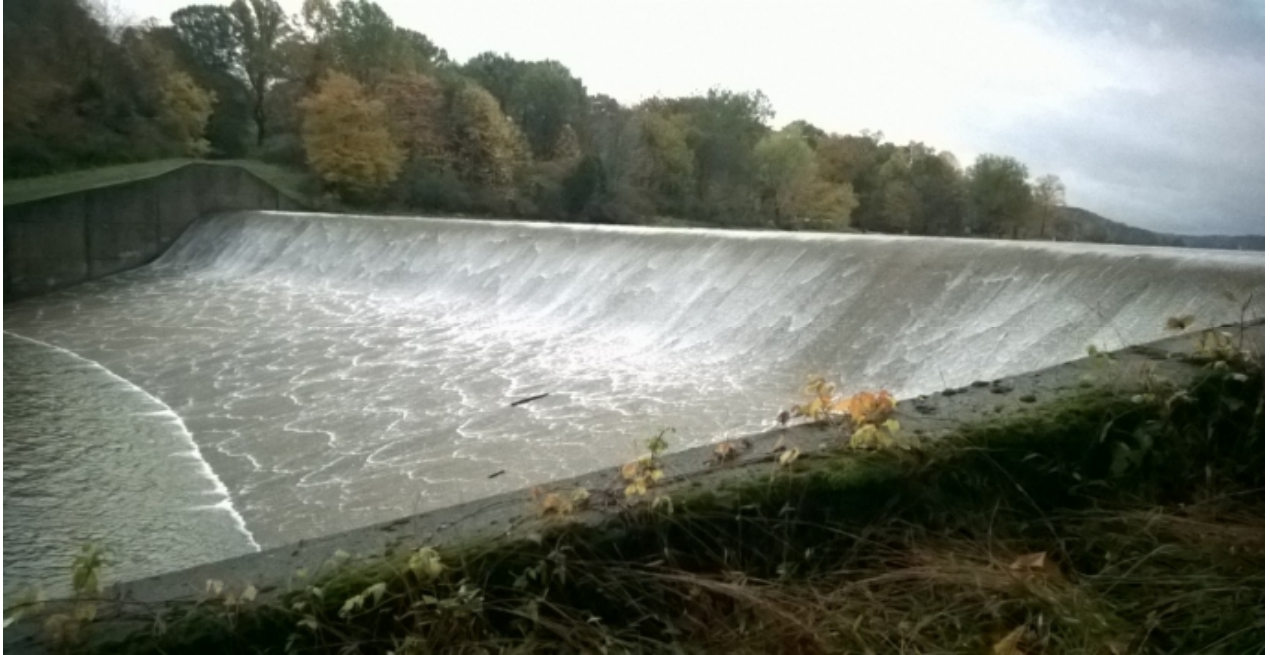
**Photograph No. 19**

Looking northeast at the ogee spillway.

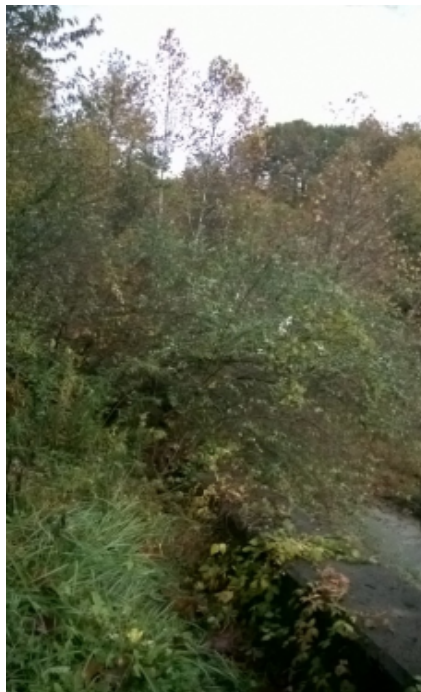
**Photograph No. 20**

Looking northwest at the vegetation encroaching the left ogee spillway wall.

The concrete ogee section and training walls appeared unchanged since the 2012 inspection. Some joints offset 1/2" to 3/4" and joint filler was squeezed out. These conditions were old and the spillway appeared to be in satisfactory condition. Vegetation was observed at the left walls of the spillway.

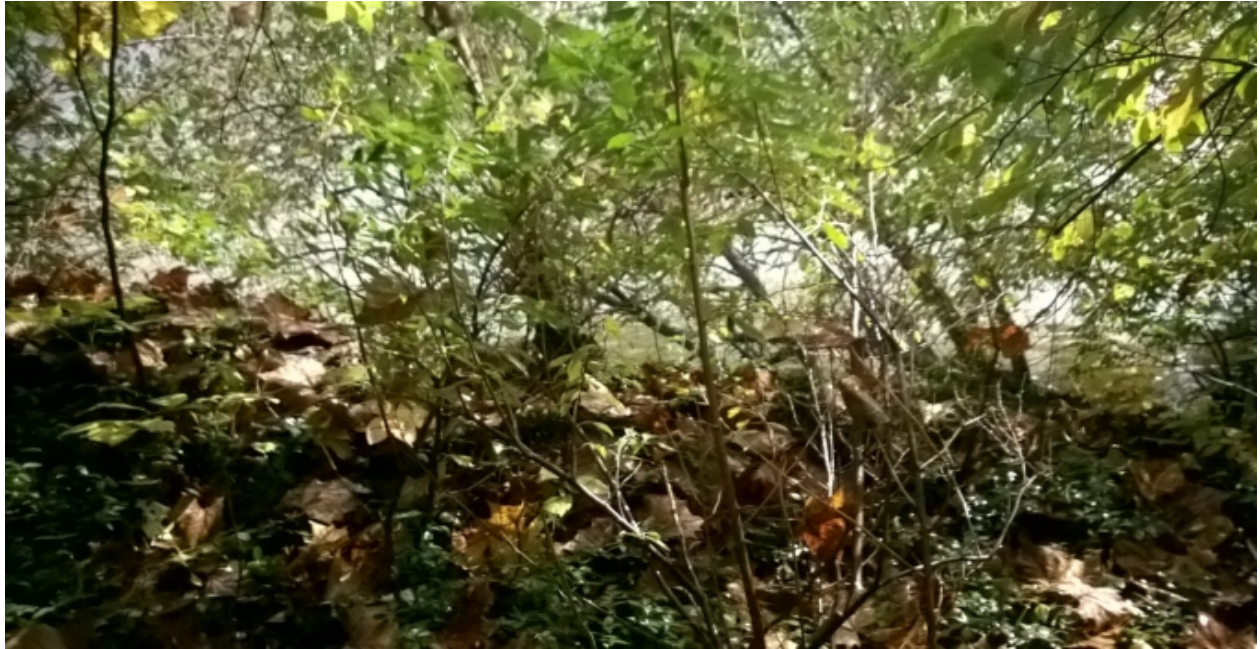
**Photograph No. 21**

Looking southeast at the vegetation encroaching the left ogee spillway wall.

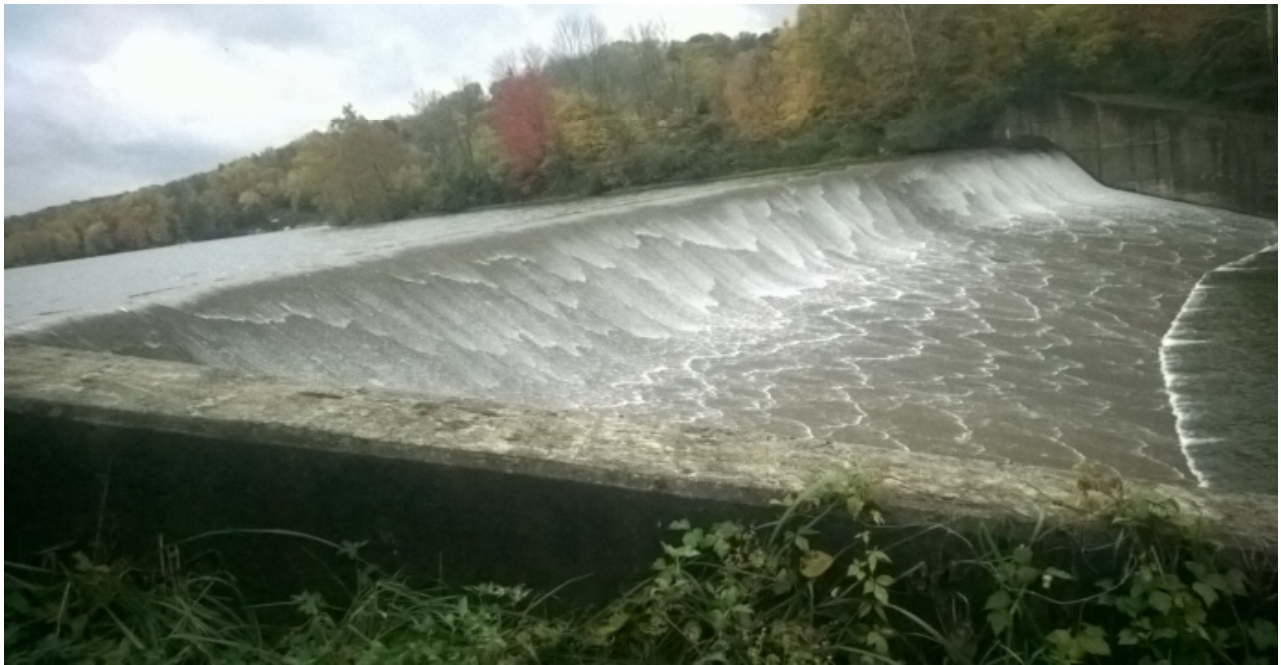
**Photograph No. 22**

Looking southwest at the ogee spillway.
