2016 Lake Lemon Dam Inspection

Unionville, Indiana

Lake Lemon Conservancy District

DLZ Indiana, Inc.

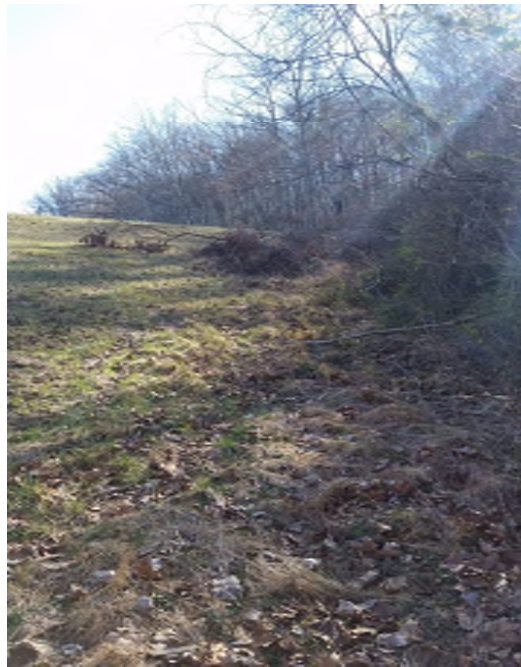
Photograph No. 8

On the northwest side of the downstream embankment there were several downed trees lying along the abutment. These trees should be removed immediately as they can cause problems with erosion which can lead to more serious problems. Downed trees can kill the underlying vegetation exposing bare dirt which will more easily erode away during rainfall events. Downed trees can also cause ponding of the rainfall runoff which also can lead to erosion of the soil.

Looking south along the western downstream abutment.

3. Remove the woody vegetation within the following locations:
 - i. Downed trees along the western side of the downstream embankment should be removed immediately as they can cause serious problems if left unattended to. (Photographs 8, 10, & 12)

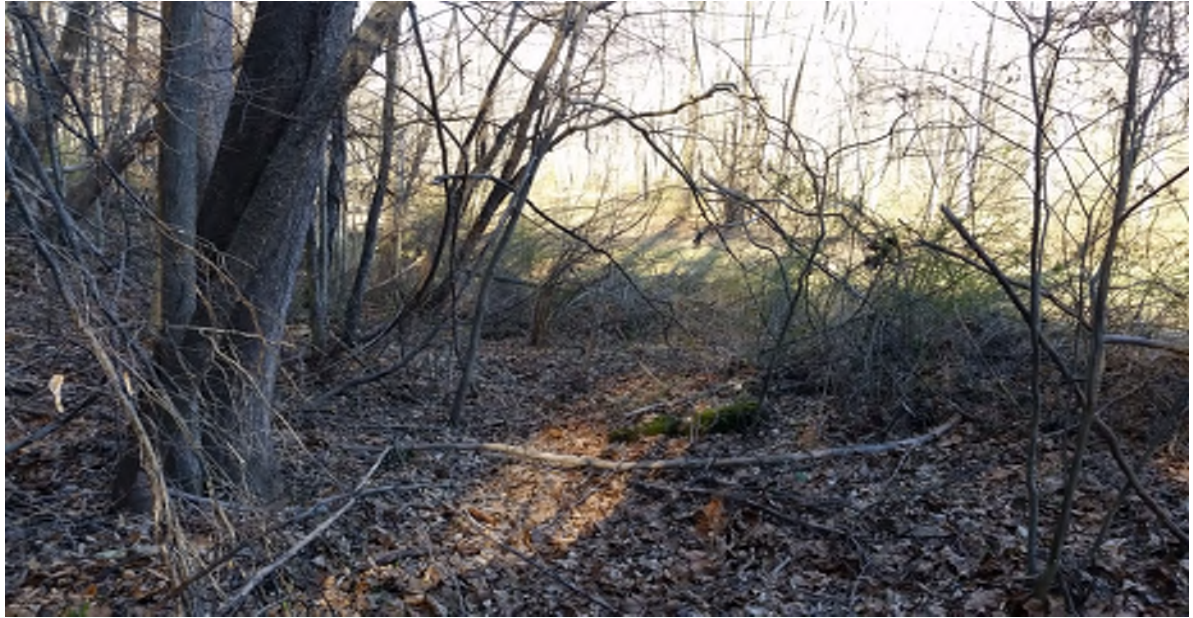
Photograph No. 9

During the 2014 inspection, an area of possible “clear” seepage was observed along the downstream toe, near the midpoint of the embankment. During the 2016 inspection this area did not show the same signs of any possible “clear” seepage. It is believed that what was observed in the 2014 report was due to the rainy conditions on the day the inspection was performed. There were two small areas where erosion was observed in a perpendicular manner from the dam. Erosion of this type could indicate the potentiality of seepage occurring but beyond these areas on the downstream side of the dam toe there were no signs of seepage. There were a few spots on the lakeside embankment where the ground was very soft but it was believed to have been caused by the recent rainfall and not due to seepage.

Looking north at the area of possible seepage noted in the 2014 report.

2014 report for precautionary purposes. Due to the high hazard associated with potential seepage, it is recommended this area be monitored on a monthly basis and following significant rainfall events. Report any appearance of erosion, seepage, turbidity, and subsequent changes in seepage quantity in this area to the engineer immediately. (Photograph 9)

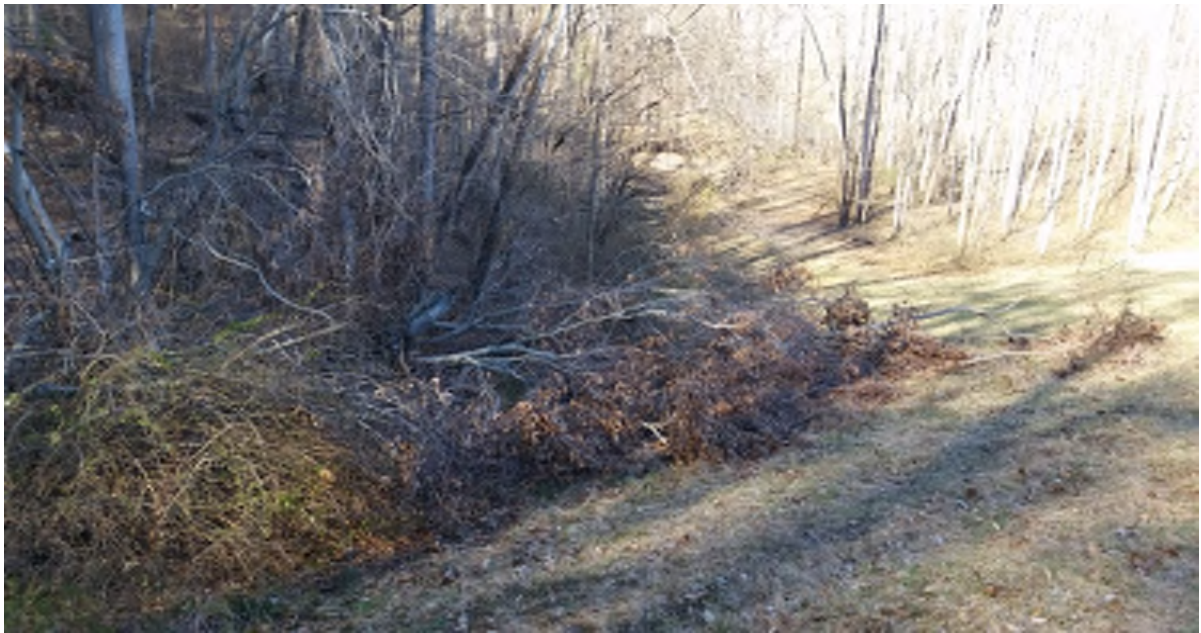
Photograph No. 10

Looking north from on top of the embankment at the fallen trees on the downstream side.

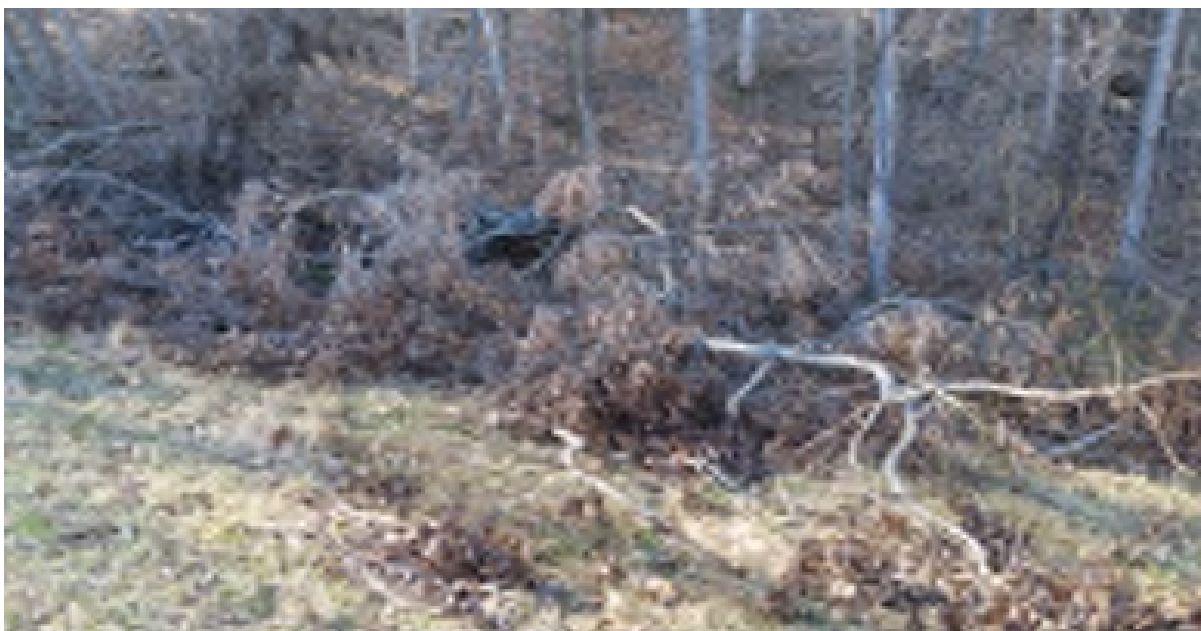
Photograph No. 12

Looking west at the fallen trees on the western abutment on the downstream embankment.

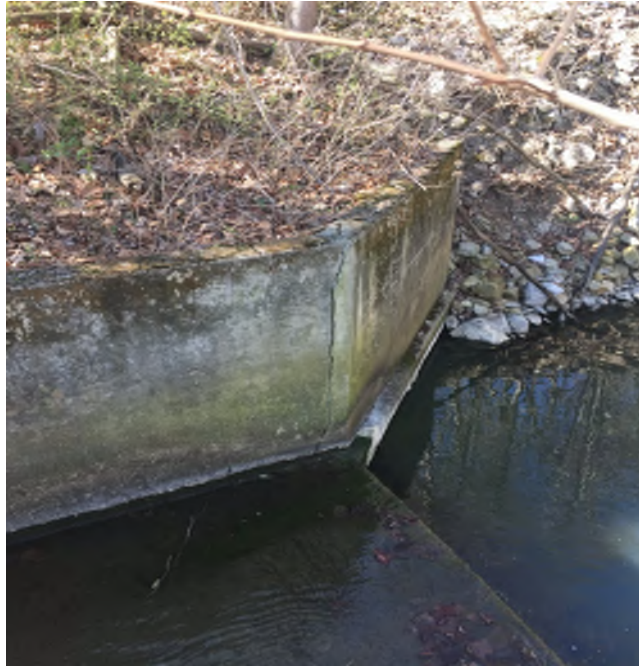
Photograph No. 13

The visible portions of the principal spillway appeared satisfactory and the stilling basin conditions appeared to remain unchanged from previous inspections. There is a large crack

observed in the left wall near the end of the stilling basin. The channel immediately downstream of the stilling basin appears to be scoured deeply. The footings for the retaining walls downstream of the stilling basin appear to be undermined. The record drawings for the stilling basin show that there are cut-off walls beneath the retaining wall footings that are up to 3-feet below the bottom of footing. The scour depth may be nearly that deep and corrective measures should be implemented to bury the retaining wall footings. It is recommended the scoured area be backfilled with properly-sized riprap or be backfilled with concrete. Because of the high hydraulic forces in the stilling basin and downstream channel when the principal spillway is operating at high flow, riprap size is expected to be very large in order to remain in place in the channel.

Crack found in the left wall of the stilling basin.

Long vertical crack in the west wing wall of the stilling basin. There is also a problem with scouring downstream of the stilling basin.

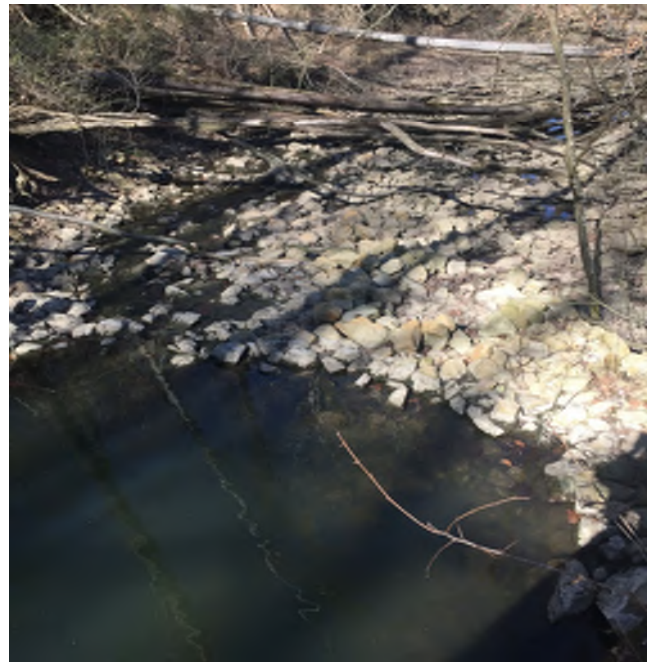
Photograph No. 14

Looking at the scoured area downstream of the stilling basin.

4. Dam should be monitored on a regular basis for the presence of any animal burrows on the embankment. If animal burrows are found at any time they should be filled with competent, well compacted material. If deemed necessary, a rodent control program should be implemented.
5. Repair the scoured area in the channel bottom immediately downstream of the stilling basin using riprap or concrete. The design velocities for the outflow will need to be evaluated to properly size the riprap. (Photographs 14)

- ☒ (5) Repair: Repair the riprap that has been scoured from the downstream side of the stilling basin of the principal spillway.
- ☐ (6) Provide Surface Drainage For: _____

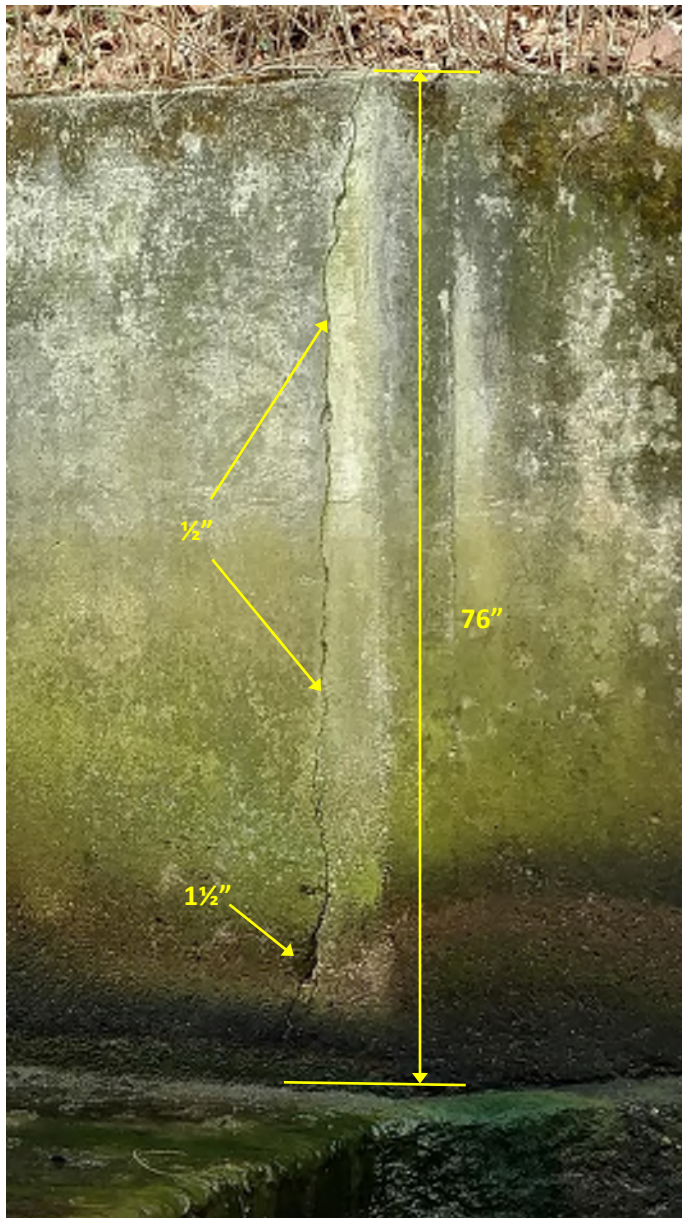
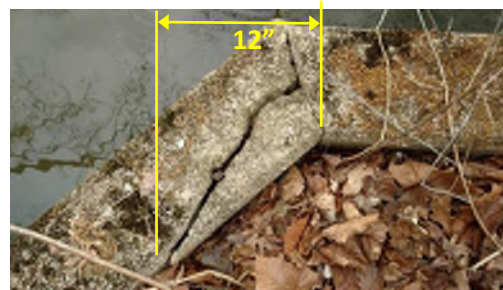
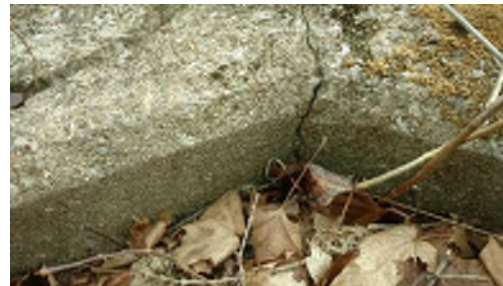
Images of Crack

The basin overall was is in good condition. There is, however one crack in the northwest corner measuring 76 inches in length and averaging ½ inch in width, which one location at the bottom were it is 1 1/8 inch in width. This same crack is visible at the top of the wall as well and appears that the crack extends completely through the wall. Also, we found undermining beneath both wing walls- on the west wall, it is 28 inches at its deepest and 31 inches at its highest. On the east wall, it is 46 inches at its deepest and 31 inches at its highest.
