2023 Lake Lemon Dam Inspection

Unionville, Indiana

Lake Lemon Conservancy District

May 2023

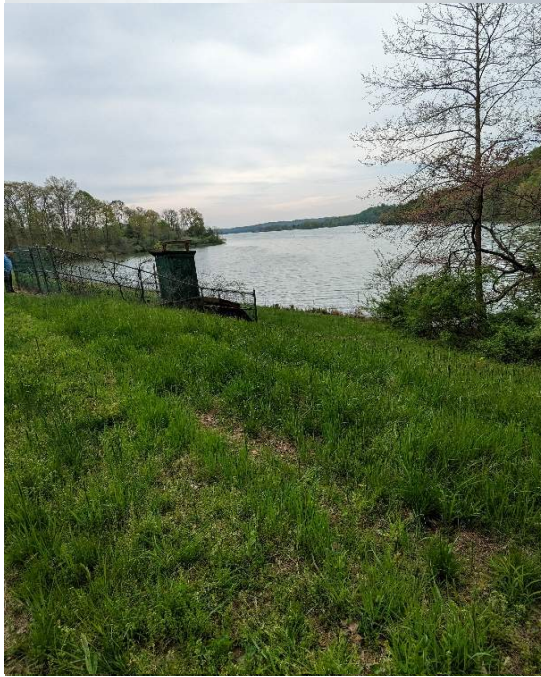
Photograph No. 1

Looking southeast at upstream slope of dam

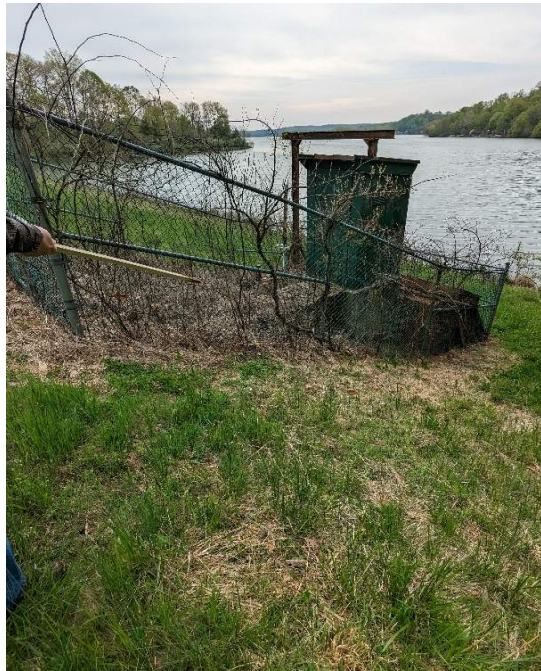
Photograph No. 2

Looking southeast at fenced area on upstream slope of dam - vines growing

Minor vines growing up along the fenced area.

1. Remove the woody vegetation within the following locations:
 - i. Brush and young trees along the downstream toe of dam.
 - ii. Vines along the fenced area at the upstream toe of the dam.

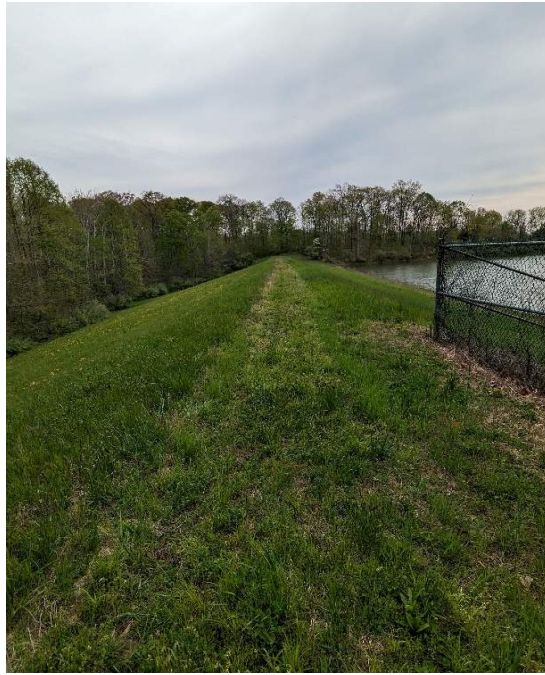
Photograph No. 3

Looking east along crest of dam

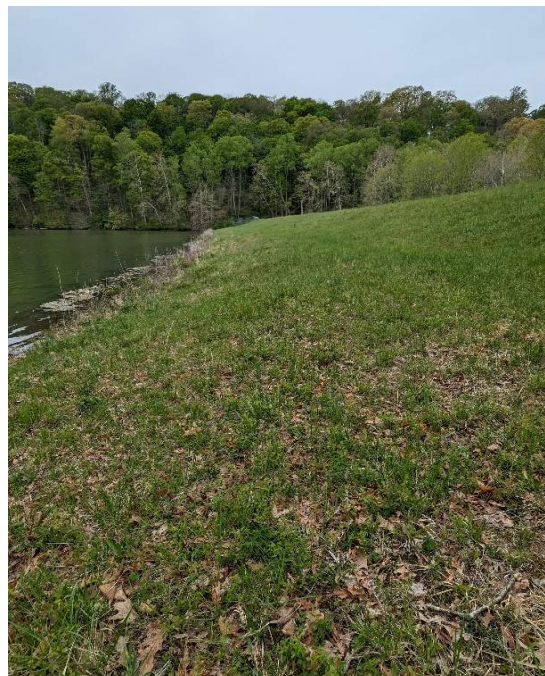
Photograph No. 4

Looking west along upstream toe of dam

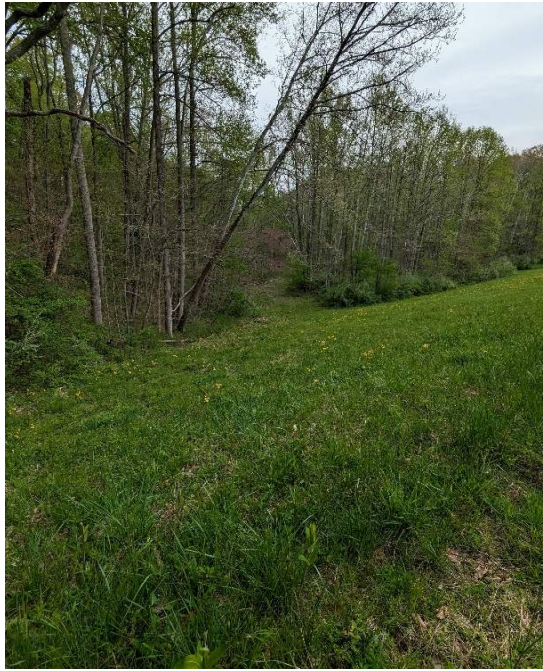
Photograph No. 5

Looking north towards downstream sluiceway

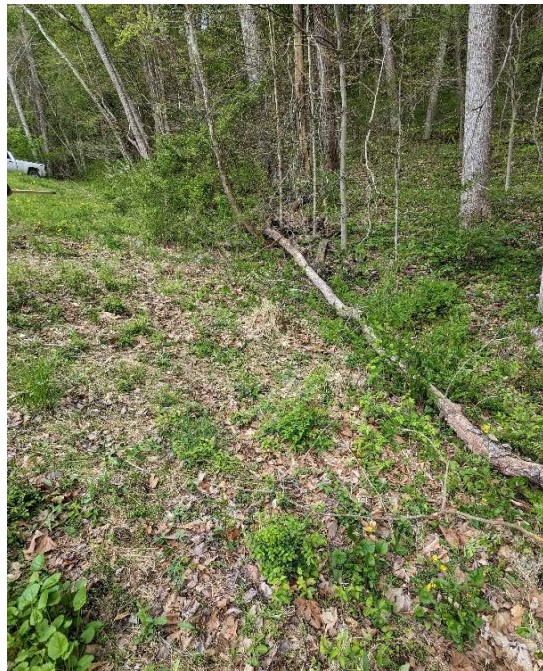
Photograph No. 6

Looking southwest along side/toe of dam - brush and trees to be removed

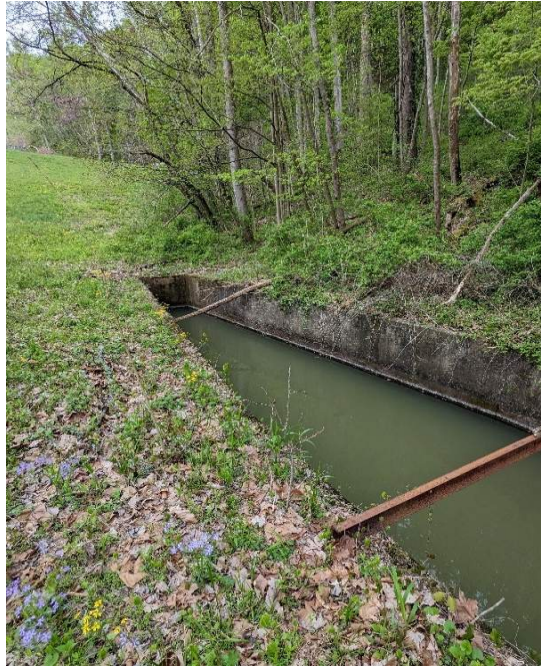
Photograph No. 7

Looking south towards crest of dam at sluiceway

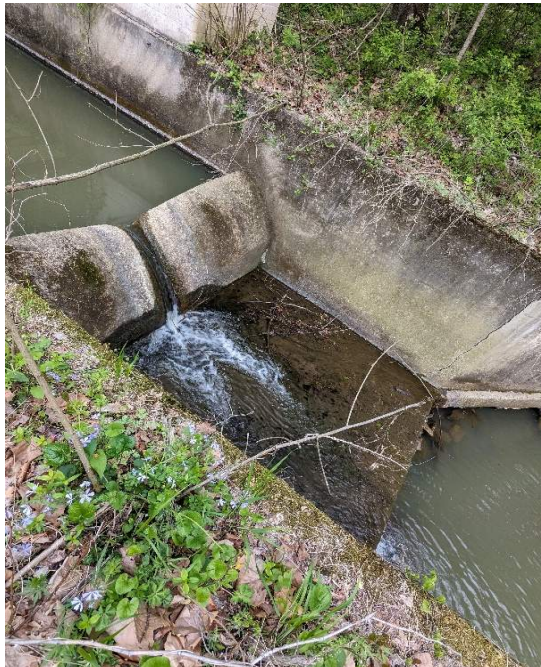
Photograph No. 8

Looking southwest at downstream end of auxiliary spillway

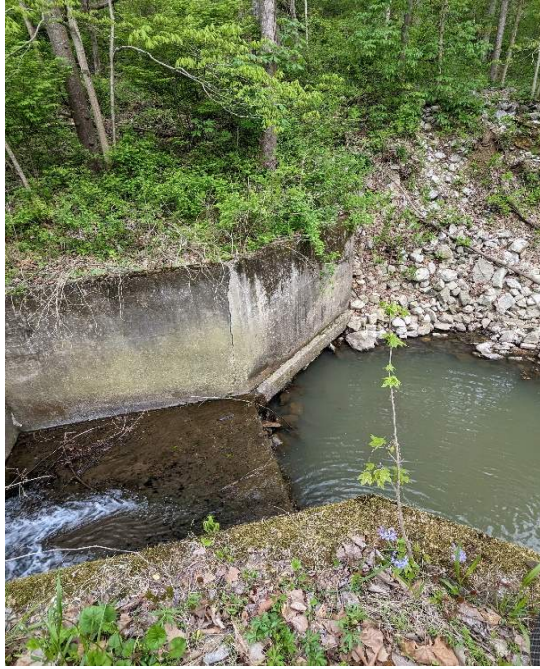
Photograph No. 9

Looking west at downstream end of auxiliary spillway - concrete wingwall with vertical crack and exposed earth underneath

Riprap remains on the downstream side of the stilling basin of the auxiliary spillway. A vertical crack in and exposed earth under the downstream concrete wingwall.

4. Implement erosion control measures at the following locations:
 - i. The downstream concrete wingwall of the Auxiliary Spillway (Western Sluiceway).
 - ii. The downstream western sloped wall of the Principal Spillway (East).Gabion baskets are recommended erosion control measures at these sites. The downstream concrete wingwall at the western sluiceway will need additional backfill for the areas of exposed earth under the wingwall. Monitoring of the Auxiliary Spillway concrete wingwall (photo 9) and the Principal Spillway's western downstream sloped wall (photo 16) and concrete panel displacement (photo 22) is recommended.

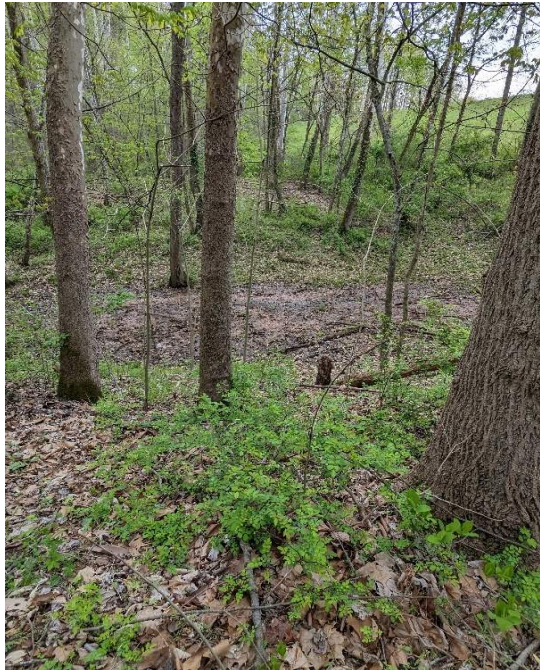
Photograph No. 10

Looking east towards downstream slope of dam -downstream back-up from recent rainfall event

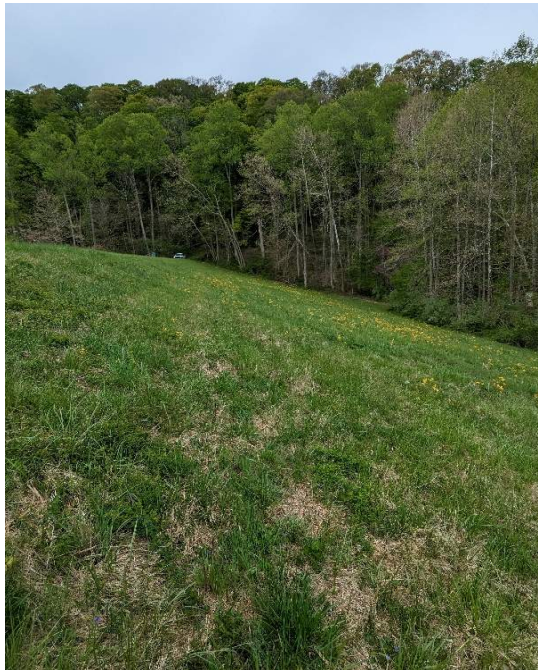
Photograph No. 11

Looking west along downstream slope of dam

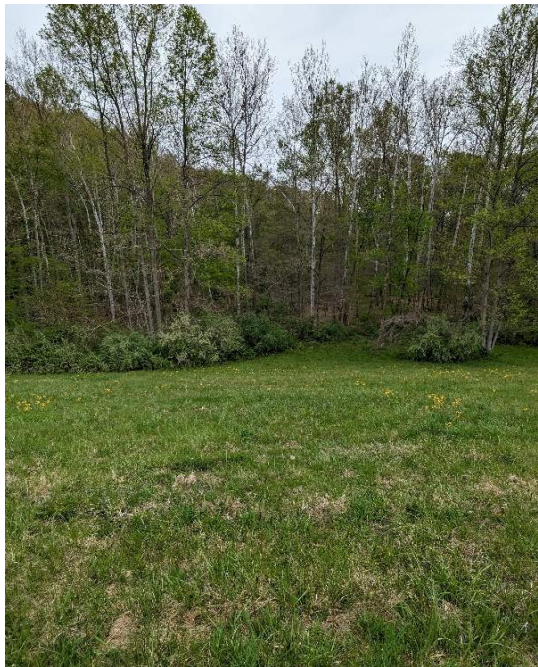
Photograph No. 12

Looking north at downstream toe of dam - brush and trees to be removed

Soft soils at surface only with no seepage apparent. Woody vegetation observed at western abutment area and northwest, north, and northeast edges at toe of downstream slope.

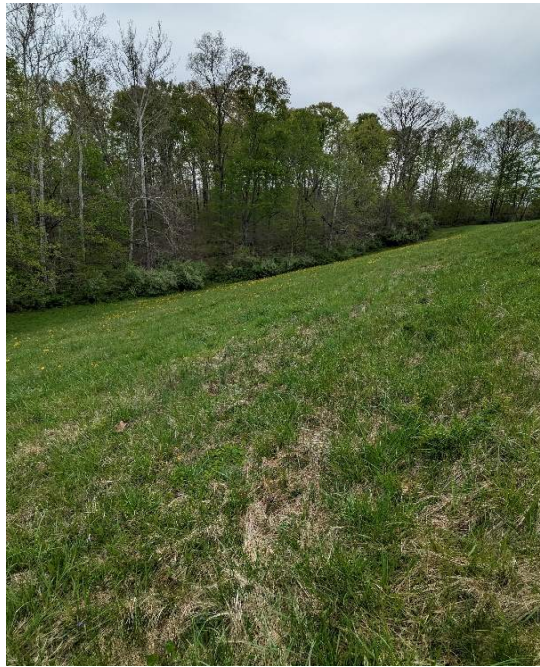
Photograph No. 13

Looking east along downstream slope of dam

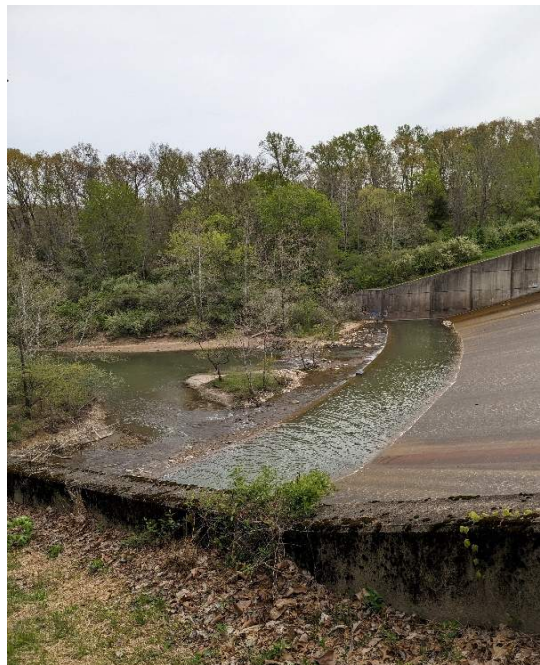
Photograph No. 14

Looking northeast at ogee primary spillway western downstream sloped wall - minor brush to be removed

- iii. Young trees along the western retaining wall of the principal spillway.All undesirable vegetation growth within these areas should be removed by cutting or spraying as part of an annual maintenance program.

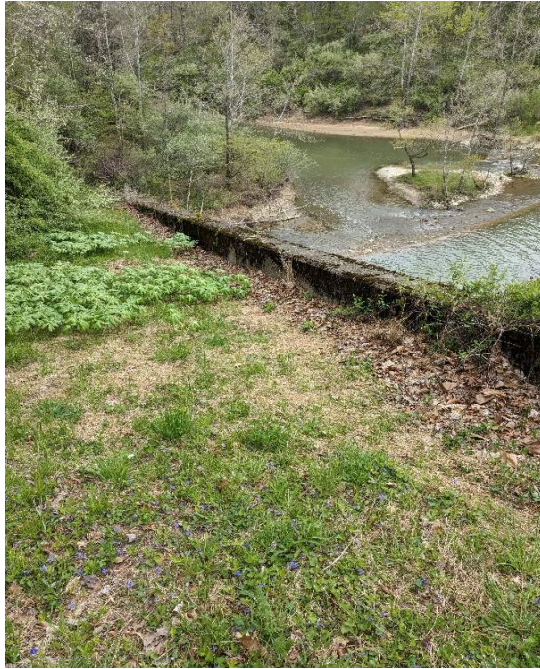
Photograph No. 15

Looking north along ogee primary spillway western downstream slope - minor brush to remove

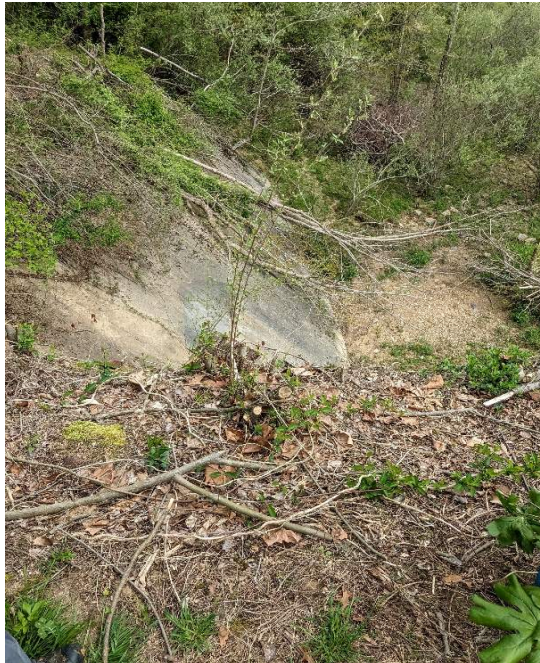
Photograph No. 16

Erosion at the downstream toe of the spillway could not be verified at the time of inspection due to the amount of water flowing over the spillway. The addition of riprap along the outside bank of the eastern abutment has prevented additional erosion since the previous inspection report. No new requirements are needed on this bank. There is erosion present at the western downstream slopewall of the principal spillway. Gabion baskets along the slopewall and monitoring of the erosion are recommended.

Looking northwest at downstream end of ogee primary spillway slope - retaining wall needs erosion control protection

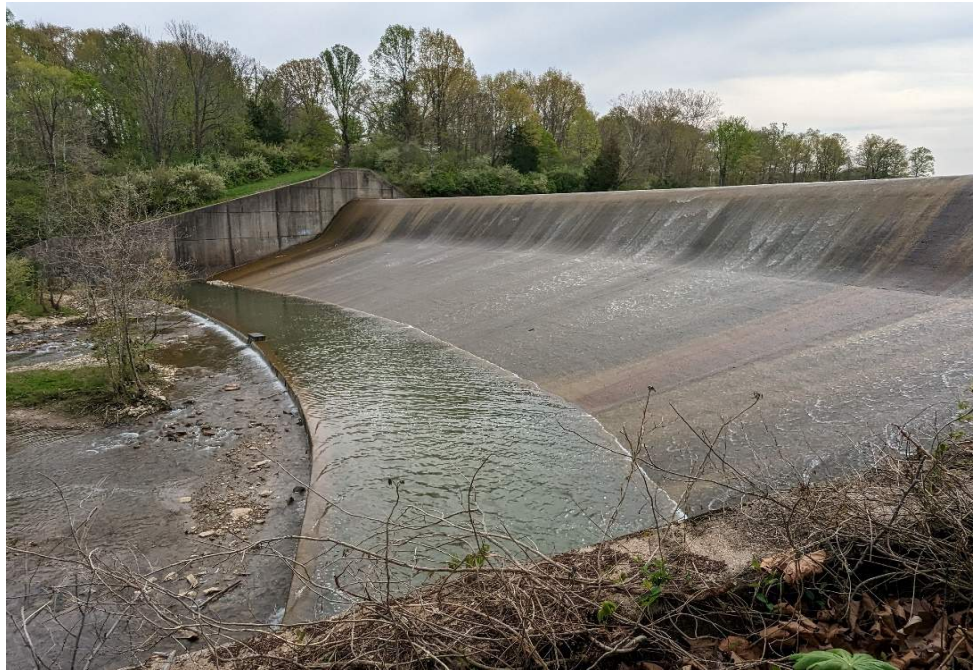
Photograph No. 17

Looking east at ogee primary spillway

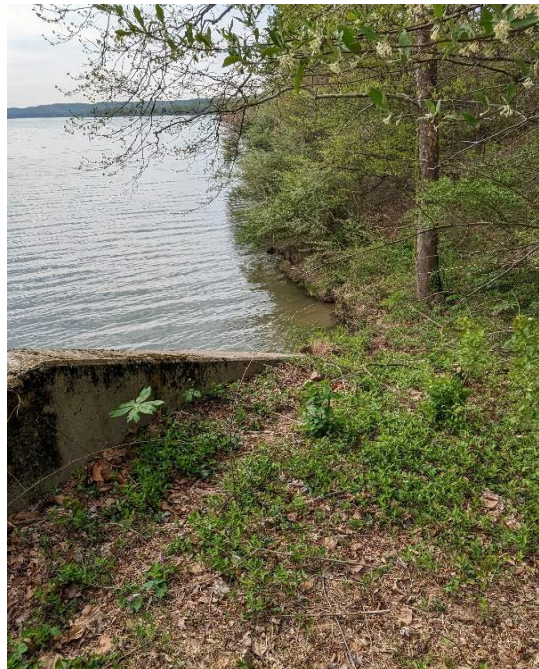
Photograph No. 18

Looking southeast along ogee primary spillway western upstram slope wall

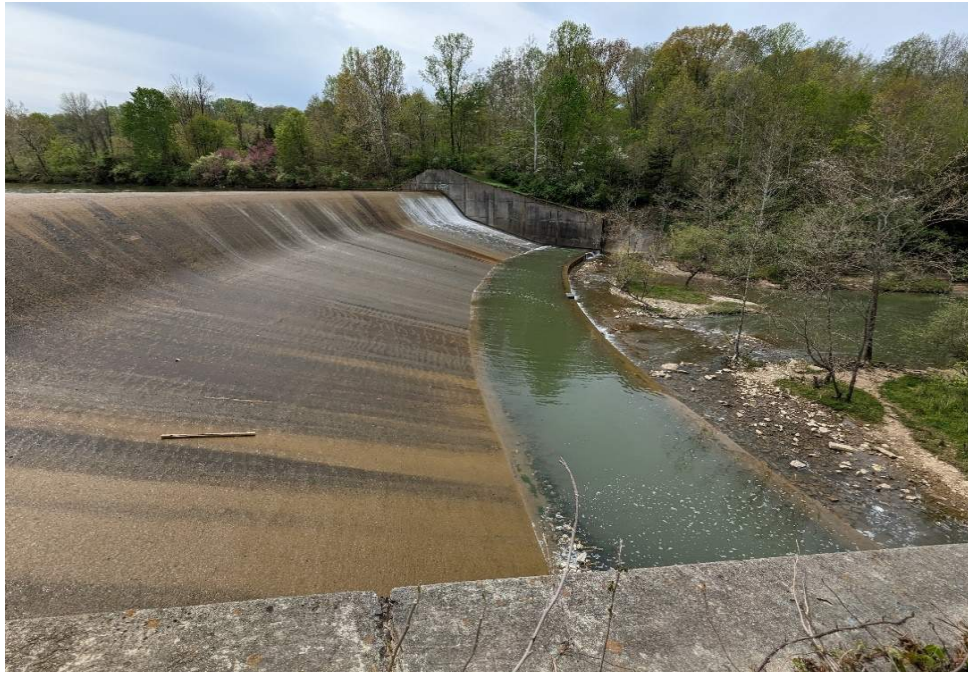
Photograph No. 19

Looking southwest at ogee primary spillway

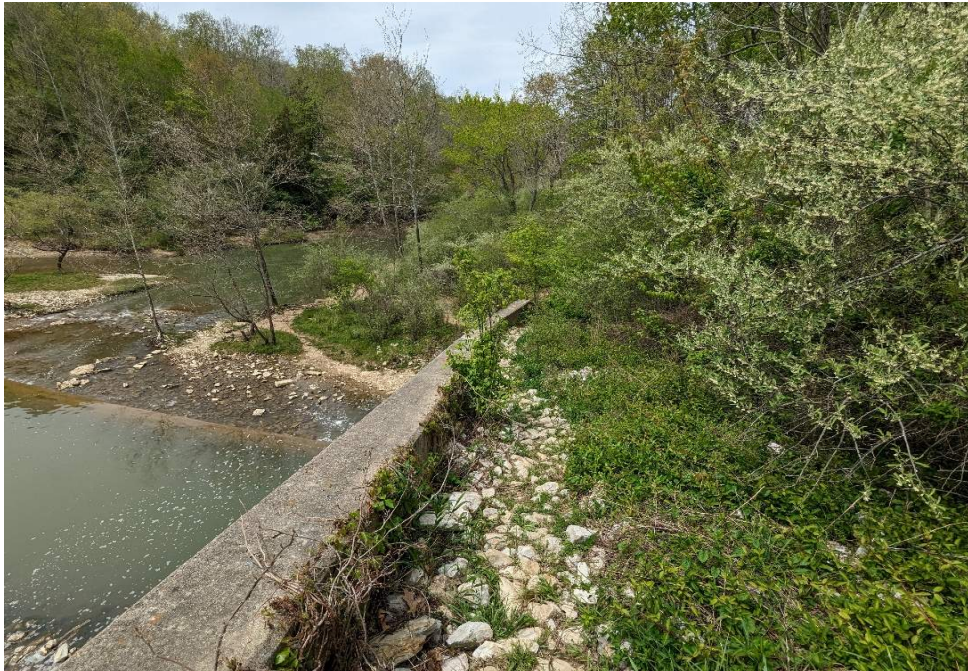
Photograph No. 20

Looking northwest along ogee primary spillway eastern downstream slope - minor brush to remove

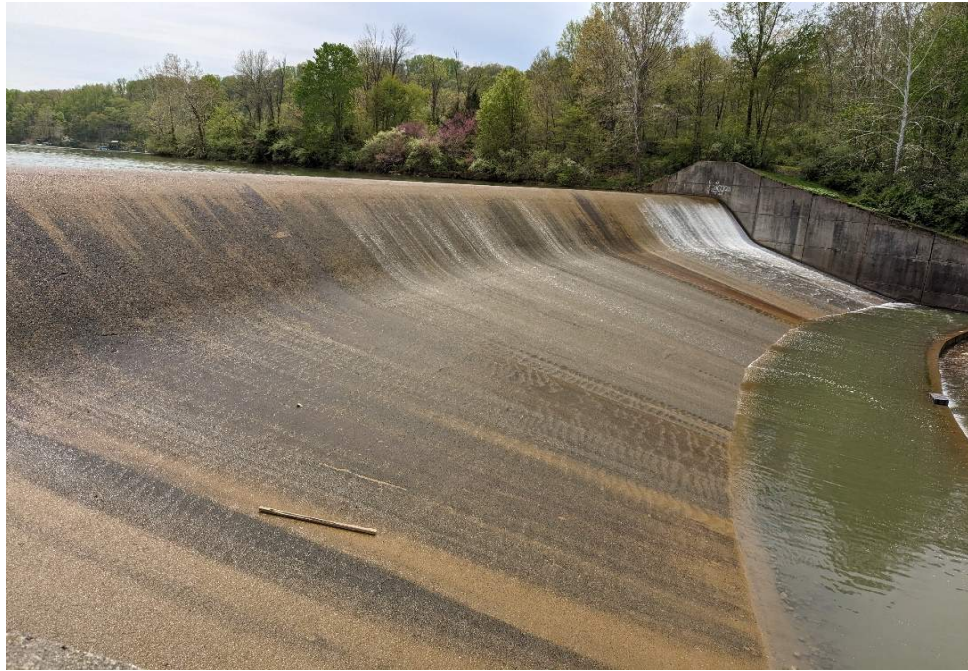
Photograph No. 21

Looking south at ogee primary spillway

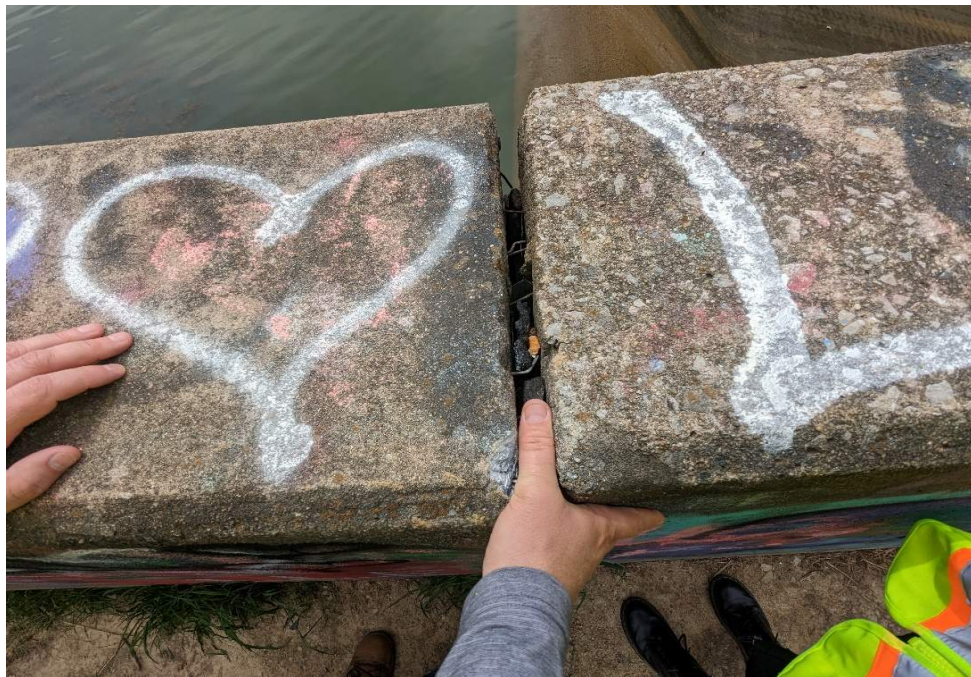
Photograph No. 22

Looking southwest at ogee primary spillway eastern downstream slopewall - concrete panel displacement

The concrete ogee section and retaining walls appear unchanged since the 2021 inspection. The spillway appeared to be in satisfactory condition. Multiple areas of brush/young trees encroaching on western retaining wall. Minor concrete panel displacement on eastern retaining wall. Erosion occurring at western downstream retaining wall.
