# LAKE LEMON 2025 DAM INSPECTION REPORT

*Monroe County, IN*

DLZ Indiana, LLC

April 23, 2025

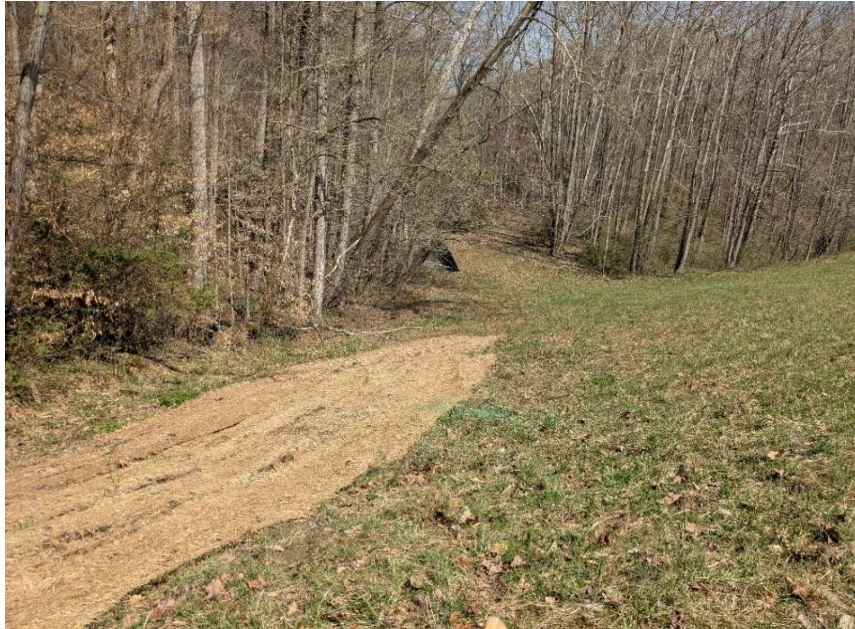
**Photograph No. 1**

West dam embankment facing northeast toward auxiliary spillway. Minor rutting repaired from recent maintenance access and brush cleared based on previous inspection.

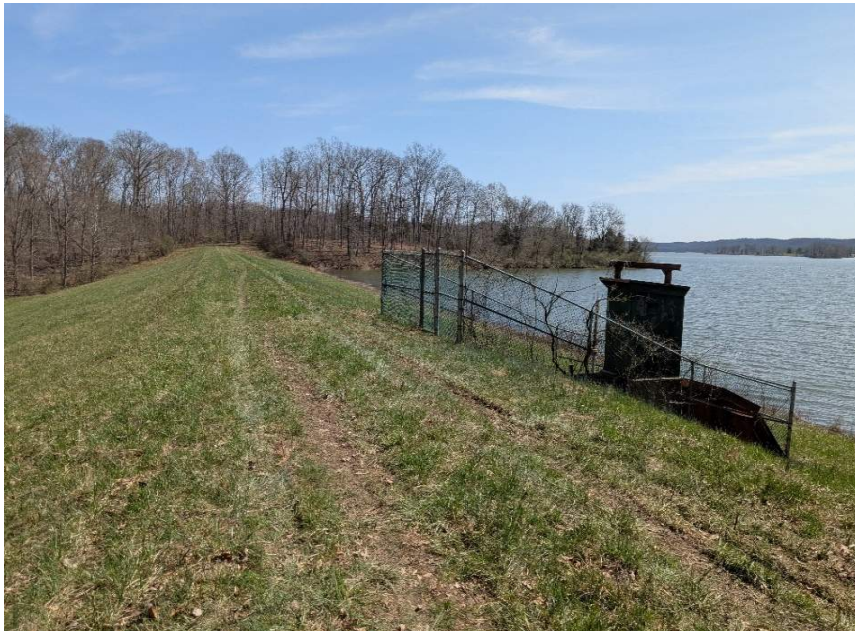
**Photograph No. 2**

West dam embankment facing east toward other end of dam embankment and the sluice gate drawdown structure. Minor brush (vines) growing up along the fence surrounding the drawdown structure.

1. Remove the woody vegetation along the fenced area around the sluice gate drawdown structure and along the western retaining wall of the primary spillway. All undesirable vegetation growth within these areas should be removed by cutting or spraying as part of an annual maintenance program.

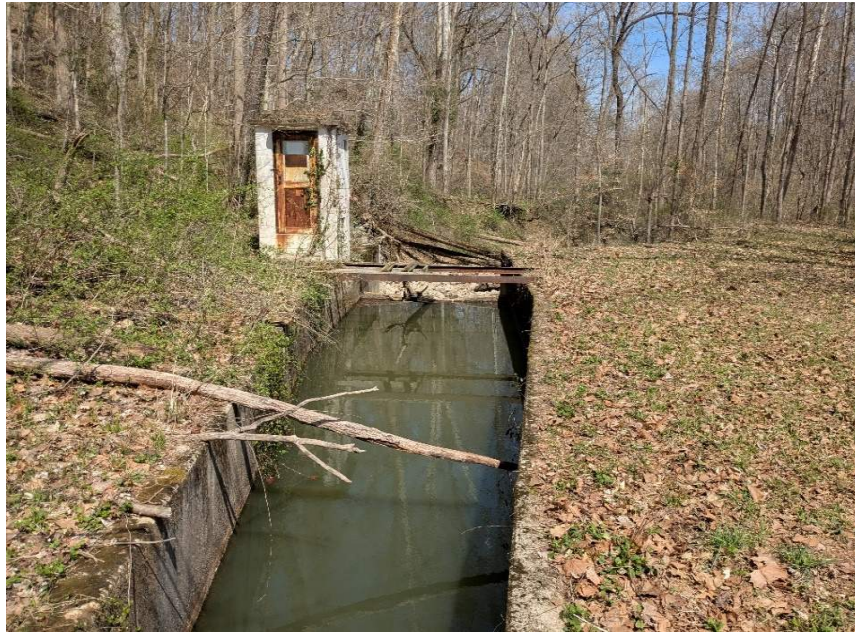
**Photograph No. 3**

Upstream end of auxiliary spillway facing northeast toward the downstream end of stilling basin. Felled tree branches to be removed. No other apparent deterioration to the spillway.

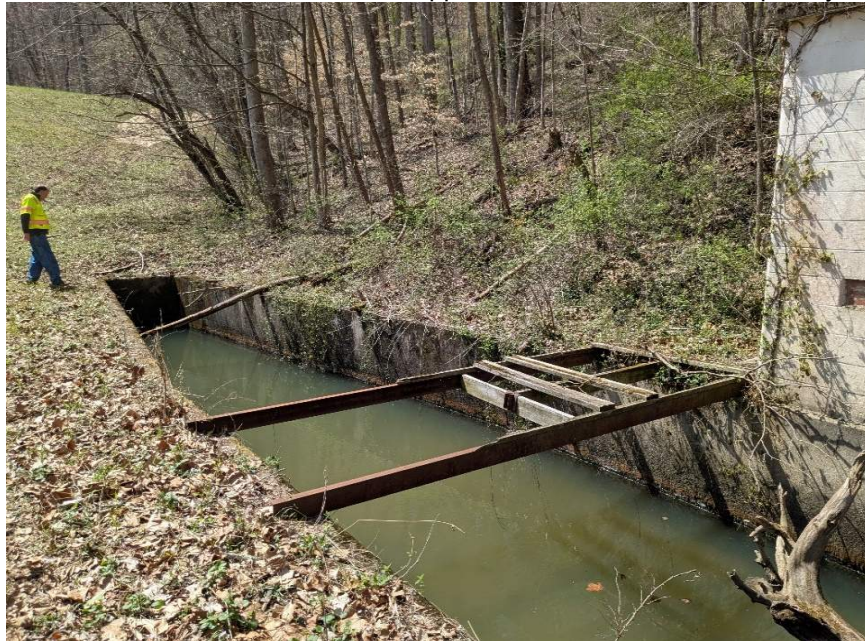
**Photograph No. 4**

Downstream end of auxiliary spillway stilling basin facing southwest. Small access structure spanning spillway not in service.

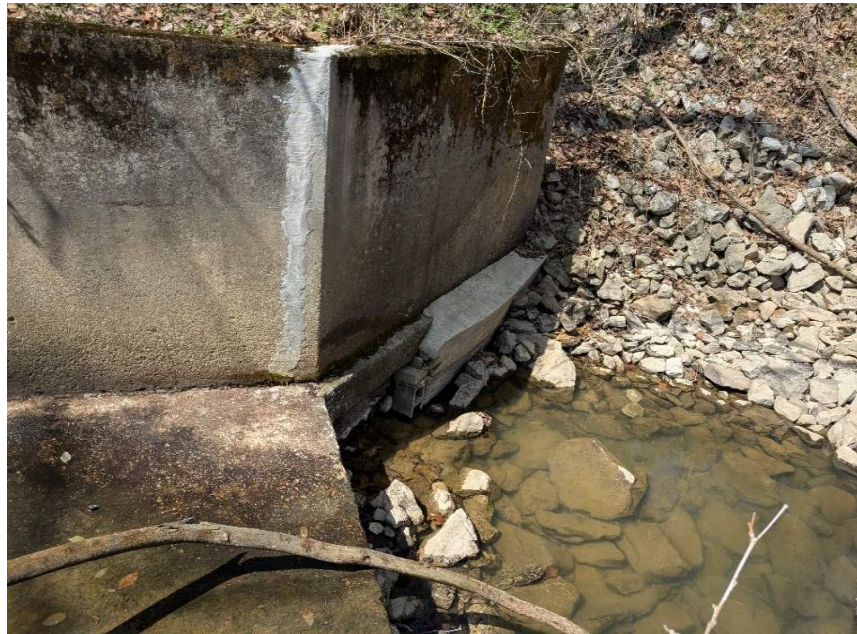
**Photograph No. 5**

Downstream end of auxiliary spillway stilling basin facing the western retaining wall. Vertical crack identified in last inspection and part of the retaining wall undermining has been repaired.

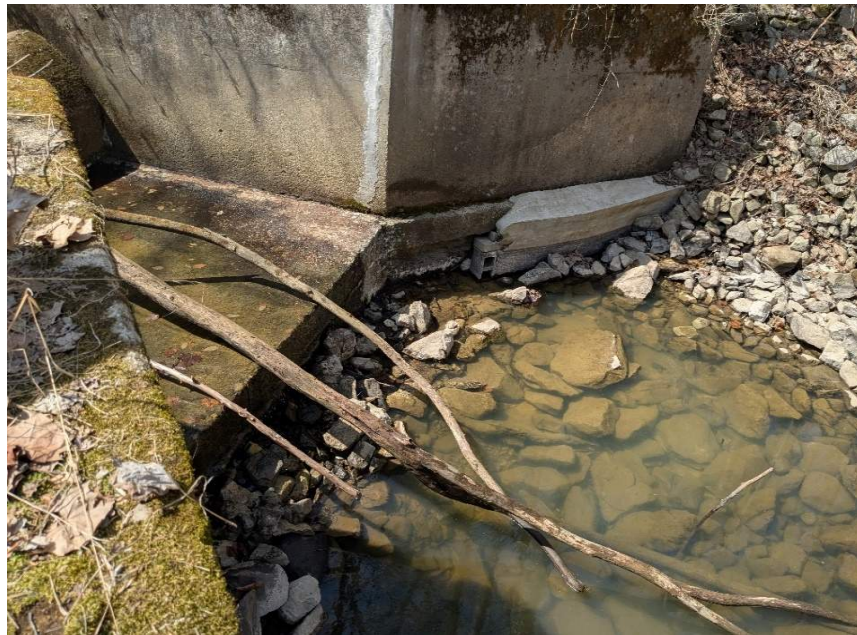
**Photograph No. 6**

Downstream end of auxiliary spillway stilling basin facing the western retaining wall. Small portion closer to the corner still undermined (left of repaired section).

- There is a small portion of the downstream western concrete retaining wall that is still being undermined next to the repaired section near the corner.

4. Implement erosion control measures at the western downstream concrete retaining wall of the auxiliary spillway. The retaining wall will need additional backfill for the areas of exposed earth under the concrete. The downstream riprap will need redistribution. Monitor the progression of the retaining wall undermining and riprap migration.

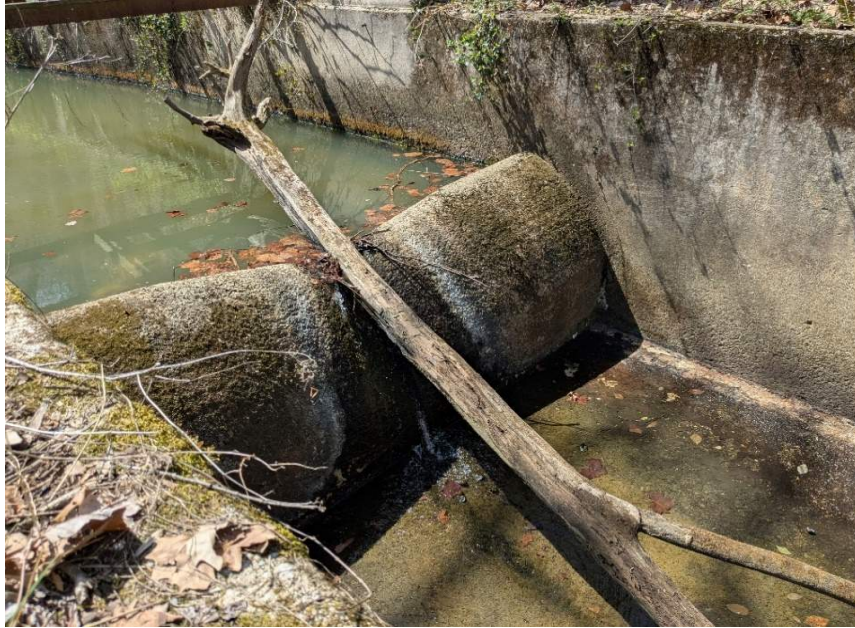
**Photograph No. 7**

Downstream end of auxiliary spillway stilling basin facing southwest. No apparent deterioration of the weir. Felled tree branch to be removed.

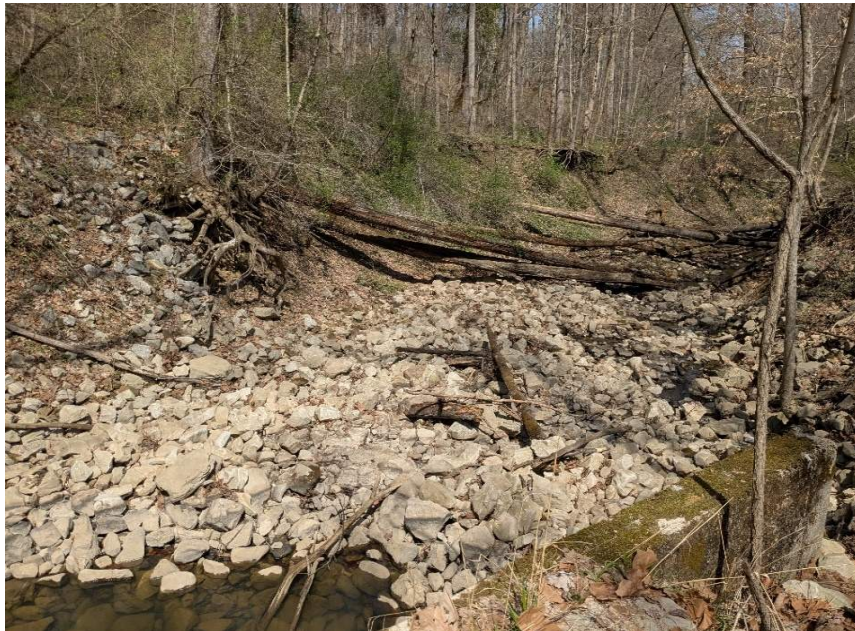
**Photograph No. 8**

Downstream end of auxiliary spillway facing northeast. Riprap to be redistributed.

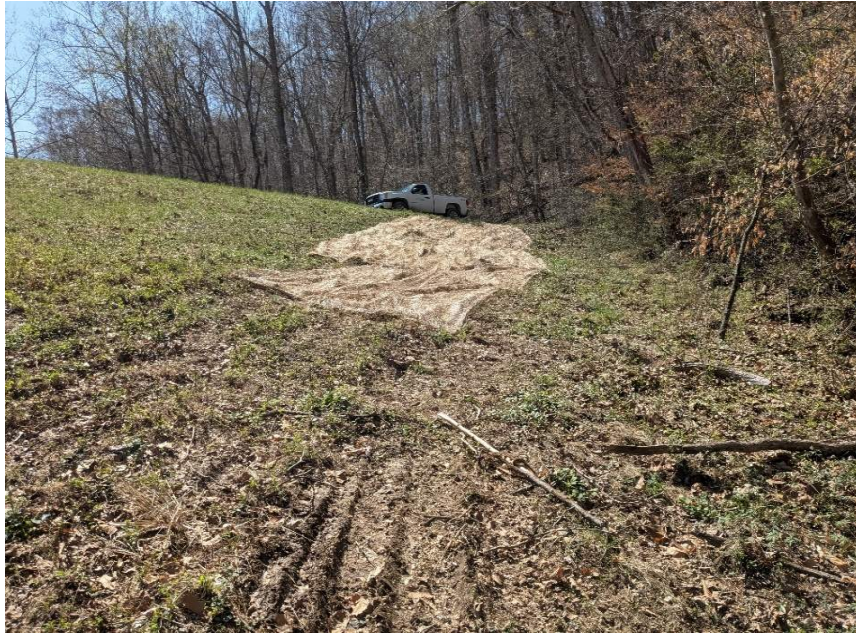
**Photograph No. 9**

Western downstream toe of dam embankment facing south. Minor rutting from recent maintenance access mostly repaired.

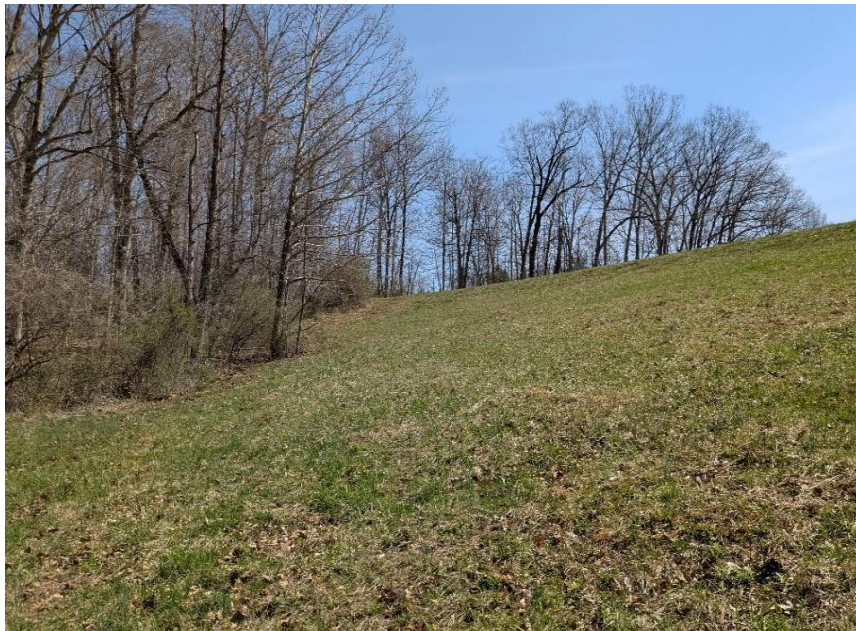
**Photograph No. 10**

Western downstream toe of dam embankment facing east. Brush identified in last inspection removed and the toe is mostly clear of woody vegetation. No apparent maintenance deficiencies.

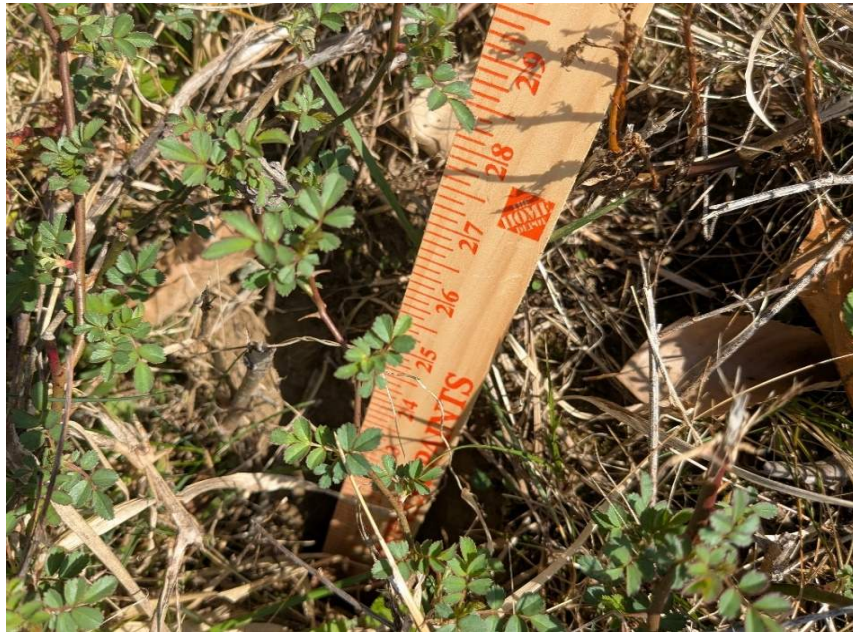
**Photograph No. 11**

There were several signs of animal burrows ranging from 7 to 22 inches observed during the inspection. The embankment should continue to be regularly monitored for animal burrows because they can create seepage pathways if not filled.

Animal burrow along downstream side of the embankment. Approximately 22 inches deep and 1.5 inches in diameter.

2. Dam should be monitored on a regular basis for the presence of any animal burrows on the embankment and the identified burrows should be filled.
3. Downstream bank of dam should be monitored for seepage and depressions. The bank should be monitored for any loss of vegetation and/or bare flow paths or patches that do not revegetate.

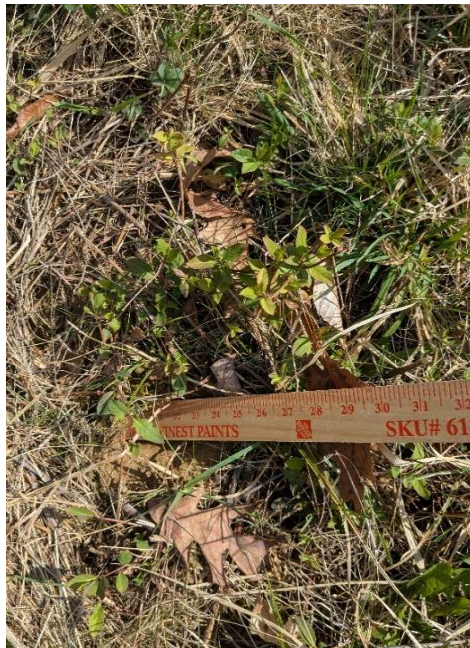
**Photograph No. 12**

Animal burrow along the downstream side of the embankment. Approximately 20 inches deep and 1.5 inches in diameter.

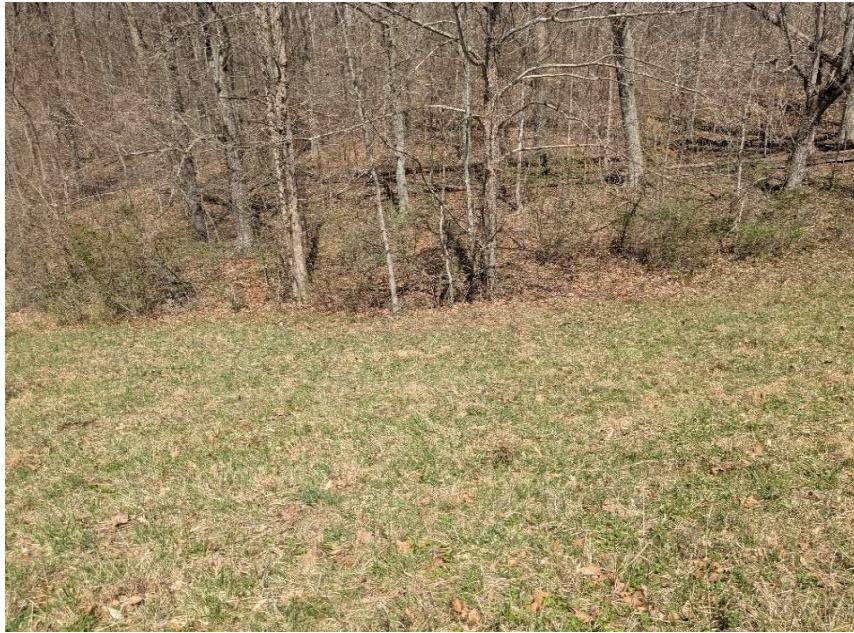
**Photograph No. 13**

Downstream side of the embankment facing north. Brush identified in last inspection removed and the toe is mostly clear of woody vegetation. No apparent maintenance deficiencies.

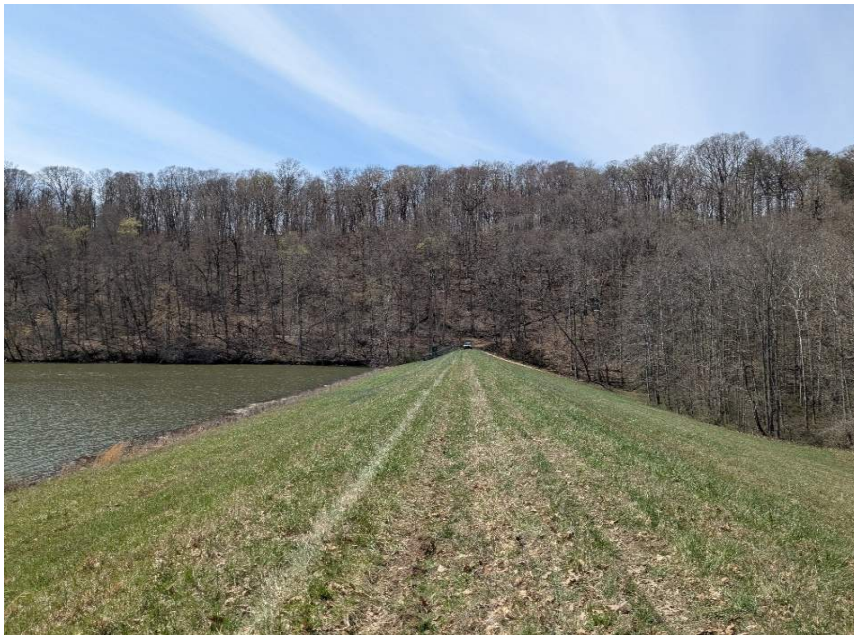
**Photograph No. 14**

Crest of embankment facing west. No apparent migration of the crest. Minor rutting from maintenance vehicle traffic.

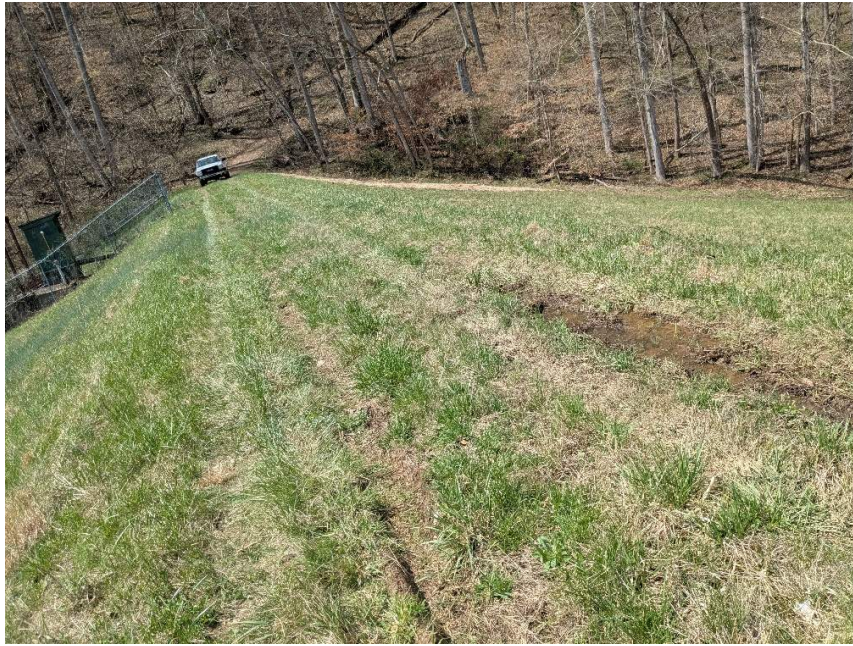
**Photograph No. 15**

Crest of embankment facing west. Minor rutting and pooling from recent maintenance vehicle traffic and rainfall two days prior the inspection.

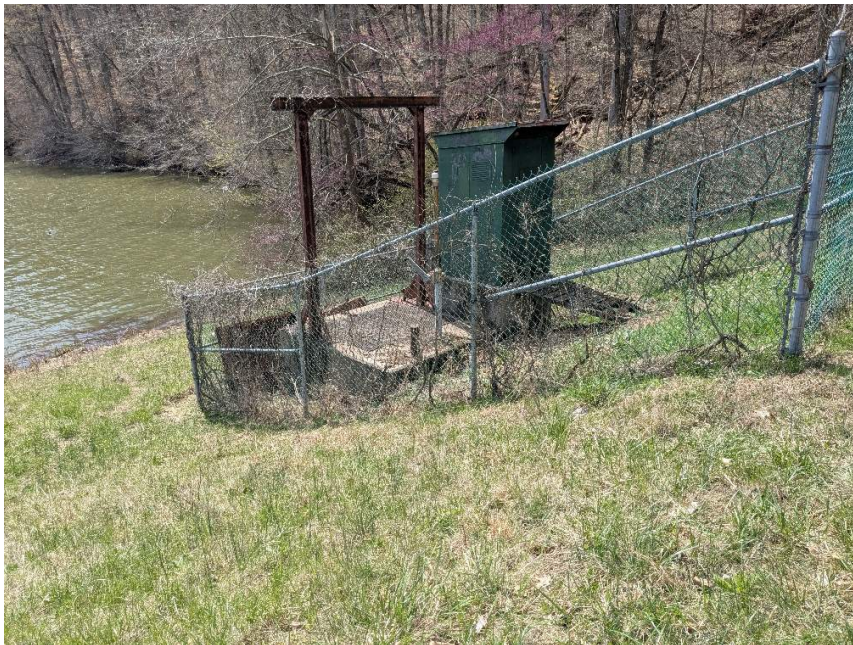
**Photograph No. 16**

Upstream side of embankment facing southwest toward the sluice gate drawdown structure. Minor vegetation (vines) growing up the sides of the fence surrounding the drawdown structure.

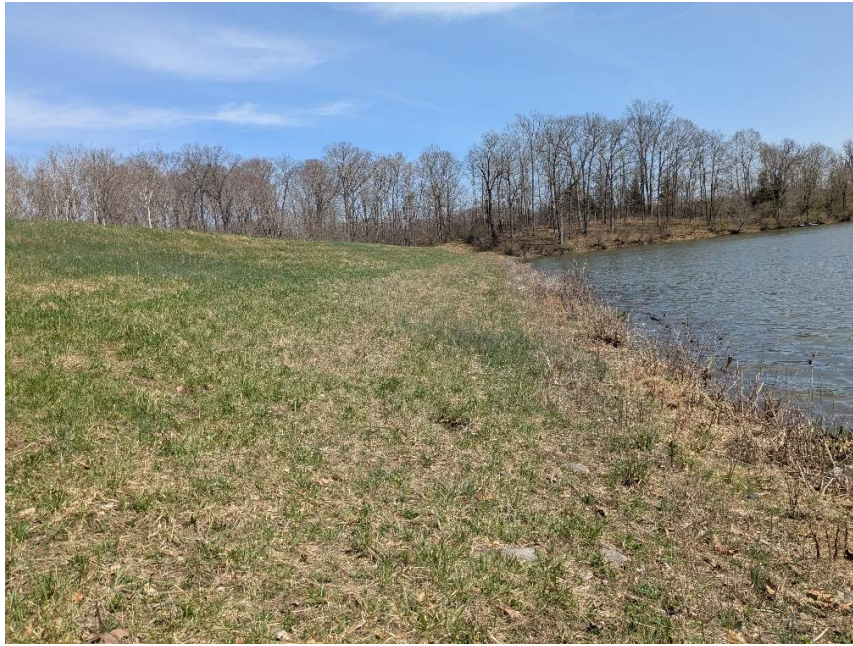
**Photograph No. 17**

Upstream side of embankment facing east. Minimal vegetation along the bank of Lake Lemon. No apparent maintenance deficiencies.

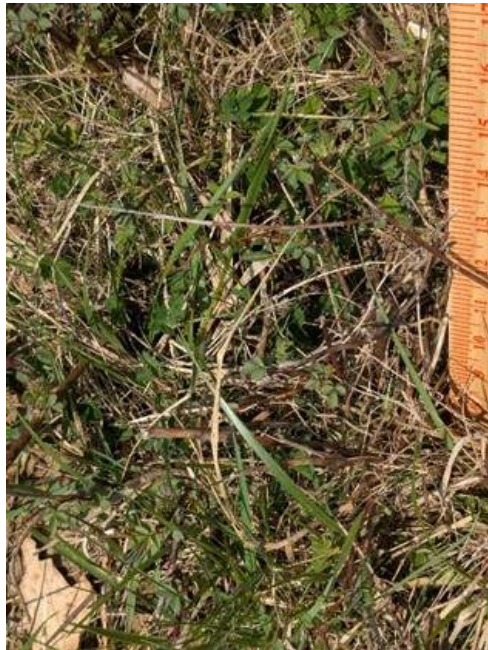
**Photograph No. 18**

Animal burrow along the upstream side of the embankment. Approximately 7 inches deep and 1.5 inches in diameter.

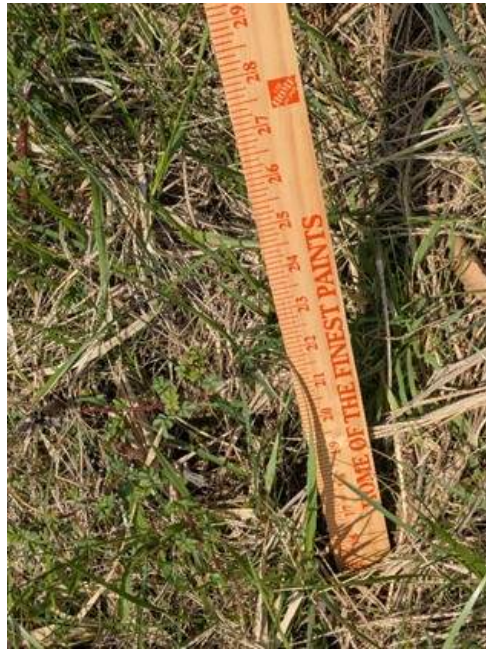
**Photograph No. 19**

Animal burrow along the upstream side of the embankment. Approximately 15 inches deep and 1.5 inches in diameter.

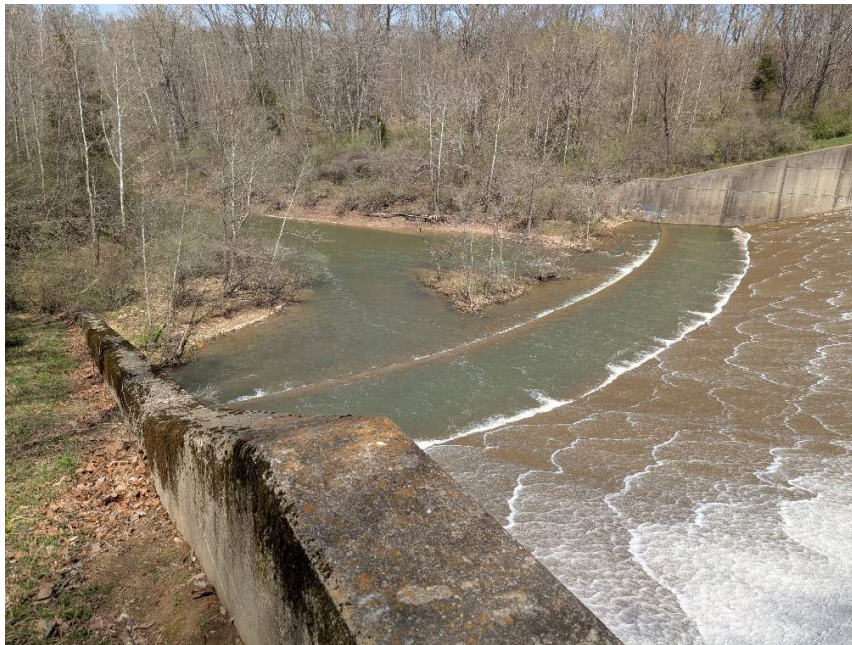
**Photograph No. 20**

West end of the primary spillway facing north. No apparent damage to the retaining walls, ogee spillway, or the stilling basin. Moss growth along the concrete.

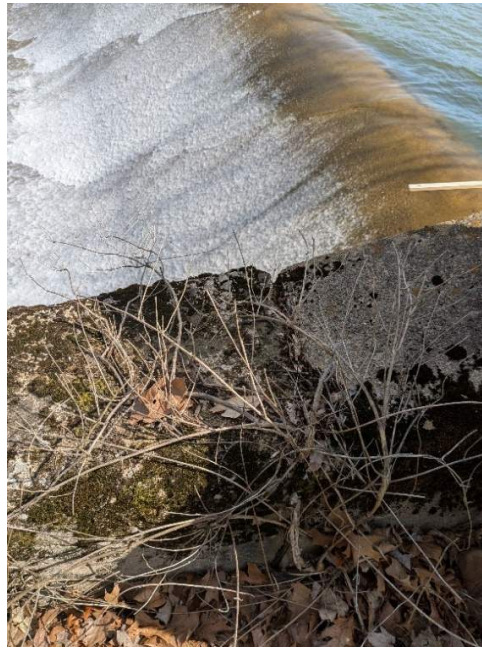
**Photograph No. 21**

West end of the primary spillway facing east. Vegetation growth along the retaining wall that appears to be growing in the joint. Minor deflection at the joint (less than 1/2 inch).

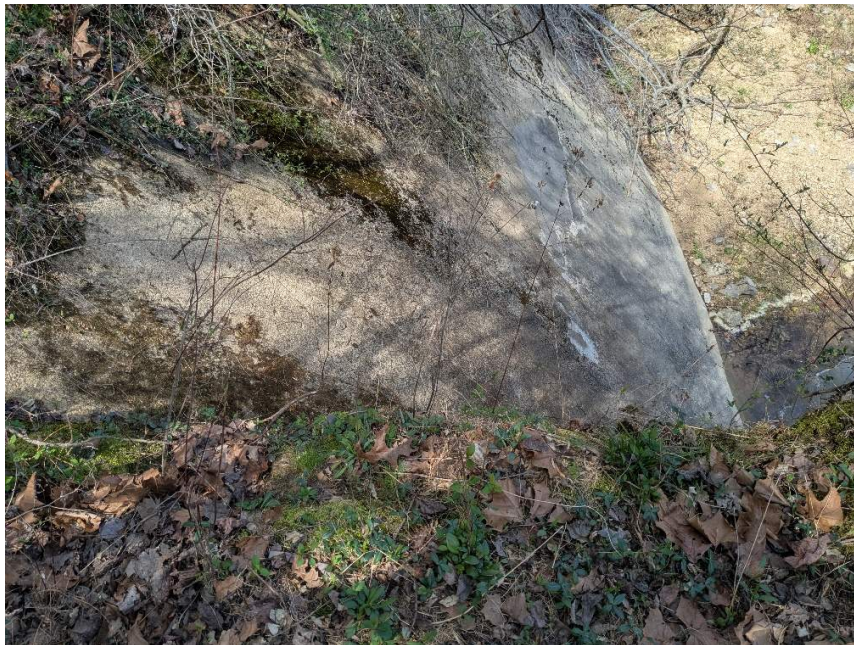
**Photograph No. 22**

West end of the primary spillway facing north towards the western downstream retaining wall. Minor erosion to be addressed.

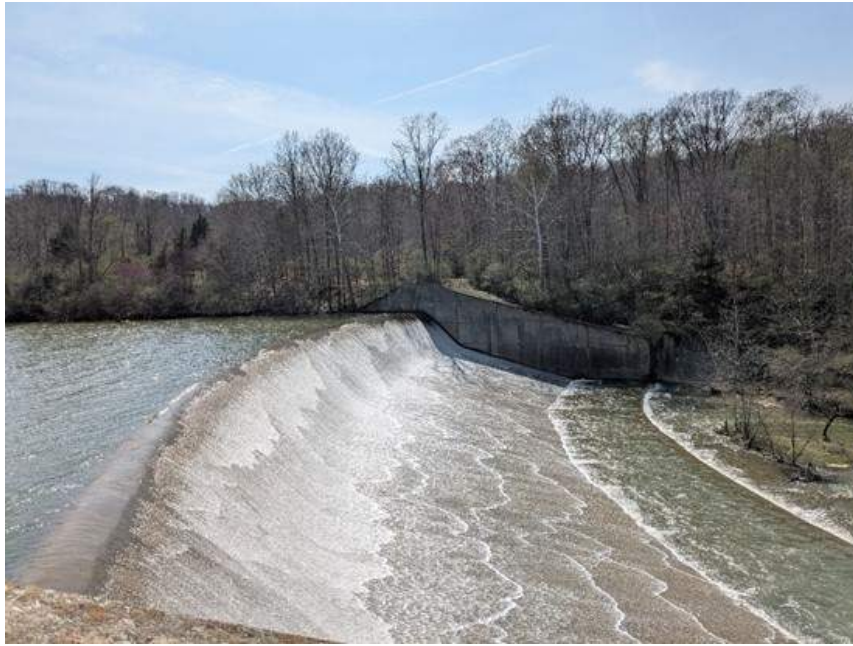
**Photograph No. 23**

East end of the primary spillway looking west. No apparent damage to the ogee spillway or opposite retaining wall.

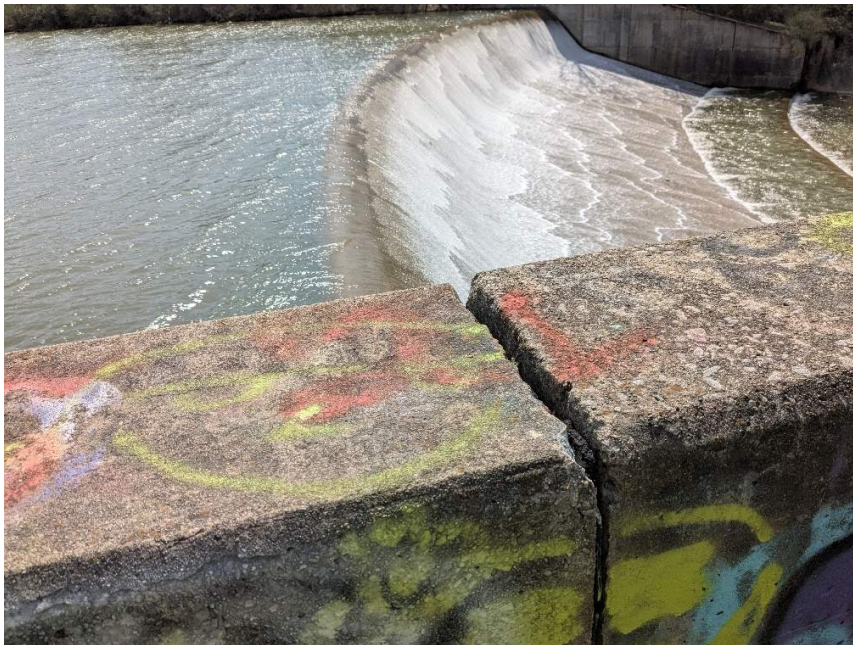
**Photograph No. 24**

The primary spillway did not change significantly since the last inspection. The previous inspection noted minor displacements of  $\frac{1}{2}$  to  $\frac{3}{4}$  inches at joints located along the eastern retaining wall. There appeared to be minimal changes, as the displacement is now  $\frac{3}{4}$  to 1 inch at the joints.

Eastern end of the primary spillway looking west. Deflection at a joint of the retaining wall.

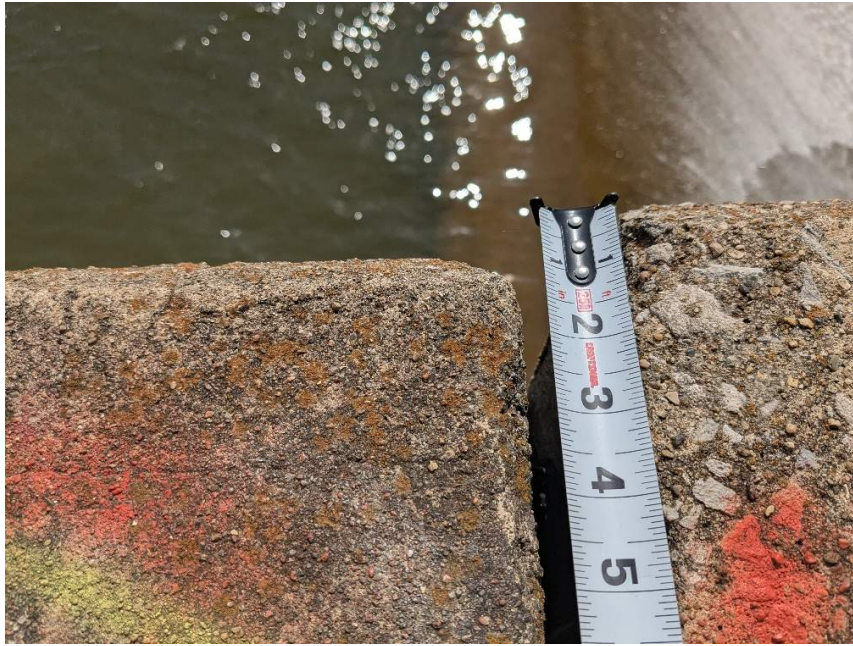
**Photograph No. 25**

East retaining wall of the primary spillway. Deflection at the joint of approximately 1 inch.

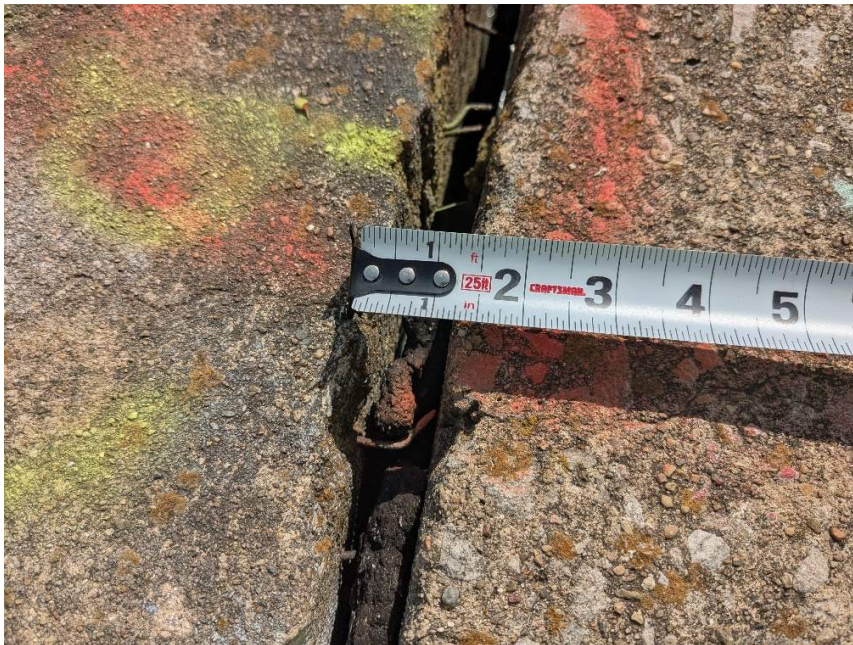
**Photograph No. 26**

East retaining wall of the primary spillway. Gap at the deflected joint appears larger than observed in the prior inspection.

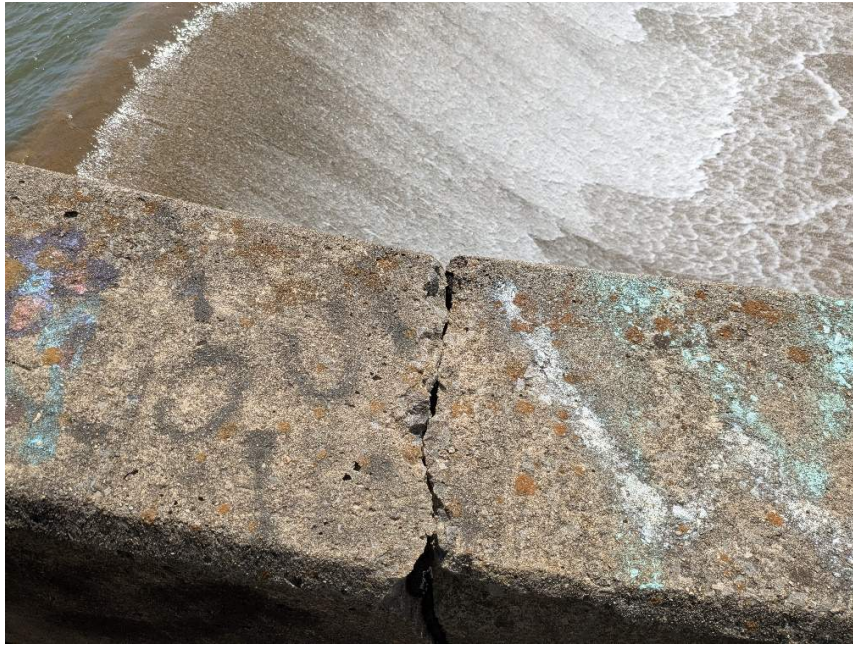
**Photograph No. 27**

East retaining wall of the primary spillway. Deflection and cracking appears to be new compared to the prior inspection.

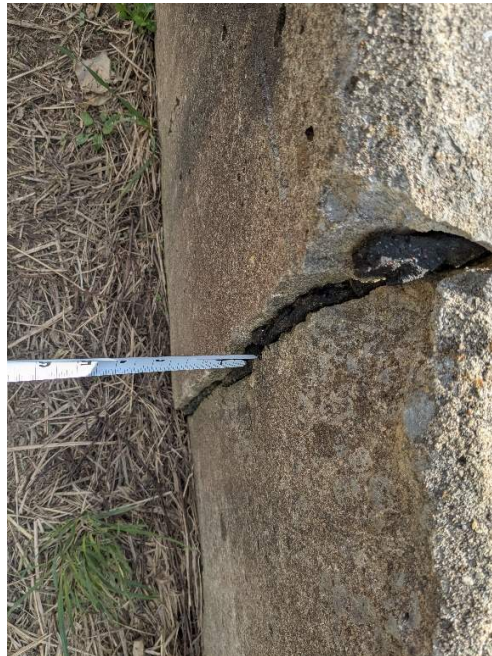
**Photograph No. 28**

East retaining wall primary spillway. Deflection along the crack of approximately 1 inch.

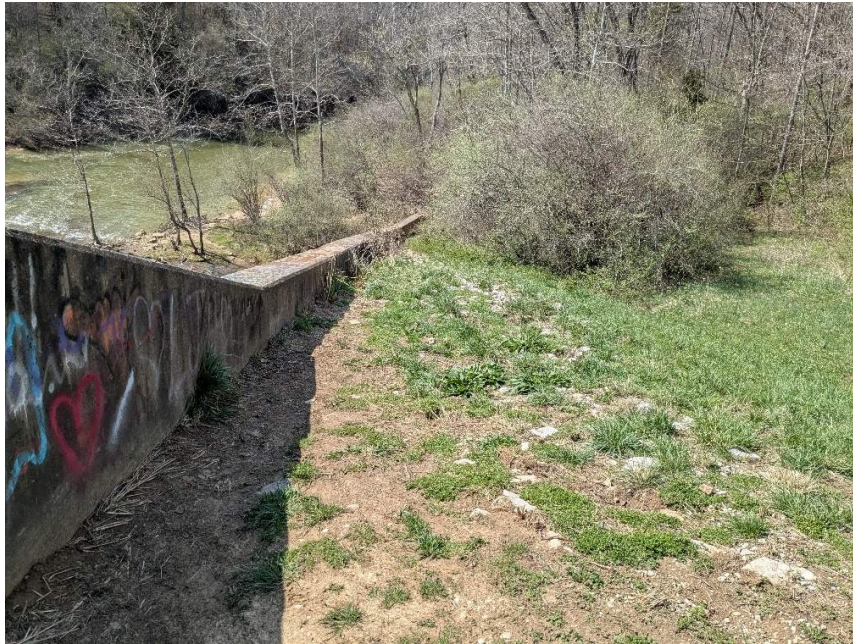
**Photograph No. 29**

East retaining wall of the primary spillway facing north. Minimal vegetation observed and no apparent damage to the retaining wall facing away from the ogee spillway.

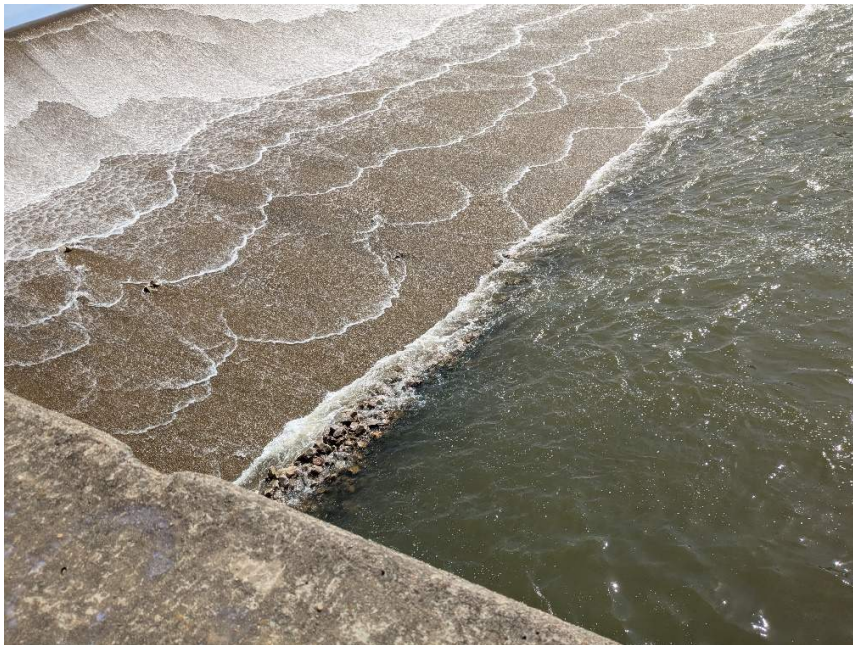
**Photograph No. 30**

There is riprap accumulation at the toe of the spillway in the stilling basin on the eastern side. It is recommended that the riprap be removed, and the area be continuously monitored for additional riprap deposition.

East retaining wall of the primary spillway facing south. Riprap accumulation along the upstream edge of the stilling basin to be removed.

5. Remove the riprap accumulated on the primary spillway stilling basin and continue to monitor and remove deposited riprap.
