2019 Lake Lemon Dam Inspection

Unionville, Indiana

Lake Lemon Conservancy District

February 2019

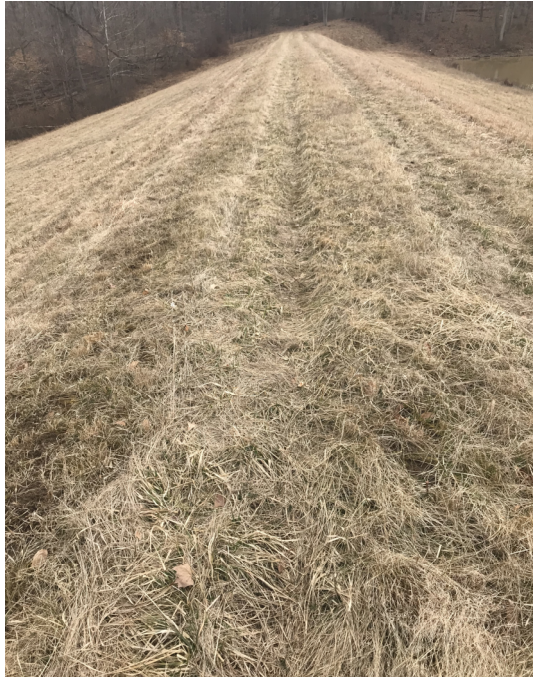
Photograph No. 1

Looking east - top of dam - minor rutting

B CREST	PROBLEMS NOTED: <input type="checkbox"/> (B-1) None <input checked="" type="checkbox"/> (B-2) Ruts or Puddles <input type="checkbox"/> (B-3) Erosion <input type="checkbox"/> (B-4) Cracks with Displacement <input type="checkbox"/> (B-5) Sinkholes <input type="checkbox"/> (B-6) Not Wide Enough <input type="checkbox"/> (B-7) Low Area <input type="checkbox"/> (B-8) Misalignment <input type="checkbox"/> (B-9) Inadequate Surface Drainage <input type="checkbox"/> (B-10) Trees, Brush, Briars <input type="checkbox"/> (B-11) Other _____
	Comments: Slight rutting due to tire tracks.

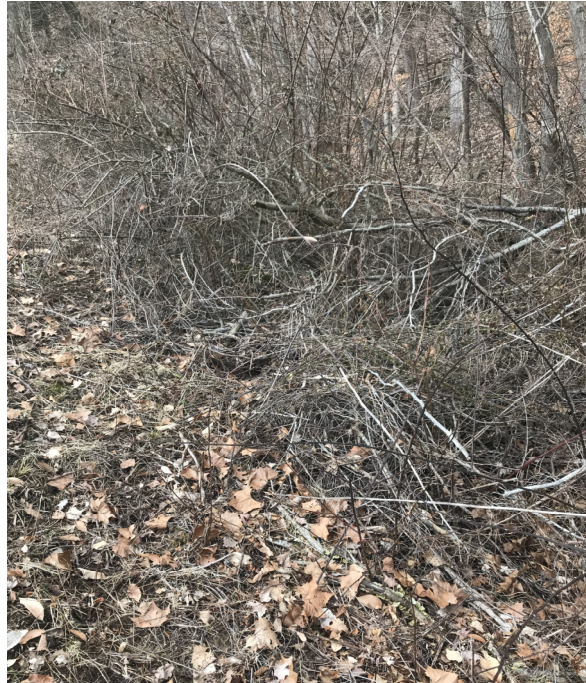
Photograph No. 3

On the northwest side of the downstream embankment there were several downed trees lying along the abutment. These trees should be removed immediately as they can cause problems with erosion which can lead to more serious problems. Downed trees can kill the underlying vegetation exposing bare dirt which will more easily erode away during rainfall events. Downed trees can also cause ponding of the rainfall runoff which also can lead to erosion of the soil. These downed trees as well as the brush was subsequently removed (see Photo 3A in the photo log).

Looking west at the west end of embankment (thorny debris to be removed). Debris has since been removed (see 3A below)

Appears to be soft soils at surface only with no seepage apparent. Woody vegetation observed at the west abutment area and at the toe of the downstream slope. There remain several downed trees that have fallen onto the west abutment of the downstream embankment.

- i. Downed trees along the western side of the downstream embankment should be removed immediately as they can cause serious problems if left unattended to. (Photograph 3). *Update: within a week of the inspection, Photo 3A came in showing this area had been cleared*

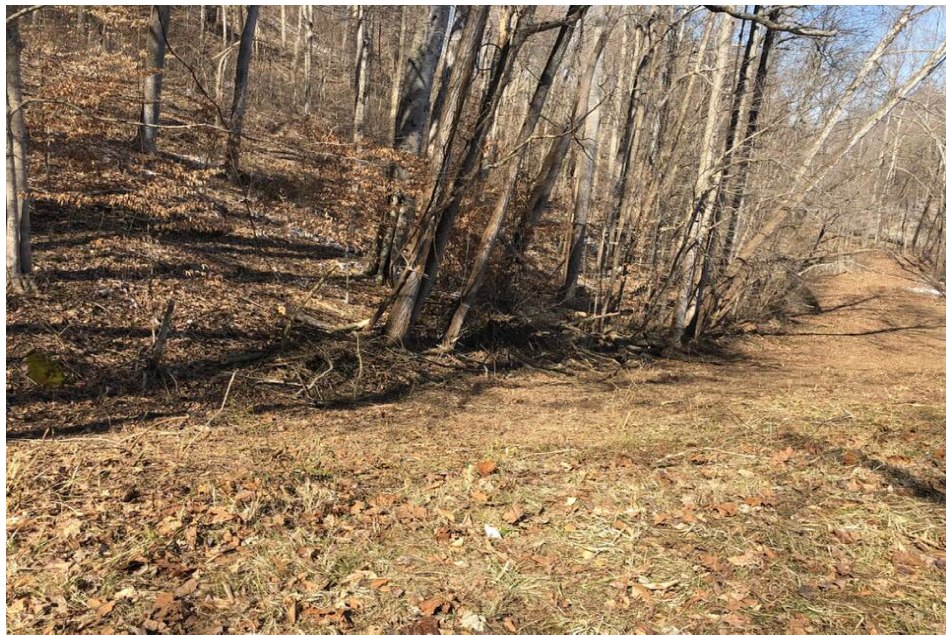
Photograph No 3A

Looking west at the west end of embankment (debris has been removed)

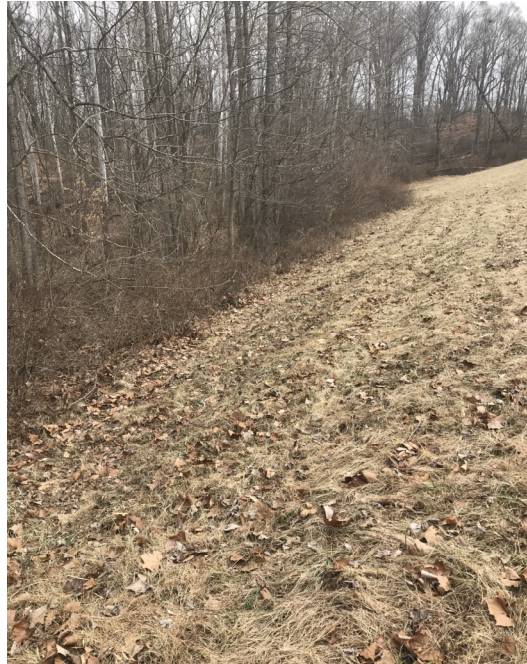
Photograph No. 4

Looking east at westerly toe of dam - no seepage

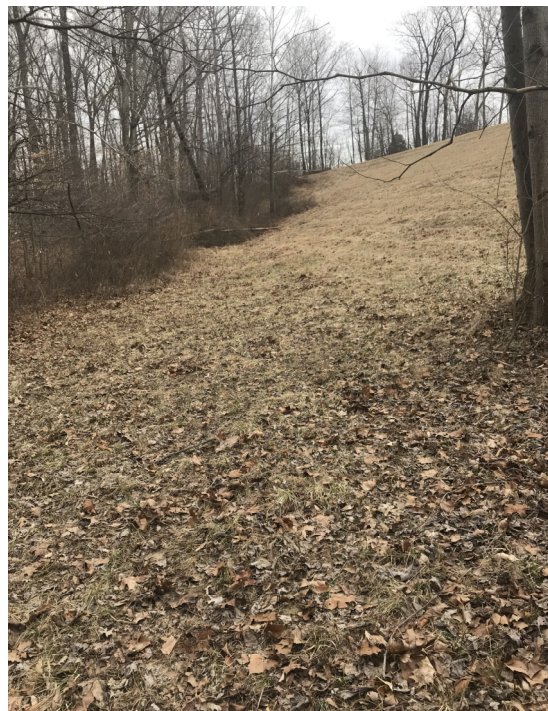
Photograph No. 5

Looking east at easterly toe of dam - no seepage

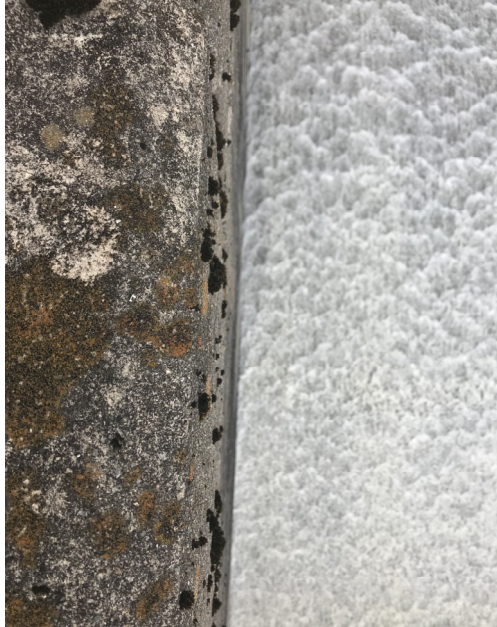
Photograph No. 8

Looking vertically down west retaining wall of ogee (no panel displacement)

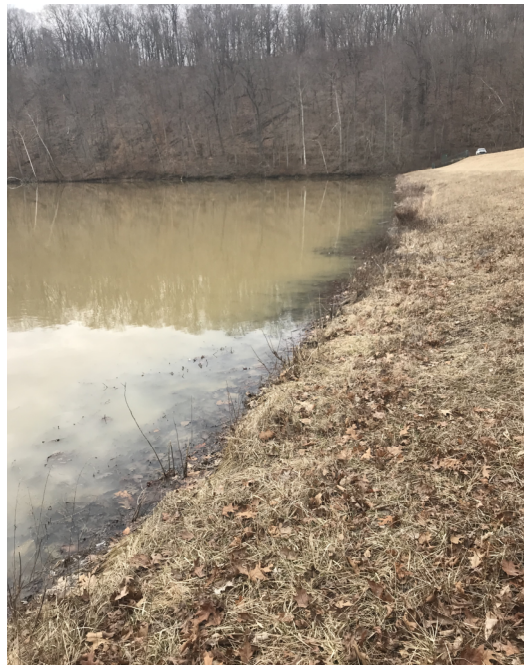
Photograph No. 9

Looking west along upstream toe of the embankment (no erosion).

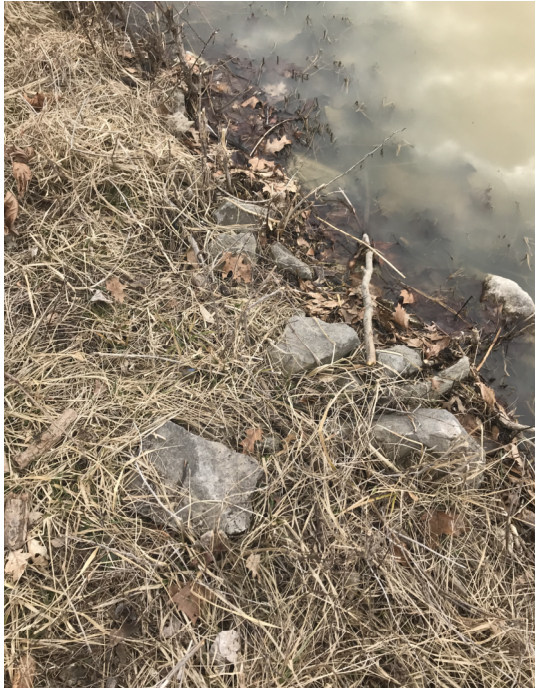
Photograph No. 10

Looking west along upstream toe of the embankment showing embedded riprap.

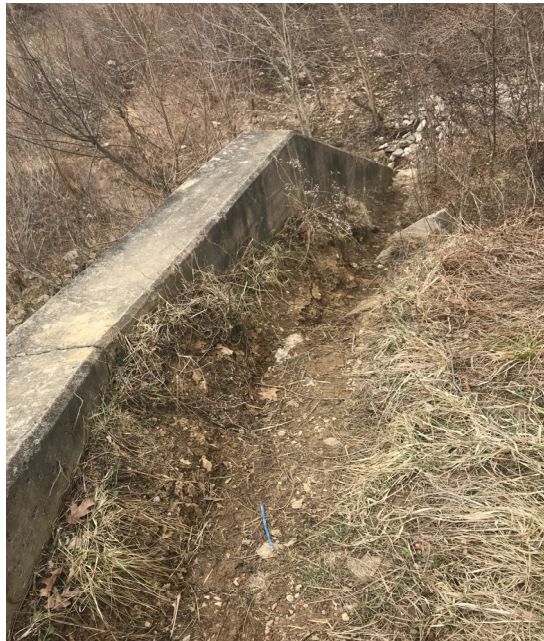
Photograph No. 11

Looking downstream along east ogee retaining wall showing some erosion to the toe

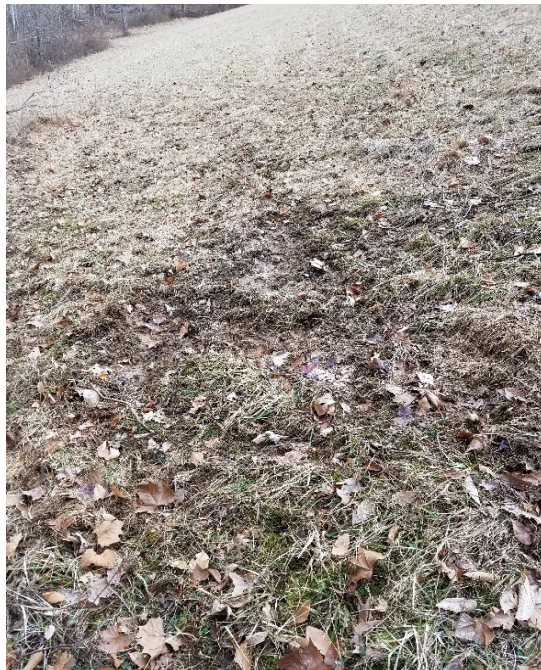
Photograph No. 13

Looking east at northern slope of dam - no seepage

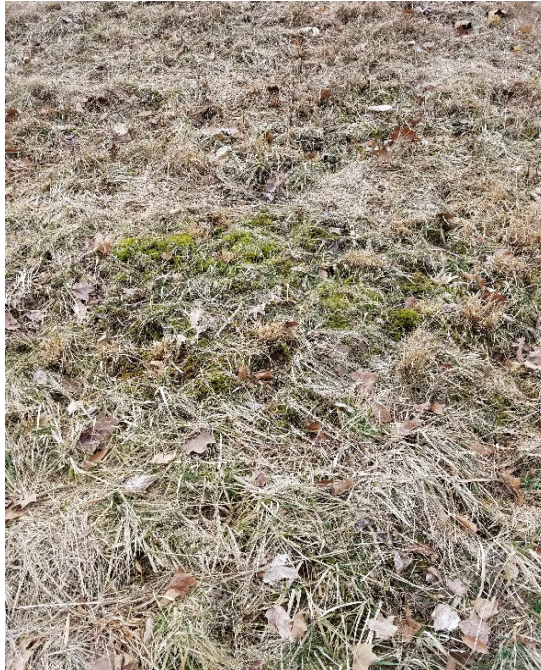
Photograph No. 14

Looking south at northern slope of dam - no seepage

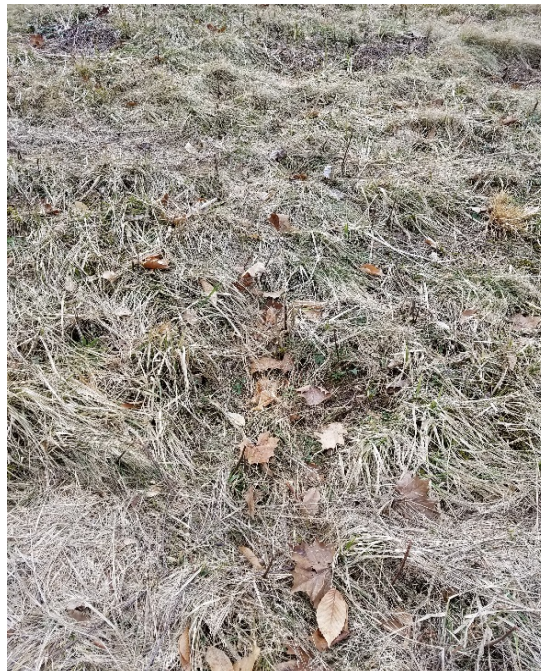
Photograph No. 15

Looking south at northern slope of dam - no seepage

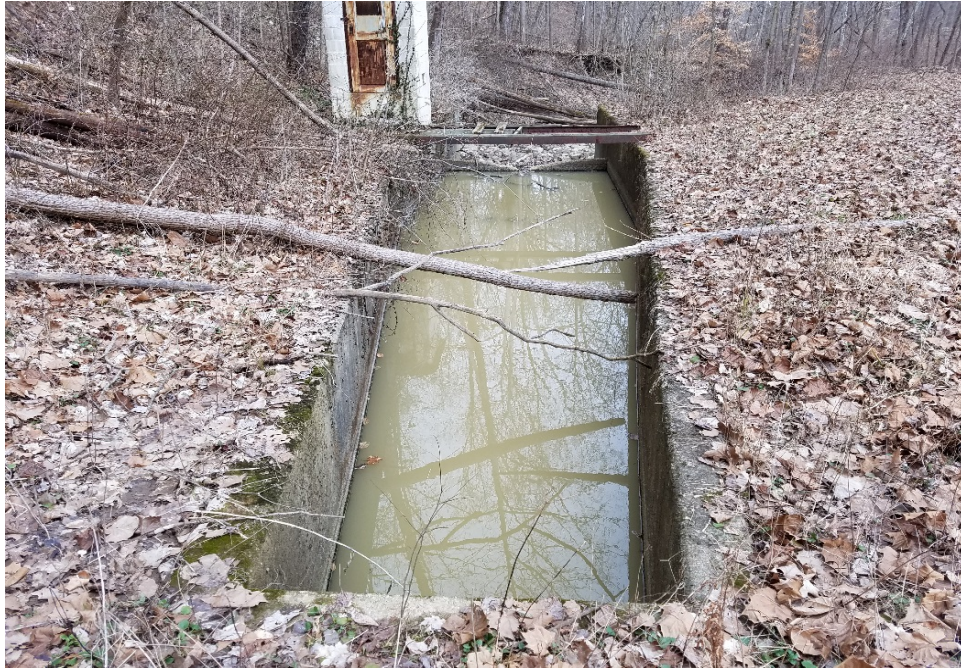
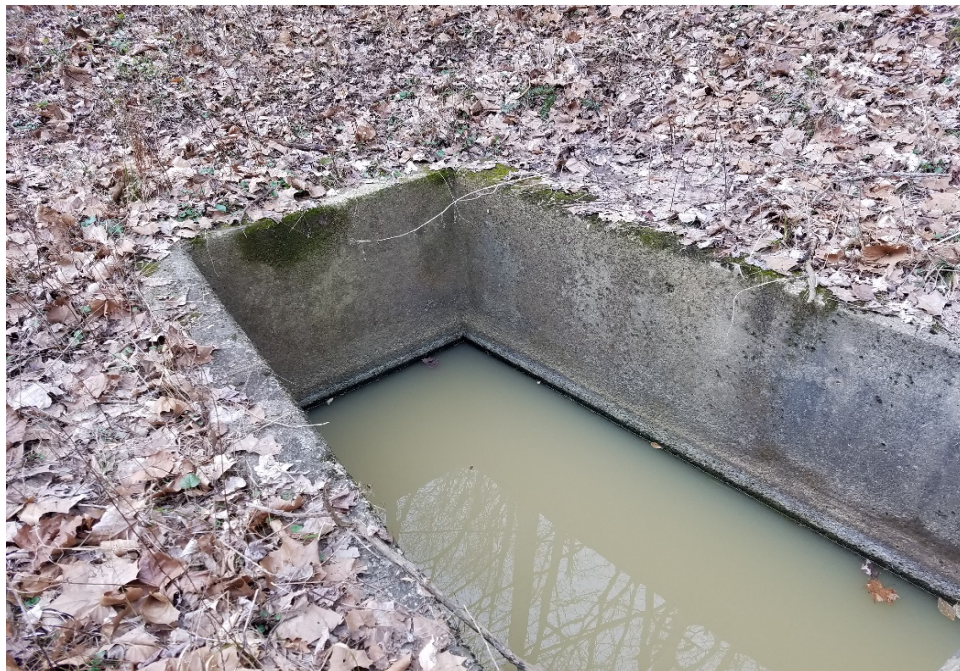
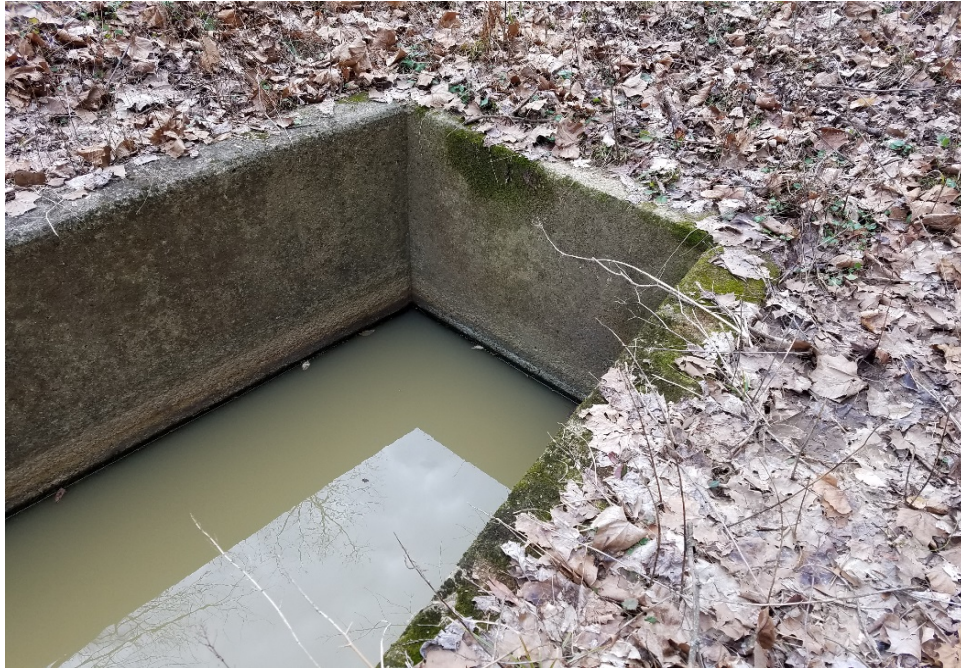
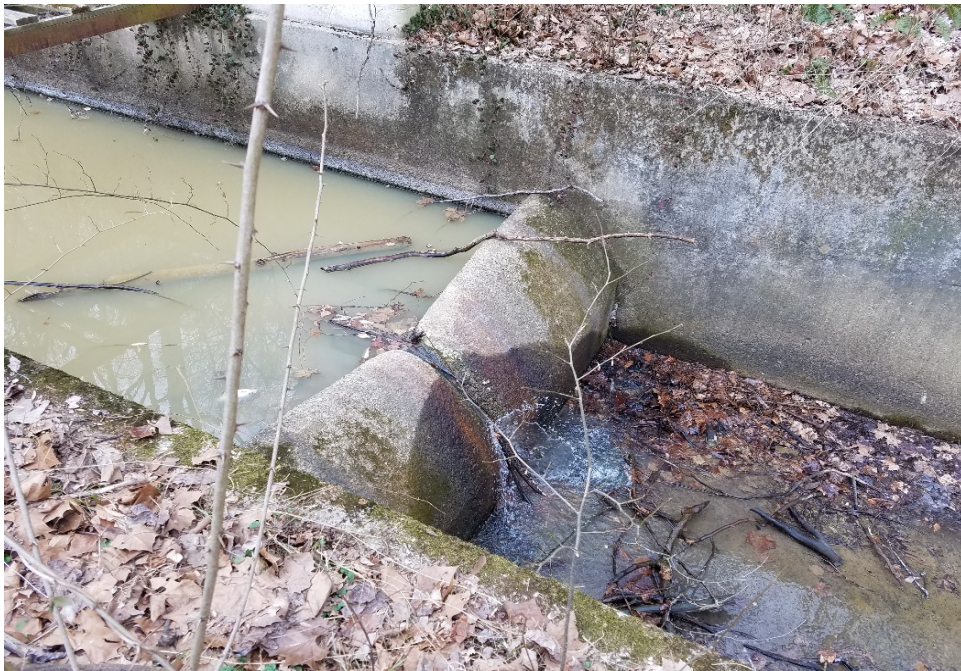
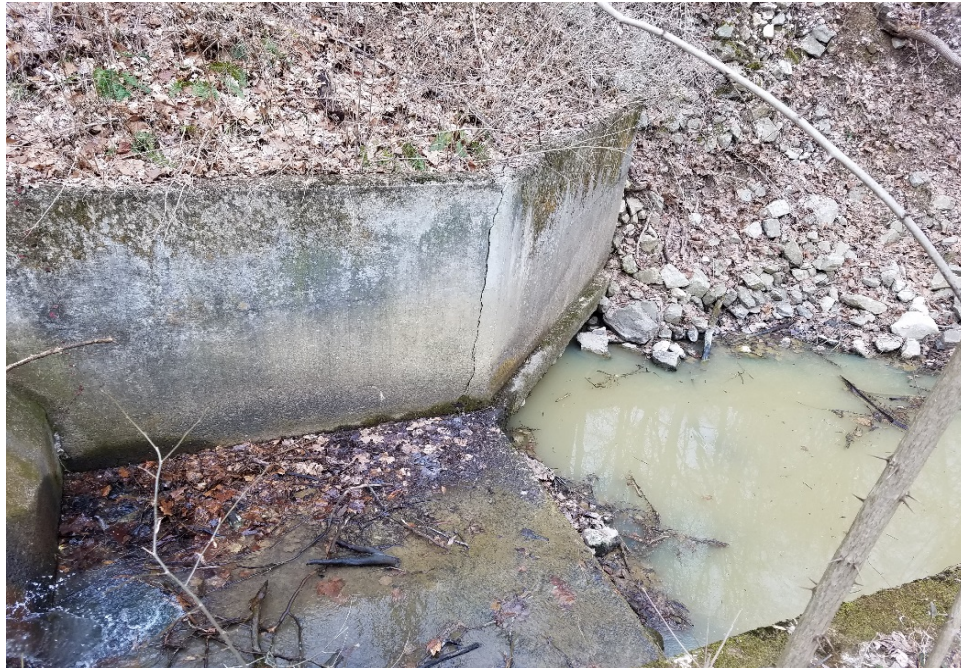
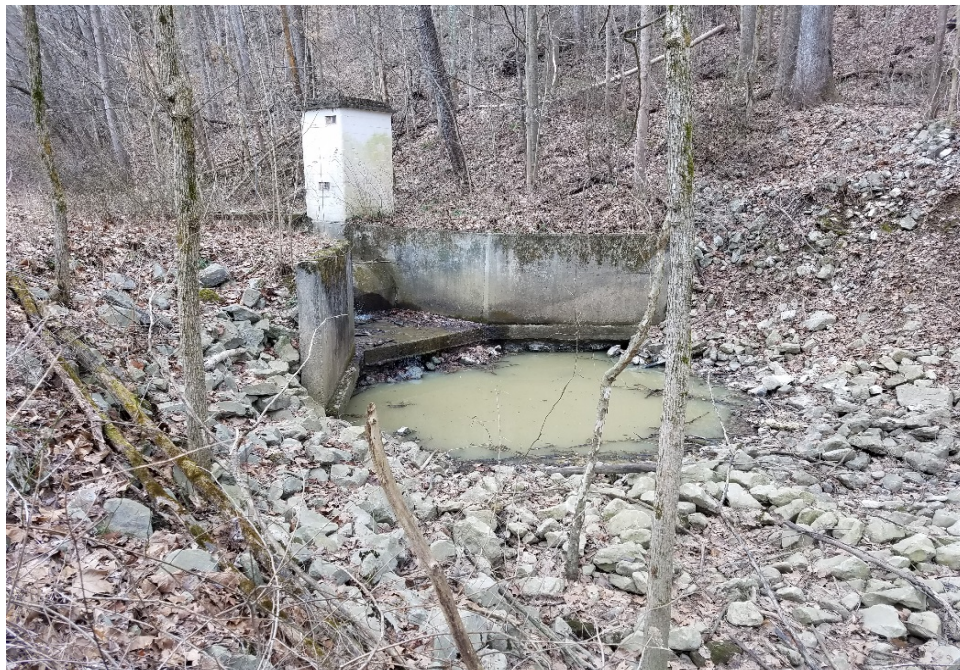
The visible portions of the principal spillway appeared satisfactory and the stilling basin conditions appeared to remain unchanged from previous inspections. There is a large crack observed in the left wall near the end of the stilling basin. The channel immediately downstream of the stilling basin appears to be scoured deeply. The footings for the retaining walls downstream of the stilling basin appear to be undermined. The record drawings for the stilling basin show that there are cut-off walls beneath the retaining wall footings that are up to 3-feet below the bottom of footing. The scour depth may be nearly that deep and corrective measures should be implemented to bury the retaining wall footings. It is recommended the scoured area be backfilled with properly-sized riprap or be backfilled with concrete. Because of the high hydraulic forces in the stilling basin and downstream channel when the principal spillway is operating at high flow, riprap size is expected to be very large in order to remain in place in the channel.

Long vertical crack in the west wing wall of the stilling basin at end of sluiceway. There is also a problem with scouring downstream of the stilling basin at end of sluiceway.

- ☒ (5) Repair: Repair the riprap that has been scoured from the downstream side of the stilling basin of the drawdown sluiceway.
- ☐ (6) Provide Surface Drainage For: _____

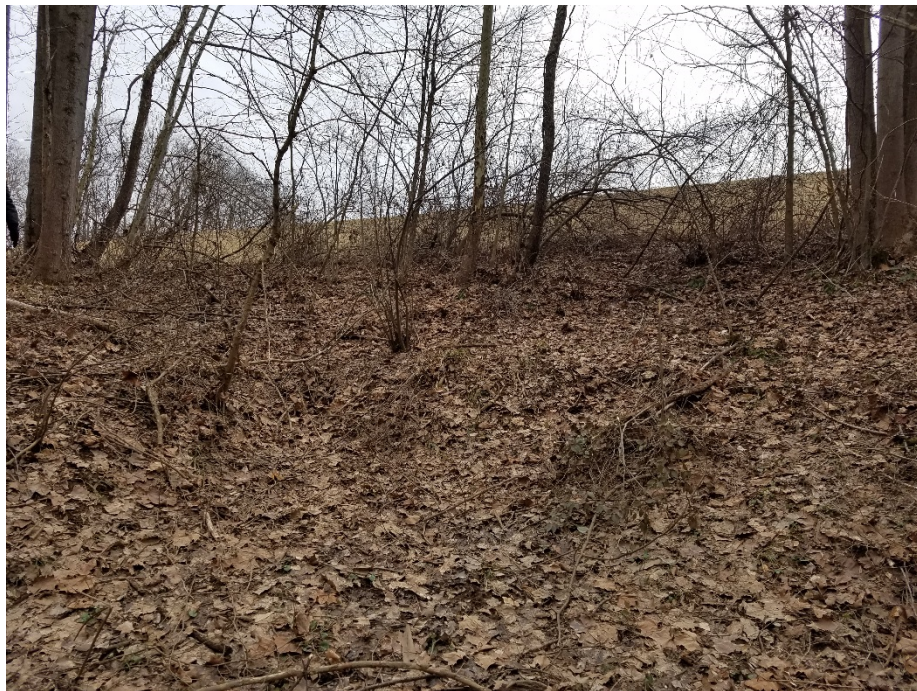
Photograph No. 25

Looking south at vegetation north of earthen embankment toe

It is recommended that all woody vegetation near the former stream channel area on the downstream embankment be removed so that this area can be monitored visually on a monthly basis. Seepage or soft ground should be reported immediately to the dam engineer.

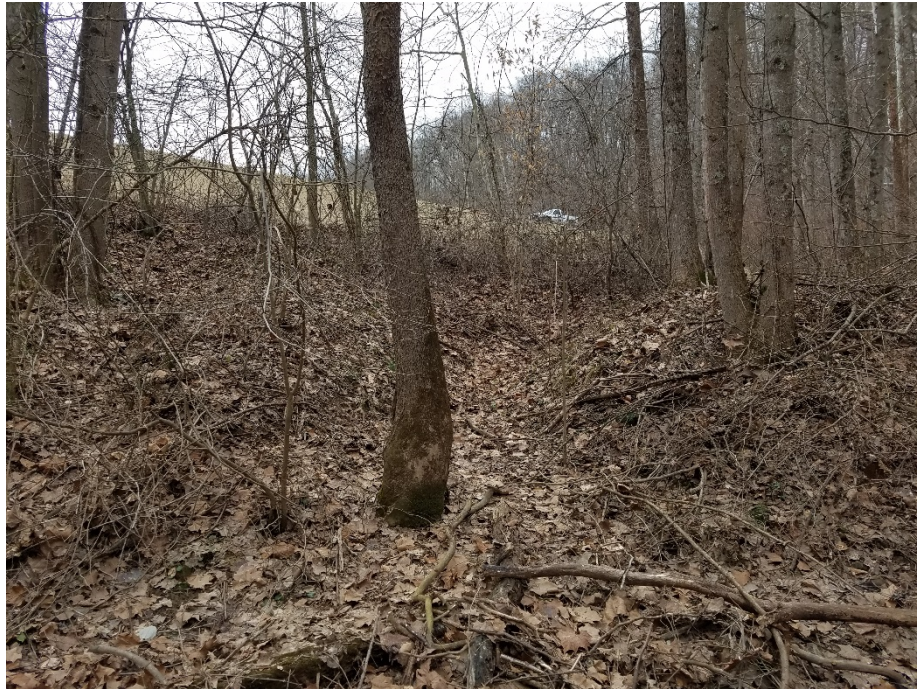
Photograph No. 26

Looking south at vegetation north of earthen embankment toe

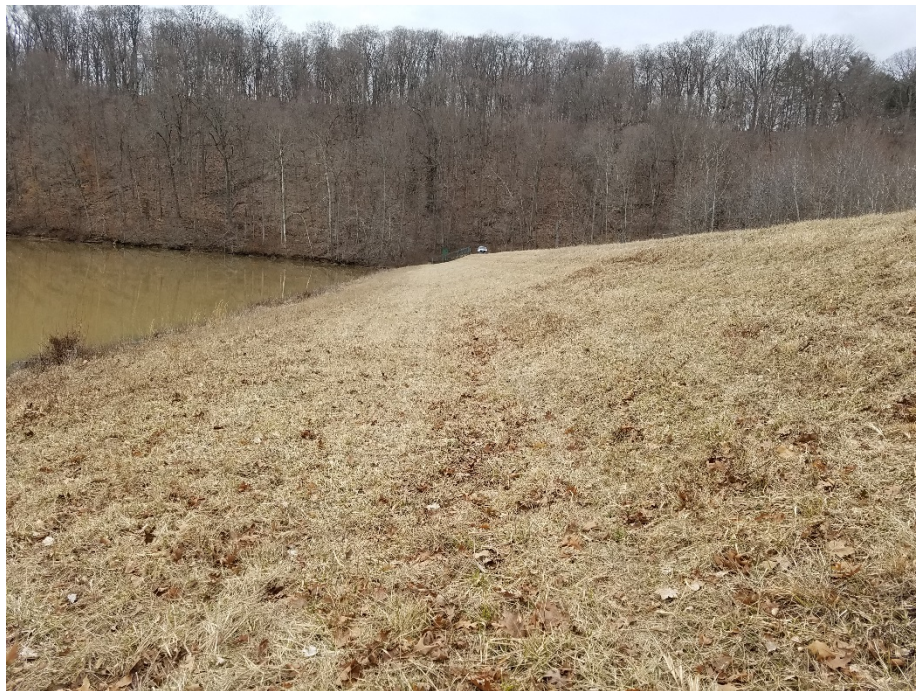
Photograph No. 35

Looking west along upstream toe of the embankment (no erosion).

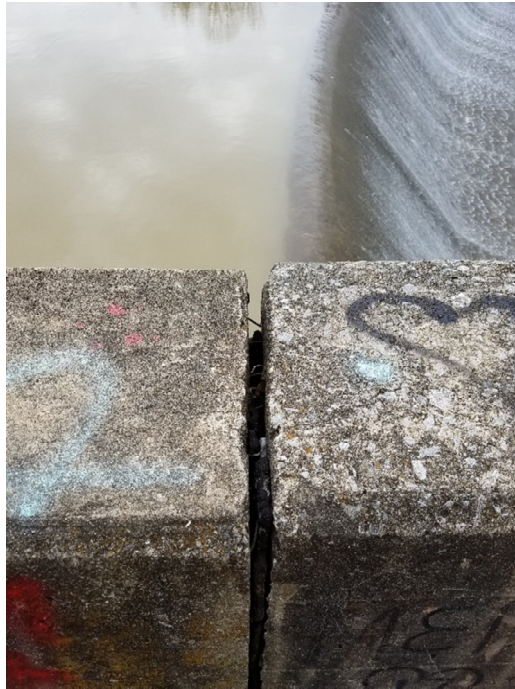
Photograph No. 40

There is significant erosion along the outside of the east slope wall. Erosion measures should be used in this area and continue to monitor for slope wall movement.

Looking west at east slope wall of Auxiliary Spillway (possible separation)
