Lake Lemon SRP Map Showing Sediment Removal Area 116

SRP Completed in 2006

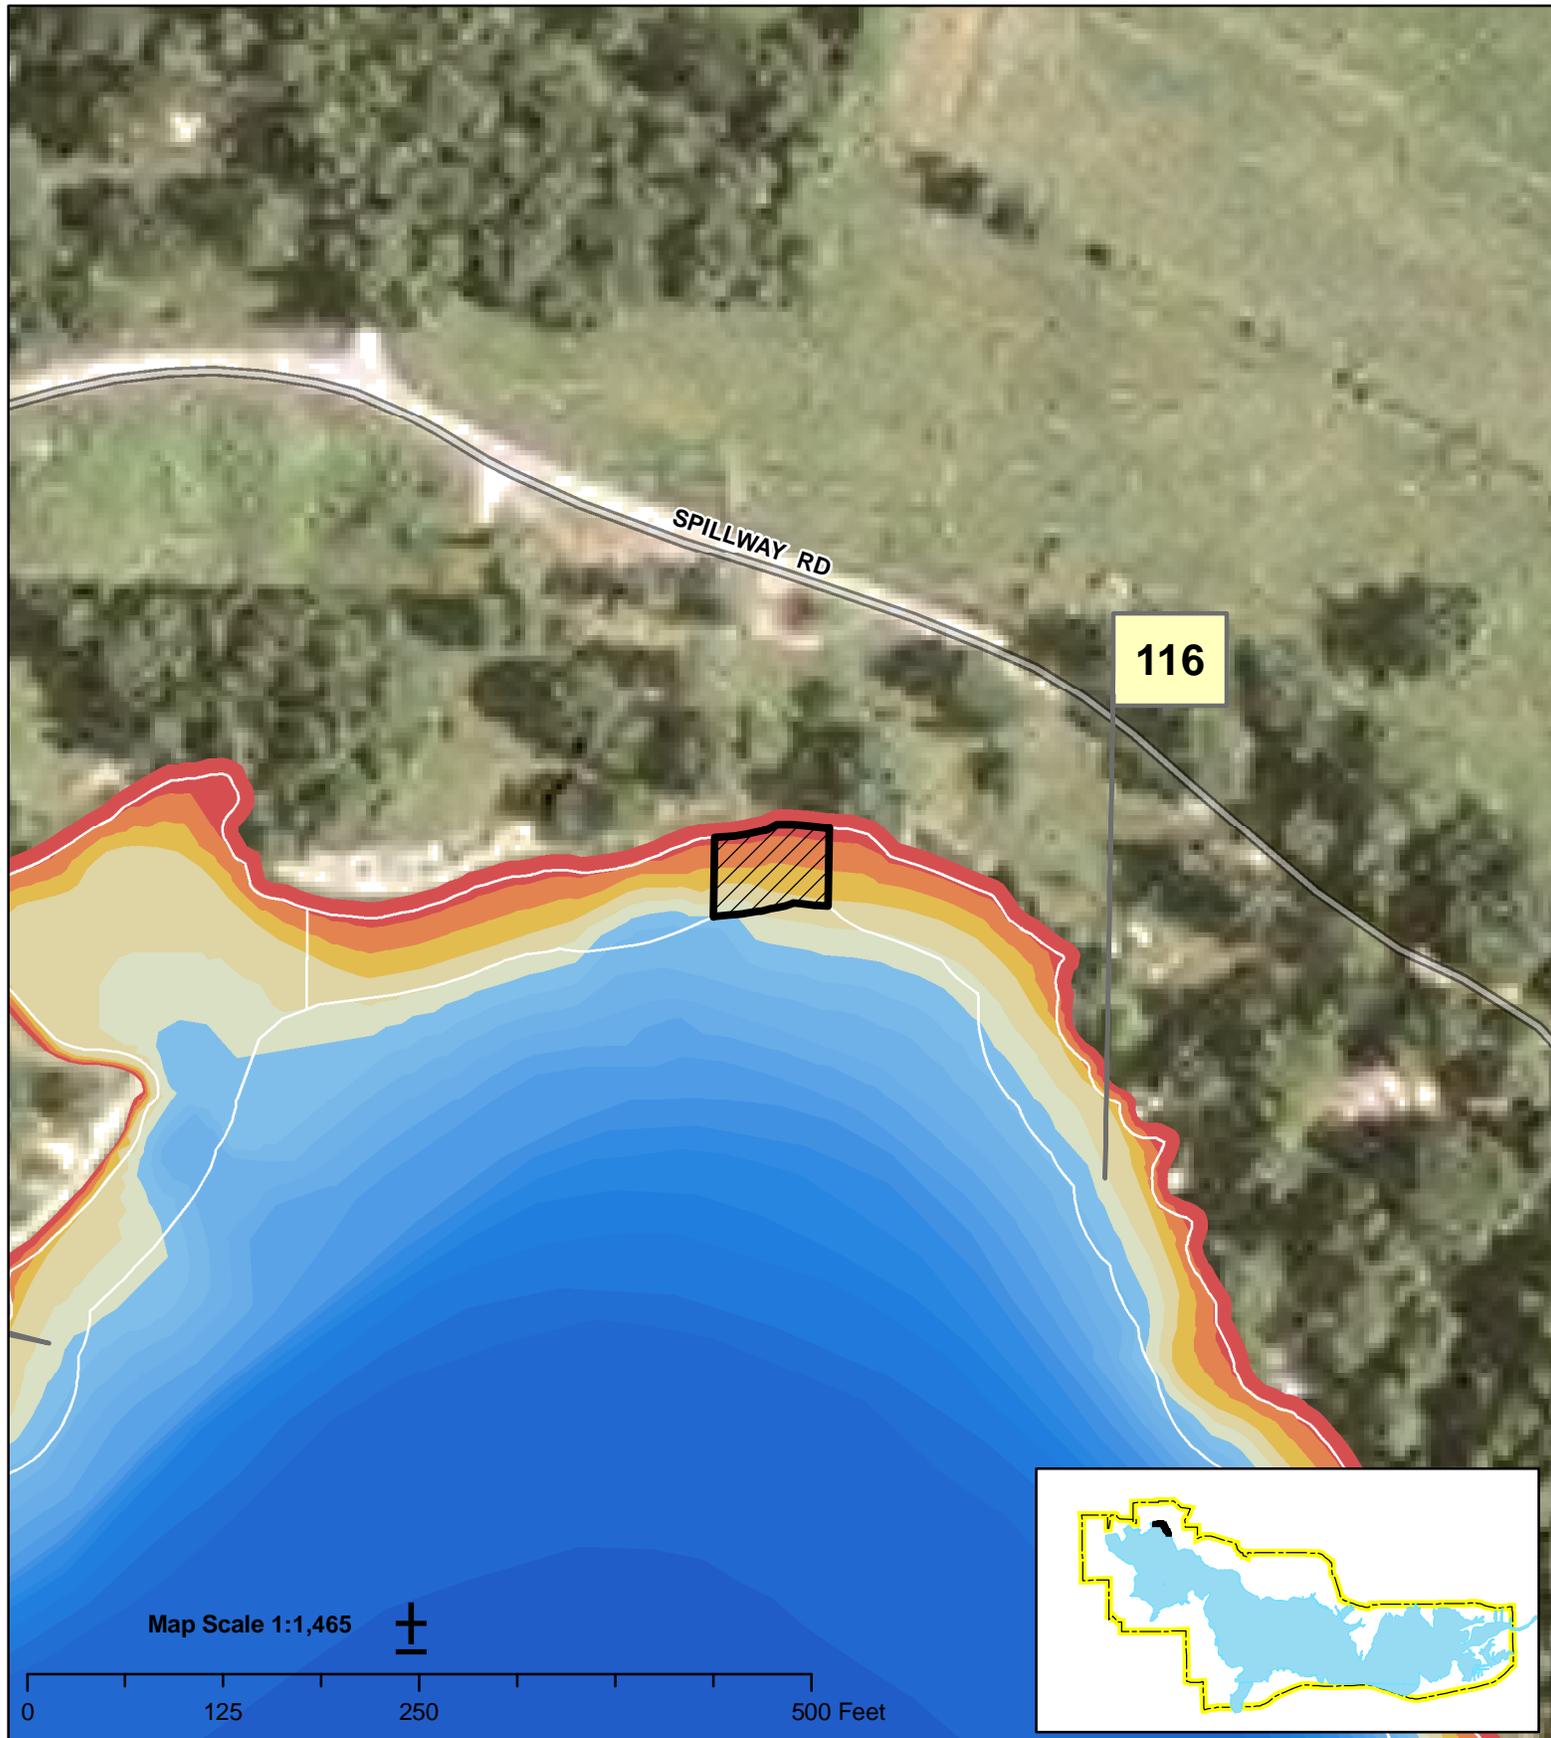
The Sediment Removal Area 116 has been dredged to provide a mooring area for the barge and an unloading area for the dredged material. The barge hauled away 6 loads, totalling 360 cubic yards of sediment.
