Lake Lemon SRP Map Showing Sediment Removal Area 117

SRP Completed in 2007

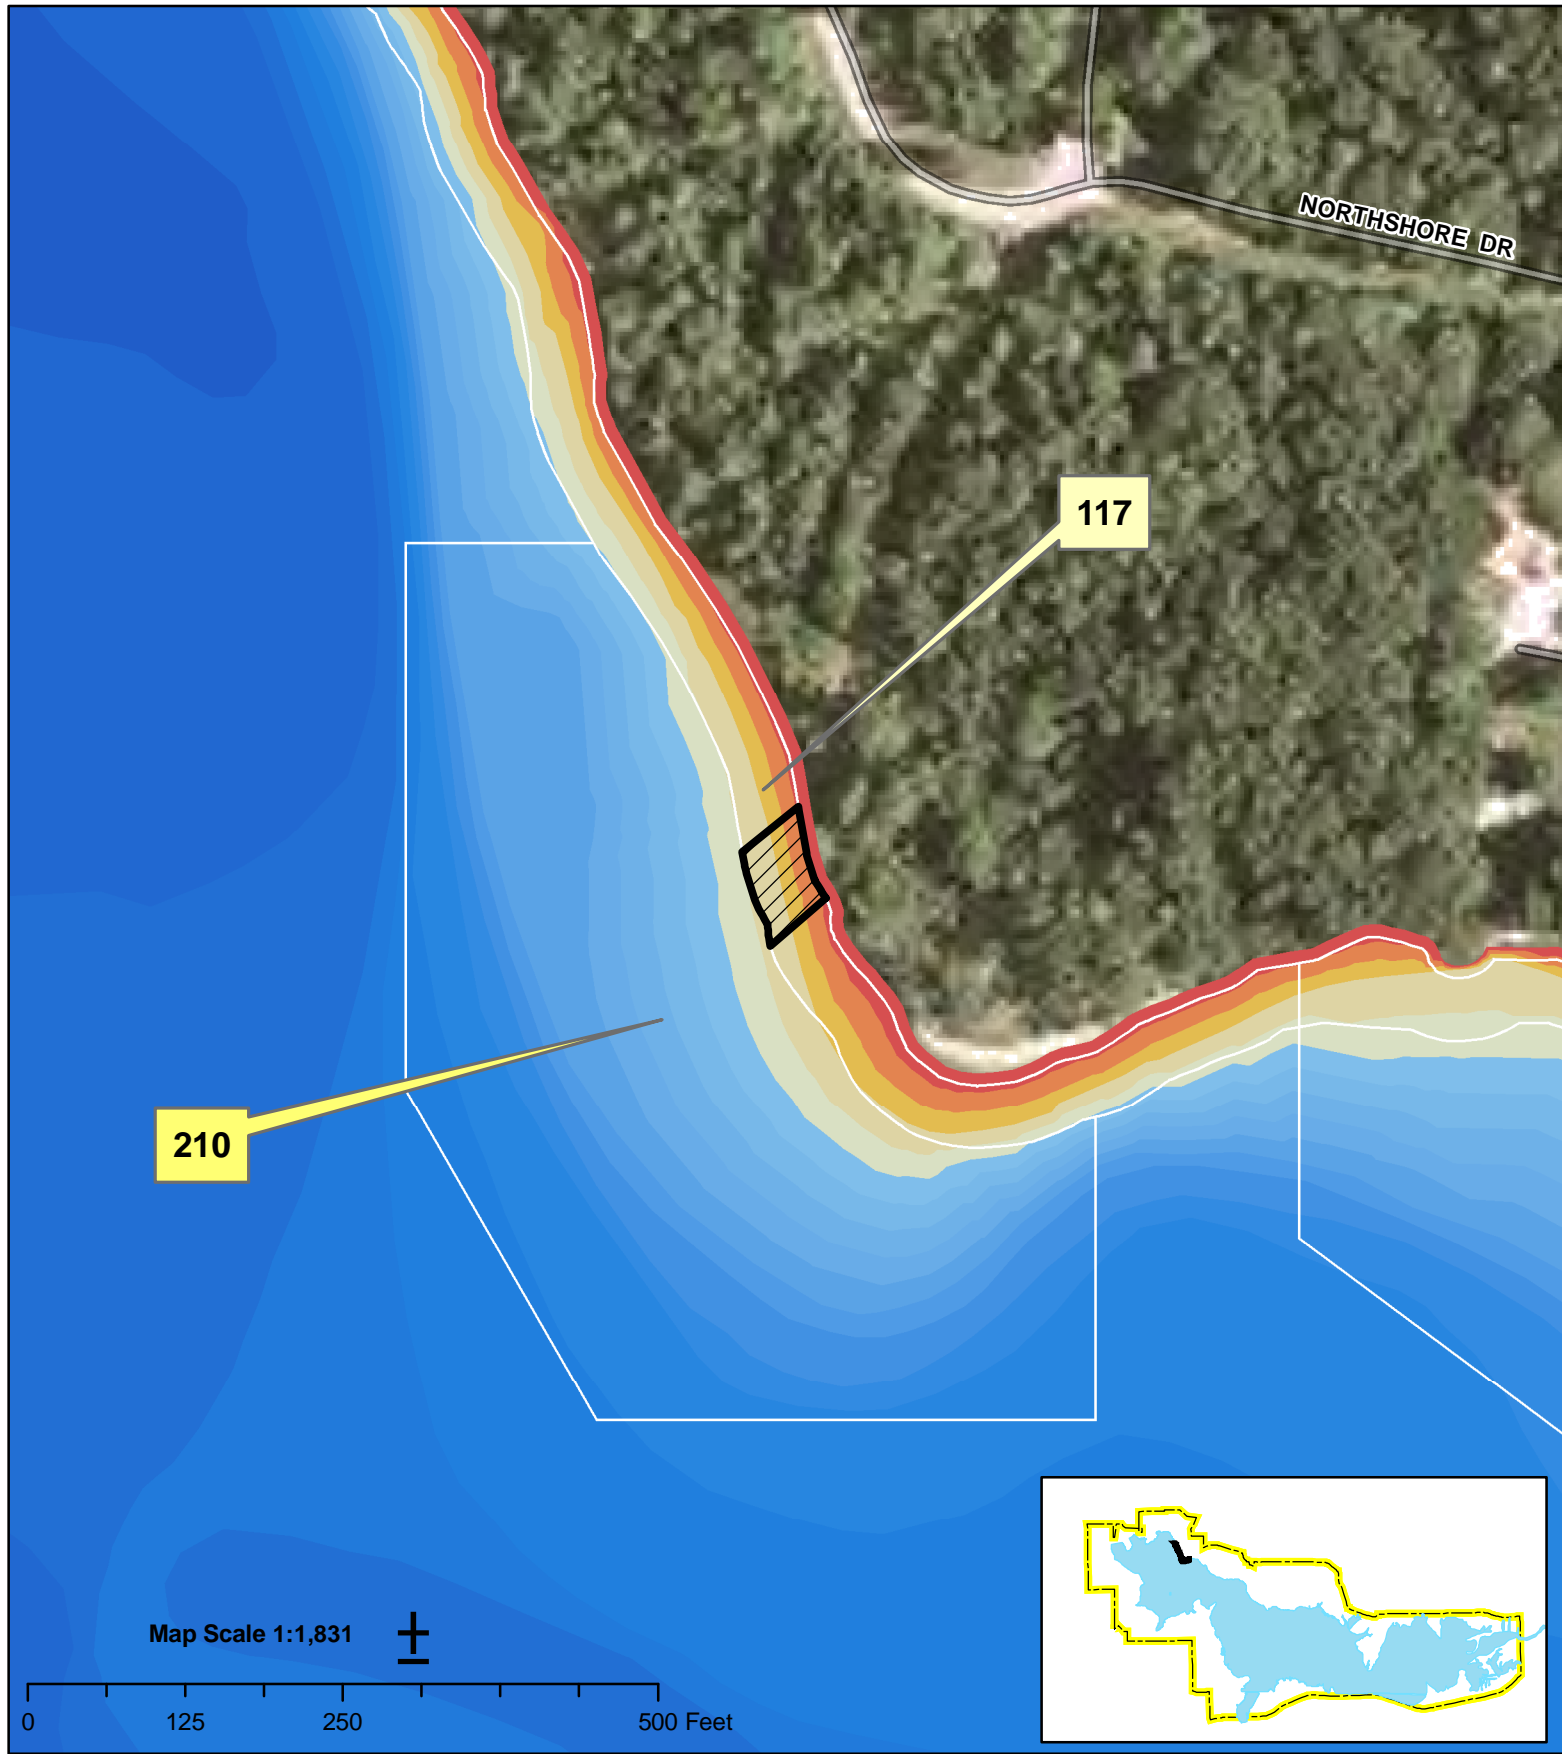
The Sediment Removal Area 117 has been dredged to provide an alternate mooring area for the barge. The barge hauled away 3 loads, totalling 240 cubic yards of sediment.
